Experimental Simulation of the Paks-2 Cleaning Tank Incident Through Separate Effect and Integral Tests

Z. Hózer, M. Horváth, M. Kunstár, L. Matus, I. Nagy, T. Novotny, E. Perez-Feró, A. Pintér-Csordás, N. Vér, A. Vimi, et al.

*Hungarian Academy of Sciences KFKI Atomic Energy Research Institute, H-1525
Budapest, P.O. Box 49, Hungary*

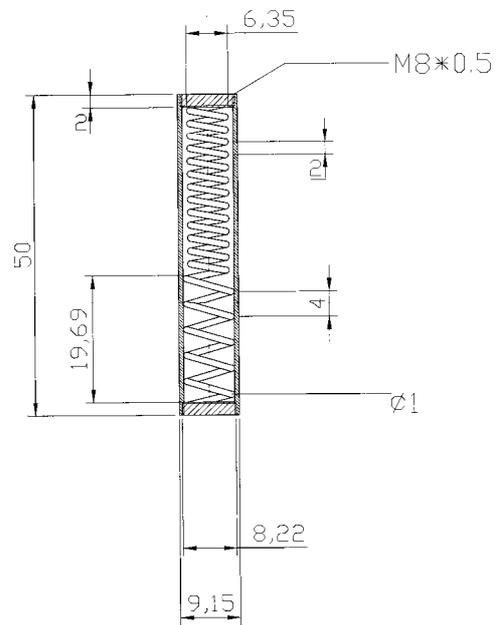
Hózer, Fig. 6.

Fig. 6. Schematic view of a cladding sample with spring

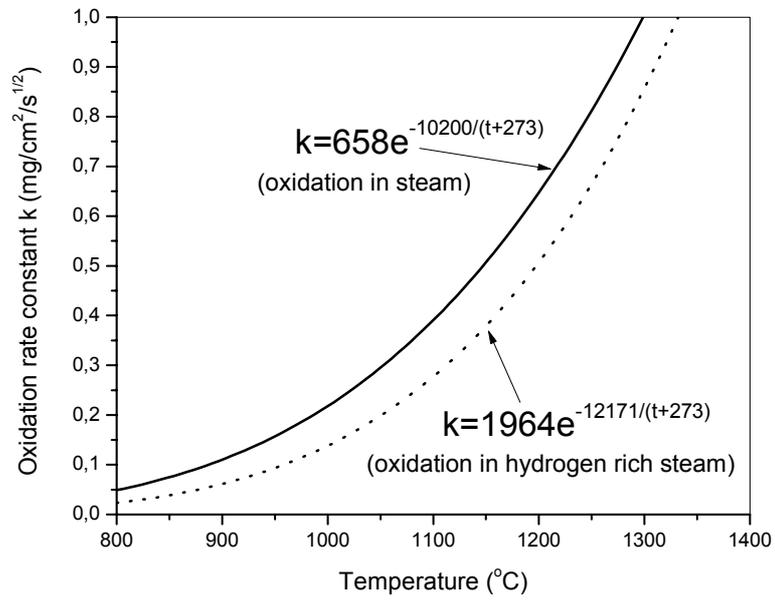
Hózer, Fig. 10.

Fig. 10. Oxidation rate constants for E110 as functions of temperature in steam and steam-hydrogen mixture

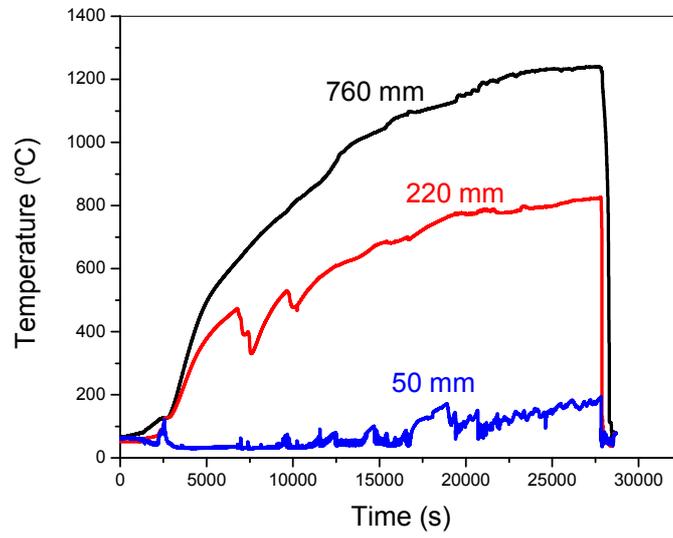
Hózer, Fig. 14.

In the CODEX-CT-1 test the fuel rods were pressurized in the beginning of the test to different values. The rods with high pressure lost their integrity due to burst at 800-900 °C. Long ballooned sections were observed in the post-test examinations. The hottest part of the rods was in the central-upper section at about 700 mm elevation. The bottom part of the rods (about 50 mm) was cooled by water and the temperatures remained low in that section. The fuel rods and bundles suffered severe damage during the tests. The final state was characterized by fragmentation, formation of cracks and brittle failure of the Zr components. The bottom part of the fuel bundle that was cooled by water remained intact. The experience of handling of fuel rods after the test showed that the material was very brittle: even a small mechanical load lead to further fragmentation of the cladding and the shroud. Cross section of the CODEX-CT-1 bundle is shown in Fig. 13. Large ballooning of the tubes can be noticed in both cross sections. In the lower cross section the accumulation of fuel rod fragments can be seen which were fallen down from higher elevations. In the preliminary test and CODEX-CT-1 test the produced hydrogen was released from the test section meanwhile the internal pressure of the cleaning tank model was kept constant. During those two tests 200-300 dm³ of H₂ was released, the atmosphere contained 60-80 vol.% hydrogen and the average degree of oxidation was above 20% ECR. The maximum temperature during the oxidation phase reached 1250 °C in the upper part of the bundle (Fig. 14).

Fig. 14. Temperature histories in CODEX-CT-1 test

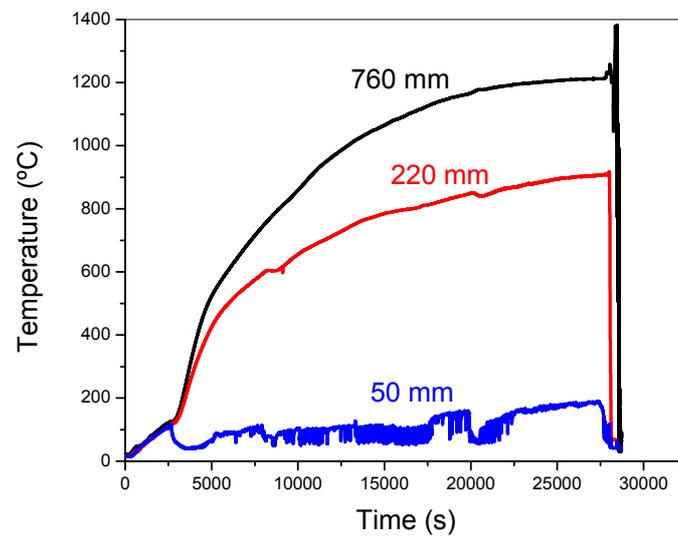
Hózer, Fig. 15.

In the CODEX-CT-2 test hydrogen was not released from the tank model during the dry phase. The oxidation was much less before quenching, for the produced hydrogen could not escape and it filled up the volume of the cleaning tank. Large amount of the produced hydrogen was taken up by the zirconium components of the bundle. The final quenching led to significant temperature increase in some positions. Fig. 15 shows that the maximum temperature reached during the oxidation phase was 1250 °C, but during quenching the peak value was 1380 °C. In the CODEX-CT-1 test there was no temperature increase during quench, since the rods were highly oxidized before this phase. In the CODEX-CT-2 test the oxidation was much less and the high temperature surfaces reacted with the cold water. The bundle was even more brittle than in the previous test. The fuel rods were broken into pieces inside of the assembly and the shroud was also severely damaged.

Fig. 15. Temperature histories in CODEX-CT-2 test

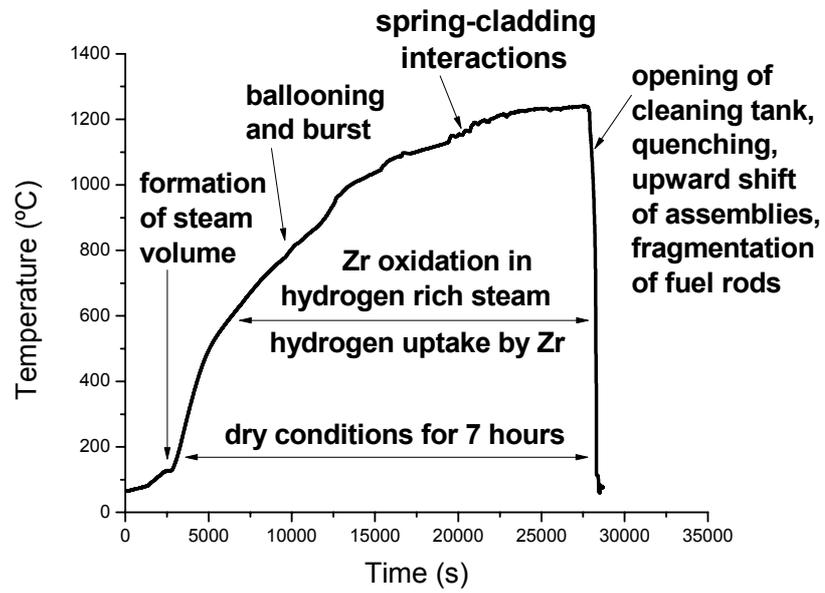
Hózer, Fig. 16.

The CODEX-CT integral tests simulated the main events of the Paks-2 incident, but the investigation of some special phenomena needed special separate effect tests. The sequence of fuel behaviour related events could be deduced considering both integral and separate effect tests. Fig. 16 shows the temperature history curve of CODEX-CT-1 test with the indication of the temperature ranges for several events and processes.

Fig. 16. Probable sequence of events in the Paks-2 incident
