Non-destructive inspection of initial defects of PA6.6-GF50/aluminum self-piercing riveted joints and damage monitoring under mechanical static loading

Amandine Gay^{1,2}, Jean-Michel Roche³,
Patrick Lapeyronnie³, Frédéric Valiorgue² and
Philippe Bertrand²

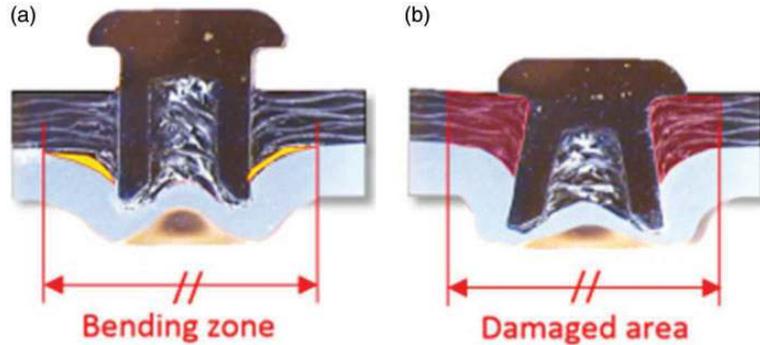
Figure 4. Cross-section of the joint (a) during the piercing and (b) at the end of the process.

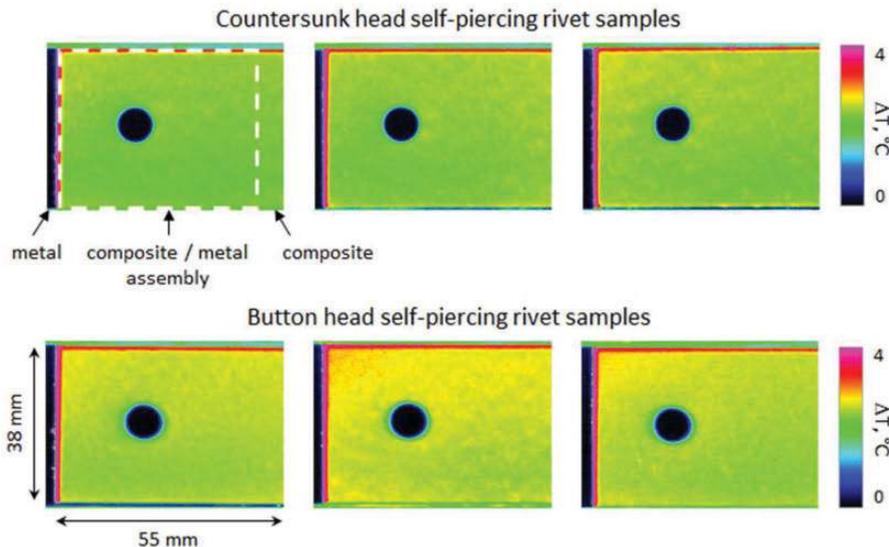
Non-destructive inspection by pulse thermography. As illustrated in Figure 5, the homogeneity of the thermal maps, from one sample to another, tends to validate the reproducibility of the manufacturing process. No major initial defects are detected on the instantaneous temperature fields: the small-sized delaminations observed on the micrographic cross-sections are not seen, which allows the assumption that they are not critical but which plainly justifies the need for a close monitoring of the damage behavior of the samples under mechanical loading (see “Non-destructive in situ damage monitoring during mechanical testing” section). The region of interest, located around the rivet, is more closely observed with the 18 mm extension optical ring. The TSR second logarithmic derivative images, for which thermal contrasts are optimal, tend to validate the assumed homogeneity.

Figure 5. Instantaneous temperature fields. Time of observation: 0.5 s after the thermal flash.

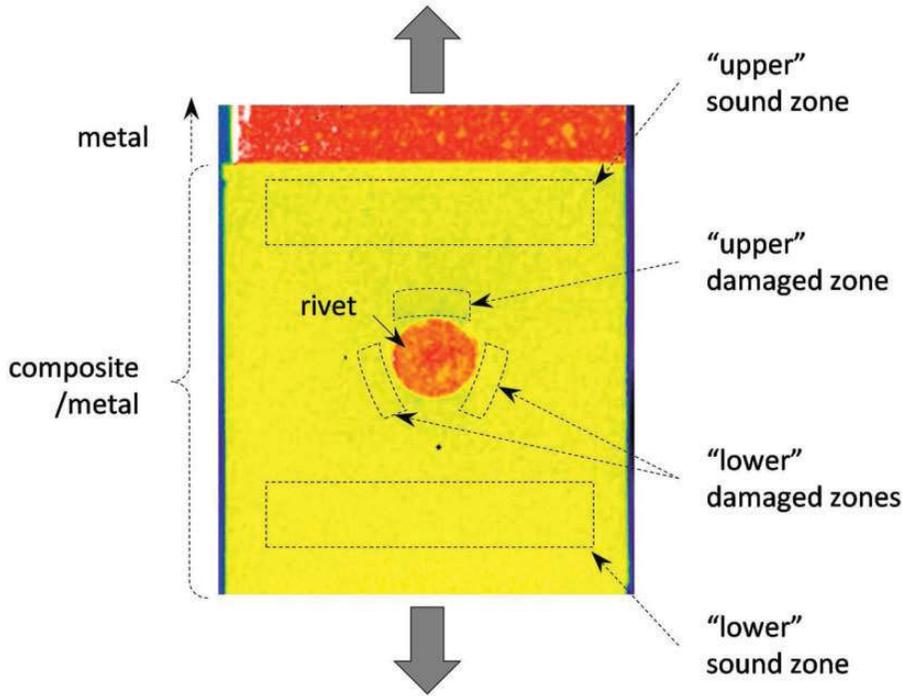
Figure 9. Location of the regions of interest thermally monitored during the SLJ test.

Passive thermal monitoring. The regions specifically observed by the infrared camera are located in Figure 9: two “sound” zones in which damage is not a priori expected; three “damaged” zones around the rivet. The time-evolutions of the temperature variations ΔT (defined as the difference between the instantaneous temperature field and the initial temperature one) are given for these zones in Figure 10.

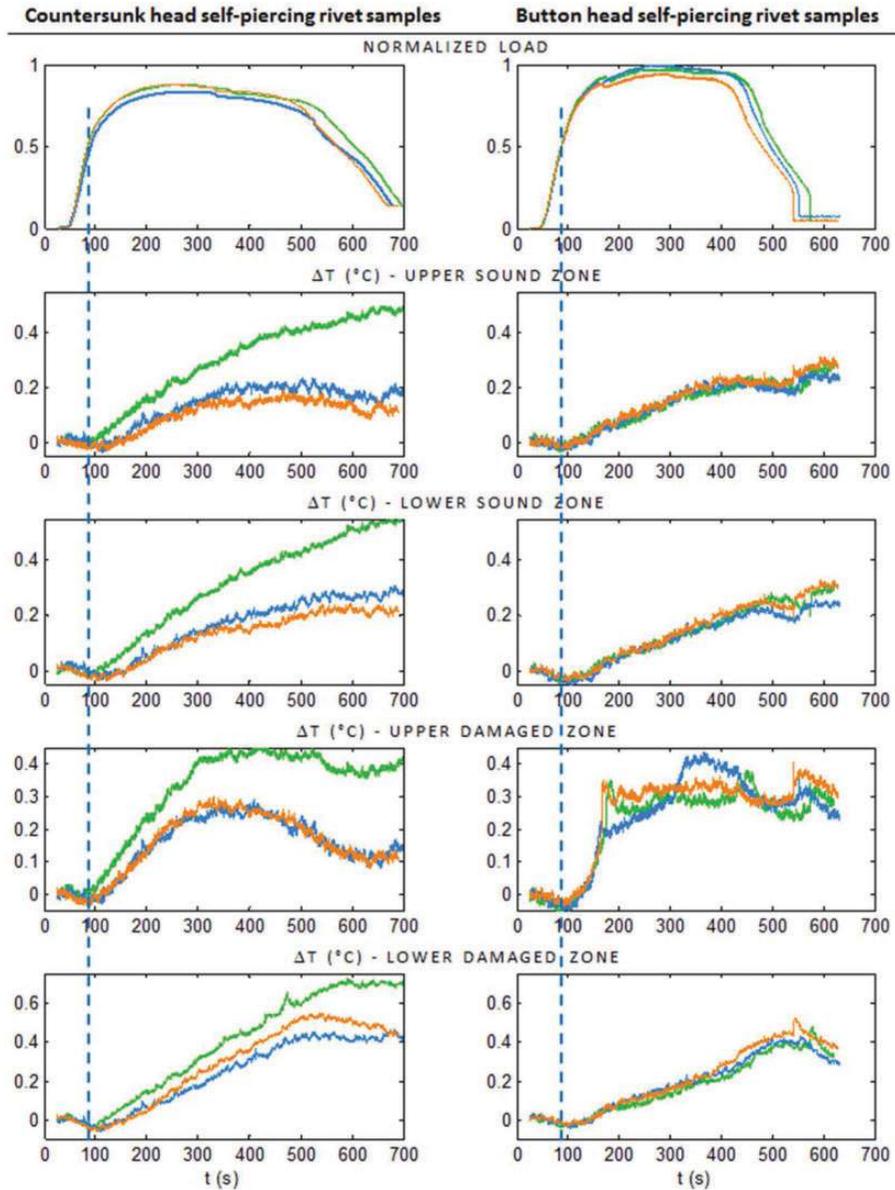
The loss of linearity, both spotted on the force and temperature time-evolutions (dotted line, Figure 10), corresponds to a damage threshold, which is quite similar from one type of rivet to another, found around $0.45 \times F_{MAX}$. The first non-linearities are mainly linked to viscous effects in the composite material and to microscale, diffuse damage. Then, the local temperature rises are associated with intern heat sources that indicate the presence of severe damage, located around the rivet, as illustrated in Figure 11.

The damage scenarios that are observed for both types of riveted joints differ from each other: for the button head rivet samples, the first major damage appears quite early, characterized by a significant rise of temperature, of about half a degree, and is located right above the rivet; for the countersunk rivet samples, the thermal discontinuities are recorded close to the end of the SLJ test,

Figure 10. Time-evolutions of the temperature variations during the SLJ tests.

and the damage is located on the sides of the rivet. However, the maximum reached efforts are higher for the button head self-piercing rivet samples, which means that the major temperature jump spotted in the upper zone of the rivet does not have critical effect on the mechanical resistance. Comparisons with complementary data, from DIC and AE, are needed to analyze such phenomenon (see “Cross-correlation between experimental data” section).

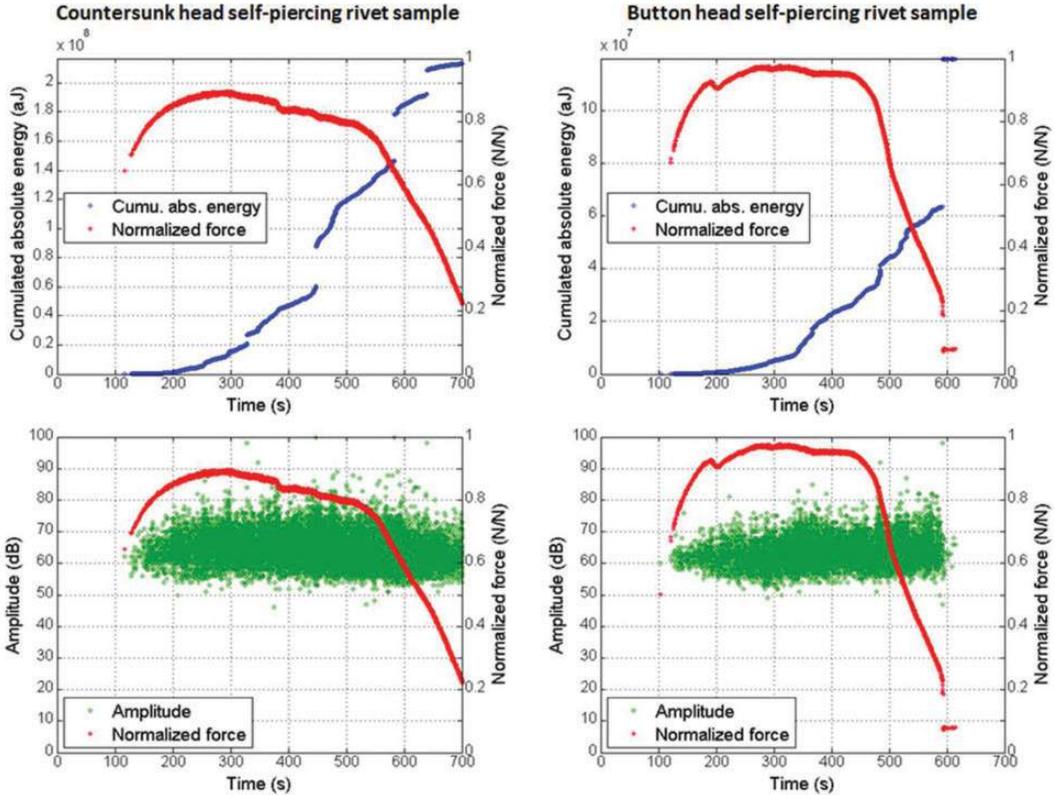
Figure 13. Acoustic measurements (amplitude peaks and cumulative energy) during the SLJ tests.

Monitoring by AE. As illustrated in Figure. 13, the acoustic activity recorded during the SLJ tests is quite similar from one type of rivet to another. The first acoustic events, mainly isolated, low-amplitude ones, appear for a high fraction of the maximum load F_{MAX} (around 0.65 for both types of riveted joints). The damage thresholds, associated with the beginning of the growth of the cumulative energy, are really too high, estimated around $0.70 \times F_{MAX}$. This value turns out to be significantly higher than what was found by passive thermography, which tends to confirm that the beginning of the heating of the composite is not associated with damage. Overall, it is also observed for both samples that most of the acoustic events are recorded after F_{MAX} that is to say during the slow decrease of the force and its final quicker drop. Moreover, the average amplitudes of the acoustic peaks are found around 60 dB, which typically corresponds to matrix cracking and delamination (Chen et al., 1992); events of higher energy (from 80 to 100 dB), which should be the signatures of fiber breaking damage, are also detected but in a much lower proportion.
