Aluminum metallization and wire bonding aging in power MOSFET modules

EDS 2016

Abstract

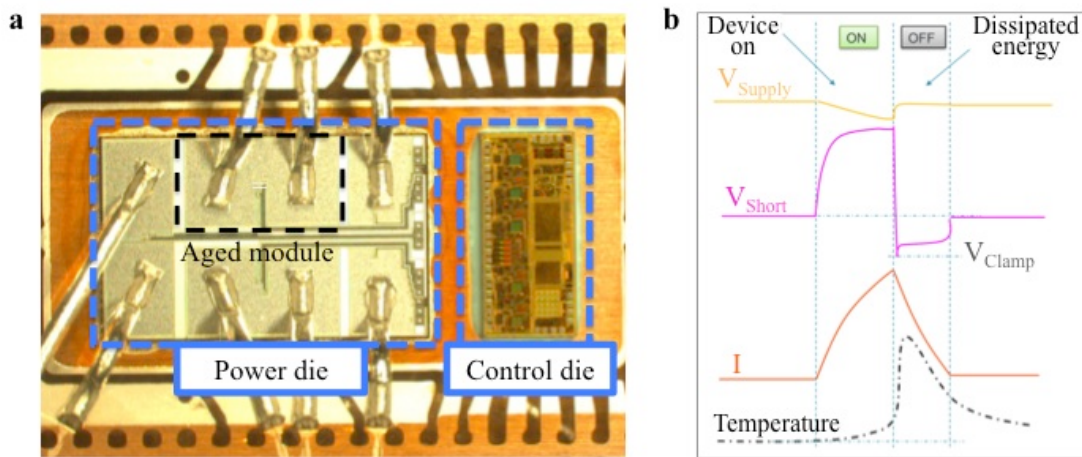
The device under test (DUT) is a 12 V SmartMOS[®] module from NXP Semiconductors designed for car applications. The device includes a power die, the active zone, and a control die, with diagnosis and protection functionalities (Fig. 1a). The power die consists in five MOS sectors, connected by eight wedge bond wires made out of Al. Here, we focus on the Al source metallization (3.6 μm thick), together with the Al bonding wires (381 μm of diameter) attached to it. The Al metallization contains 0.5 wt% of copper (Cu) and tungsten (W) and is coated by

Fig. 1. (a) 12 V NXP's SmartMOS[®] including the power and the control die. (b) Typical signals during a short cycle event in the power MOSFET by activation of overload protection.

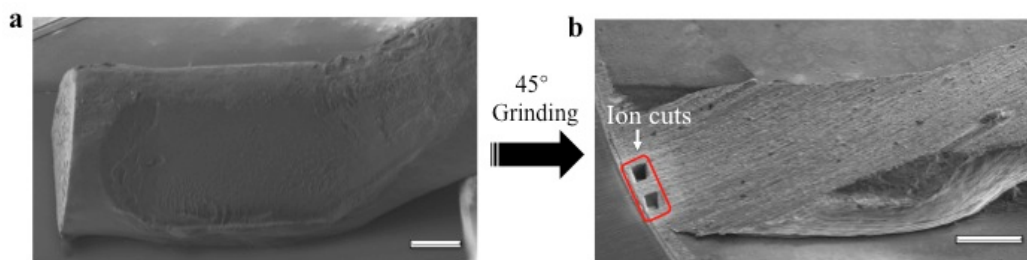
However, cross-sectional observation of the Al power metallization under the bonding wire requires a preliminary sample preparation of the device: this is because it's unfeasible to cut through the entire wire thickness by ion beam. At the same time, a mechanical polishing could induce mechanical damage of the wire-metallization interface while it is the object of the investigation, and also cause the wire lift off that is usually poorly attached in the case of an aged device,. This preparation (Fig. 4) combines a mechanical grinding of the bonding wires at 45°, in order to locally reduce the wires thickness, and a final ion polishing by FIB. The cross-section ion images at the wire-metallization interface (Fig. 5) give us a first idea about the quality of the bonding process. It also allows to measure the initial deformation imposed to the Al layer by the wire bonding process and investigate the behavior of this interface during aging.

Fig. 4. (a) Bonding wire welded on the source metal of a power module. (b) The wire is cut and polished at 45° before being cut by FIB for interface observation. Scale bar 100 μm.

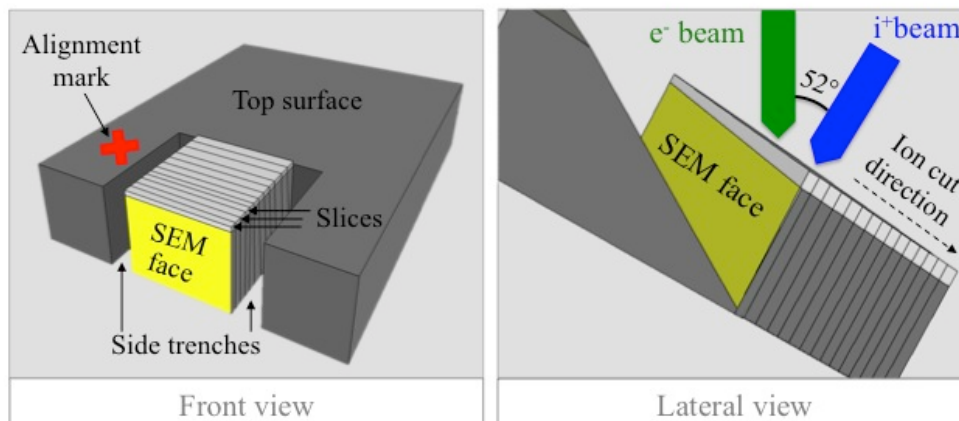
High-resolution 3D images are acquired in a Helios 600 FIB/SEM, equipped with the Auto Slice and View software from FEITM. The FIB-tomography consists in the following steps: 1) preparation of a parallelepiped of user-defined size, 2) creation of a reference mark, close to the area of interest, for the automated drift correction, 3) serial sectioning and acquisition of a SEM images stack. The sample is placed at the eucentric position, where the ion and the electron beam converge with an angle of 52° (Fig. 6). While the ion beam is used to cut and polish serial thin slices, the relative images are acquired by the electron column. The result is a stack of electron images at the wire-metal interface, which allows to follow the crack propagation inside an aged module volume. In our experiments we collected a stack of 200 SEM images with a z-spacing of 50 nm.

Fig. 6. Schematic illustration of the serial sectioning procedure by dual-beam FIB.

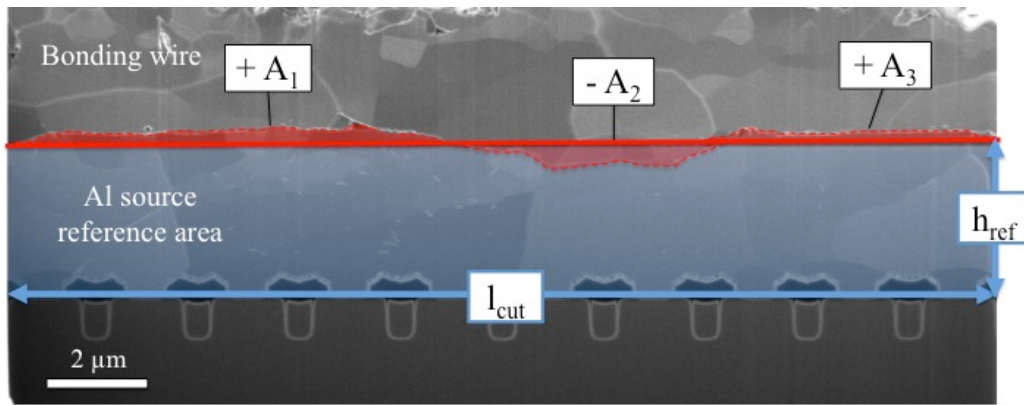
The surface impacted by the wire is about 0.25 mm², which, taking in account the pressure applied during the ultrasonic process, leads to an average compressive stress of 35 MPa. This stress is much smaller than the yield stress of a commercially pure Al with a grain size in the range of 1-2 μm, typically in the range of 100-150 MPa [19]. To explain that significant plastic deformation occurred under this small load, we have to assume that only a fraction of the 0.25 mm² of the metallization surface was truly in contact with the wire. A very coarse estimate would lead to a third of the metallization being impacted by wire-bonding plastic deformation. This also explains why the surface is deformed very inhomogeneously.

Upon aging, we locally measured the deformation by taking the initial metallization thickness away from the bonding wire (in a non-aged device) as reference. The amount of plastic deformation does not change significantly, in line with previous results [9].

Fig. 9. Schematic illustration of the measurement of the plastic deformation imposed to the Al source metallization by the bonding process.
