EXPERIMENTAL ANALYSIS OF FAILURES IN FILLED HOLE COMPRESSION TESTS OF CARBON/EPOXY LAMINATE

Bruno Castanié, Serge Crézé, Jean-Jacques Barrau, Frederic Lachaud,
Laurent Risse

Bruno Castanié, Serge Crézé, Jean-Jacques Barrau, Frederic Lachaud, Laurent Risse. EXPERIMENTAL ANALYSIS OF FAILURES IN FILLED HOLE COMPRESSION TESTS OF CARBON/EPOXY LAMINATE. *Composite Structures*, 2010, 92 (5), pp.1192-1199. hal-02048231

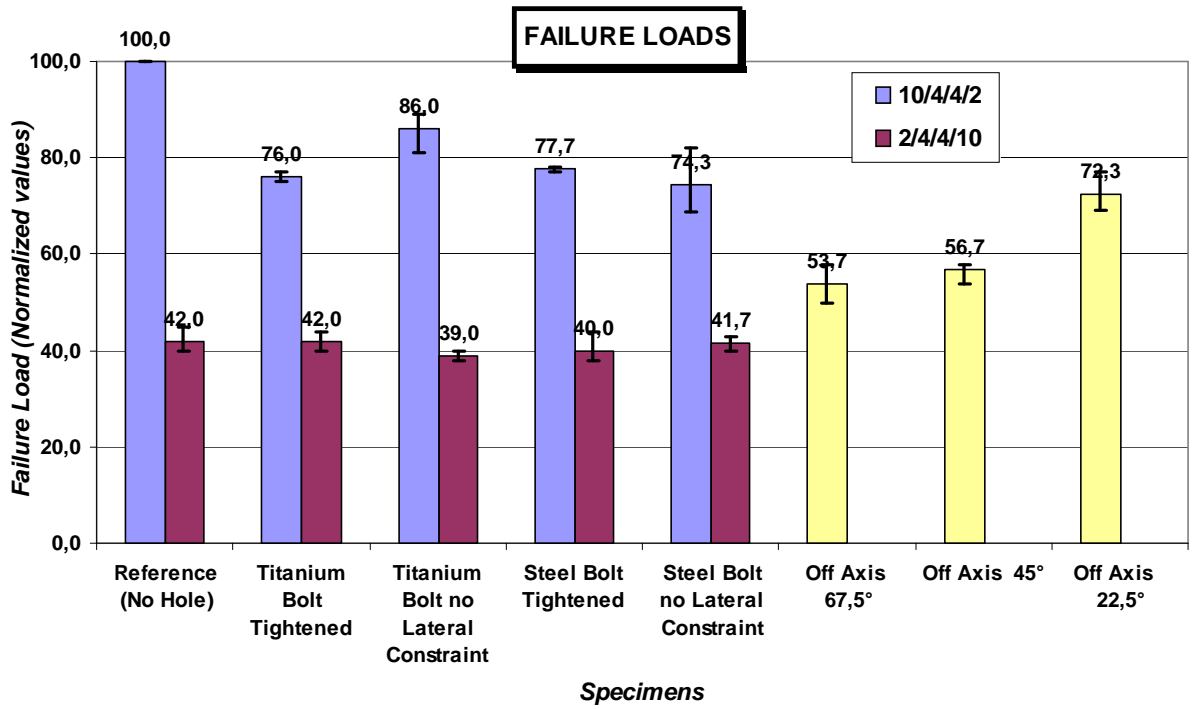
Figure N°6: Failure loads for FHC Tests.

The strain gauges measurement are not provided here since the response is quasi linear until failure. Only parasitic bending moments were identified due to a small curvature of the specimens. The failure loads with scatter bars are given Figure N° 6. The values are the average of the three tests carried out for each configuration and are normalized by respect to the value of the [10/4/4/2] stacking reference specimen fixed to 100.
