Crack arrest capabilities of AA2024 and AA7175 aluminum alloys under impact loading

Gunasilan Manar, Patrice Longère

Gunasilan Manar, Patrice Longère. Crack arrest capabilities of AA2024 and AA7175 aluminum alloys under impact loading. *Engineering Failure Analysis*, 2019, 10.1016/j.engfailanal.2019.06.075 . hal-02164321

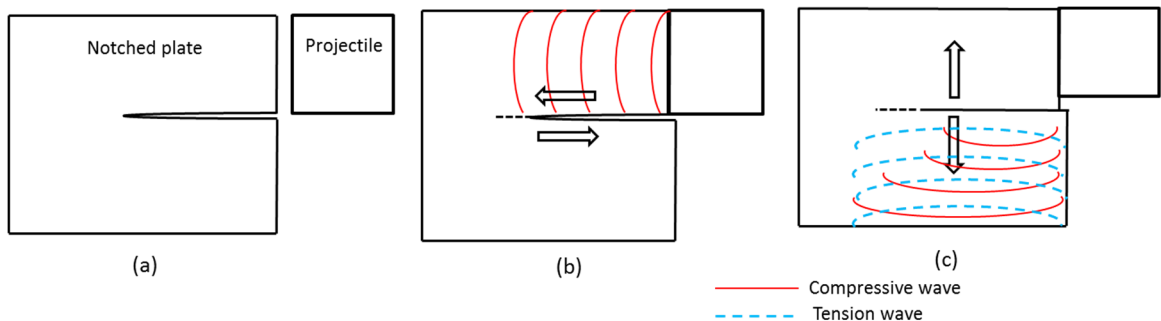
The same scenario, which is depicted in Fig.14, is observed in Fig.13 for AA7175. Fig.14(a) schematically depicts the projectile and plate before interaction. In Fig.14(b), it is shown that compression wave was generated inside the impacted part of the plate. This compression wave was transformed into a predominant shear wave at the notch tip. Due to Poisson effect-induced gap closure, a compression wave is generated which reflects as tension wave from the free edge of the plate, see Fig.14(c) [5].

Fig.14 : Principle of wave interactions. (a) Configuration before impact accounting for symmetry. (b) Compression wave induced in the specimen part impacted by the projectile resulting in shear wave at the notch tip (c) Tension wave resulting from the reflection of the compression wave at the specimen edge. After [5].

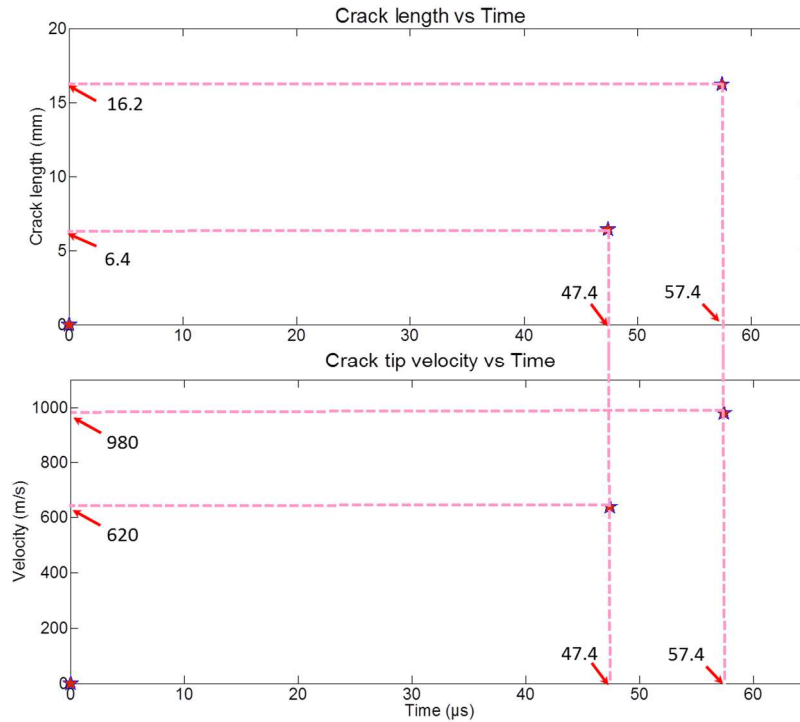
Fig.16 : Crack length and crack tip speed for AA 2024

Fig.16 shows the evolution of crack length and crack tip speed for AA 2024.

- At $t=47.4\mu\text{s}$ crack length is 6.4 mm and at $t=57.4\mu\text{s}$ crack length is 16.2 mm.
- At $t=47.4\mu\text{s}$ crack tip speed is 640 m.s^{-1} and at $t=57.4\mu\text{s}$ crack speed is 980 m.s^{-1} .

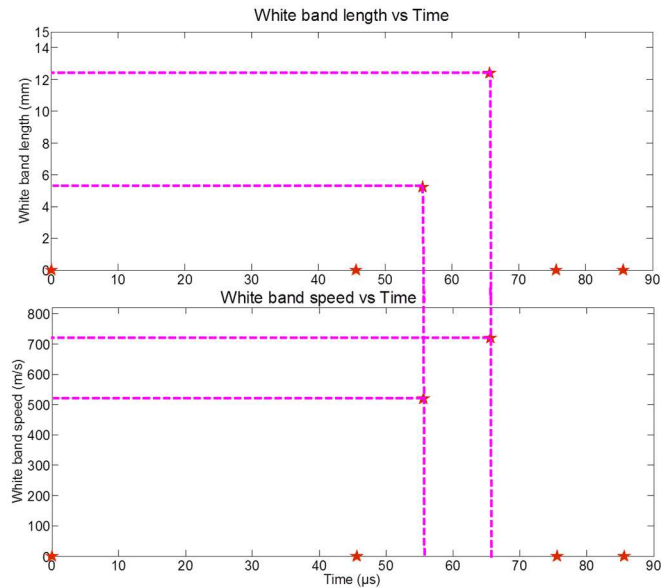
Fig.18 : White band length and white band speed for AA 7175

The average speed of the white band propagation in AA 7175 for the duration of $10\mu\text{s}$ can be estimated by applying equation 2. Fig.18 shows the white band length and its speed evolutions.

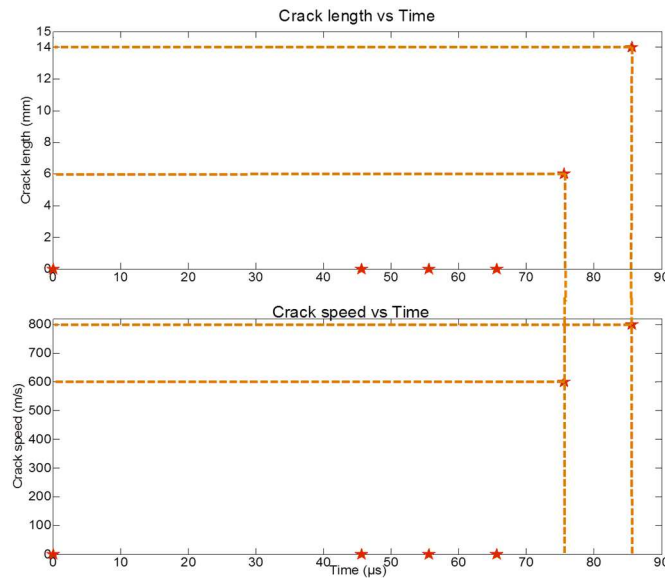
Fig.19 : Crack length and crack speed for AA 7175

Fig.19 shows the evolution of crack length and crack tip speed:

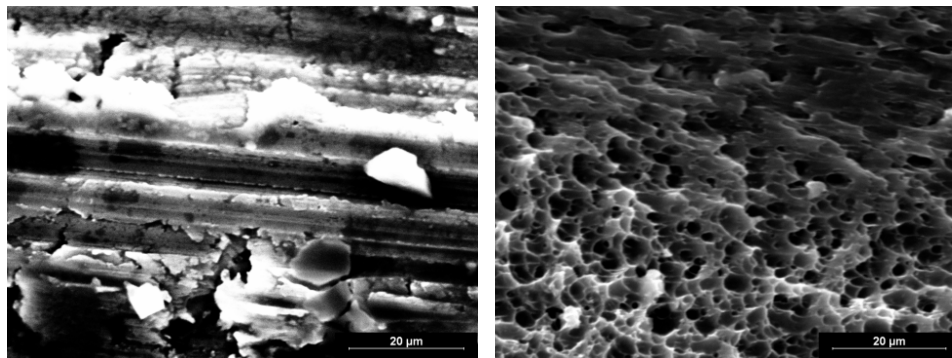
According to Fig.28(a) for AA2024 two different fracture zones can be seen. Zone 1 shows the surface at crack initiation and zone 2 shows the crack propagation which ultimately leads to full fracture of the specimen.

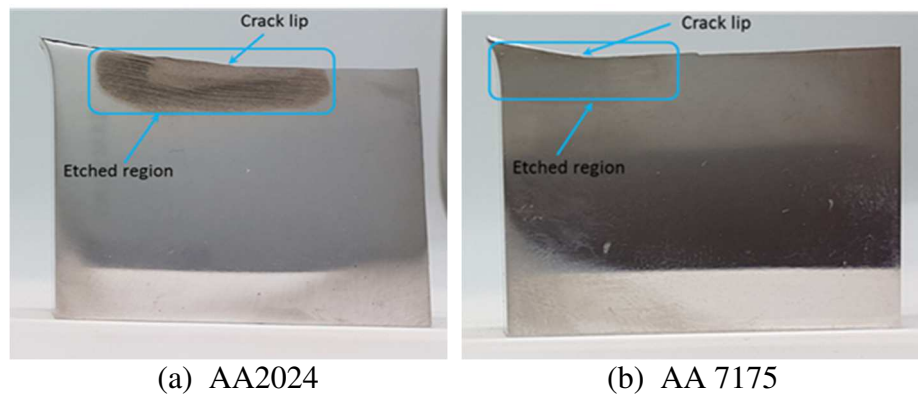
Fig.34 : Specimens of AA2024 and AA7175 after polishing and etching

Specimens were polished and etched near the crack lip by acid (M4) in order to observe the microstructure near crack lip, see Fig.34.

For AA2024 crack lip analysis does not show any evidence of shear band see Fig.35, and on the other hand for AA7175 the adiabatic shear band with average width of $6\mu\text{m}$ is visible on the crack lips as shown in Fig.36.
