Crack arrest capabilities of AA2024 and AA7175 aluminum alloys under impact loading

Gunasilan Manar, Patrice Longère

Gunasilan Manar, Patrice Longère. Crack arrest capabilities of AA2024 and AA7175 aluminum alloys under impact loading. *Engineering Failure Analysis*, 2019, 10.1016/j.engfailanal.2019.06.075 . hal-02164321

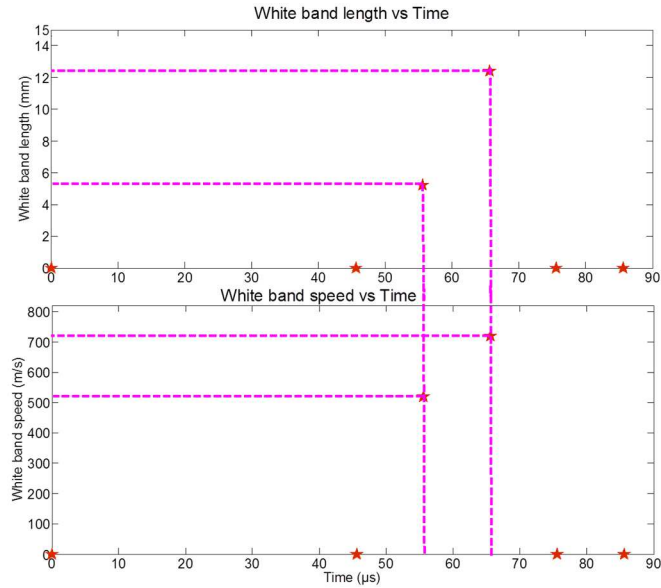
Fig.18 : White band length and white band speed for AA 7175

The average speed of the white band propagation in AA 7175 for the duration of $10\mu\text{s}$ can be estimated by applying equation 2. Fig.18 shows the white band length and its speed evolutions.

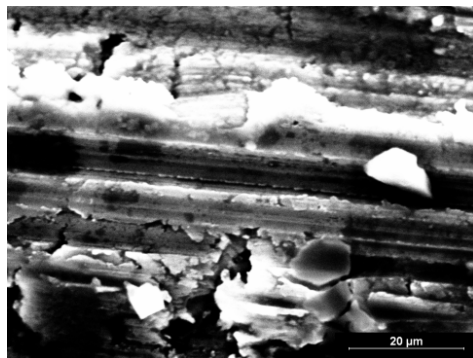
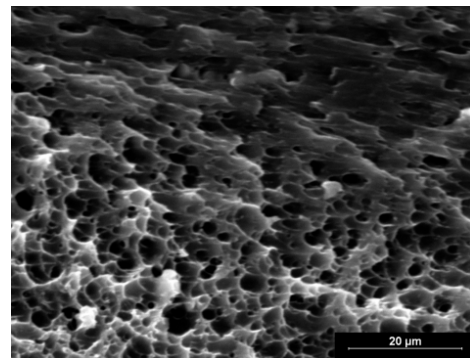
Fig.29 : Microstructural view of AA2024 at fractured surface after impact at speed of 150 m.s⁻¹

Fig.29 shows the microstructure of AA2024 for both zones of ruptures after impact at 150 m.s^{-1} . Microstructural view for AA2024 shows, first zone is flat shear (Mode II) and second zone is opening mode where microstructural view shows a dimple cluster (Mode I) for AA2024.

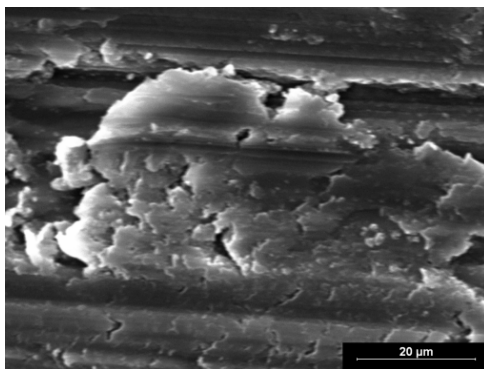
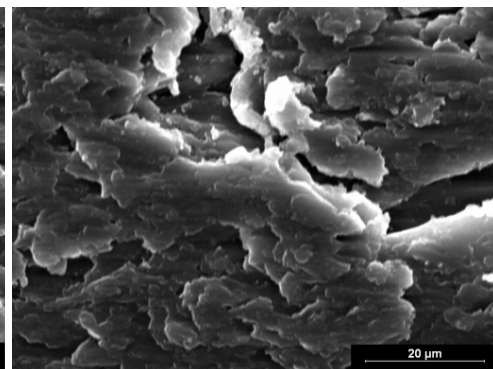
Fig.30 : Microstructural view of AA7175 at fractured surface at speed of 164 m.s⁻¹ (a) Flat shear (b) Flat shear

Fig.30 shows the microstructure of AA7175 after impact at speed of 164 m.s^{-1} . Microstructural view of AA7175 shows both region are flat shear surface, thus the failure is mainly due to shear (Mode II).

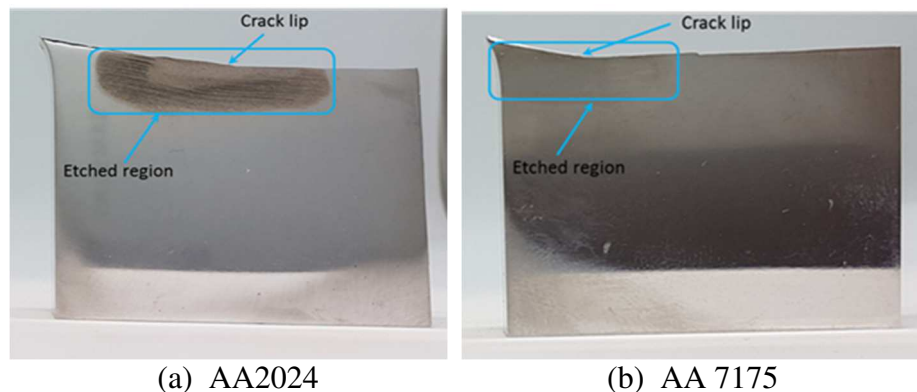
Fig.34 : Specimens of AA2024 and AA7175 after polishing and etching

Specimens were polished and etched near the crack lip by acid (M4) in order to observe the microstructure near crack lip, see Fig.34.

For AA2024 crack lip analysis does not show any evidence of shear band see Fig.35, and on the other hand for AA7175 the adiabatic shear band with average width of $6\mu\text{m}$ is visible on the crack lips as shown in Fig.36.

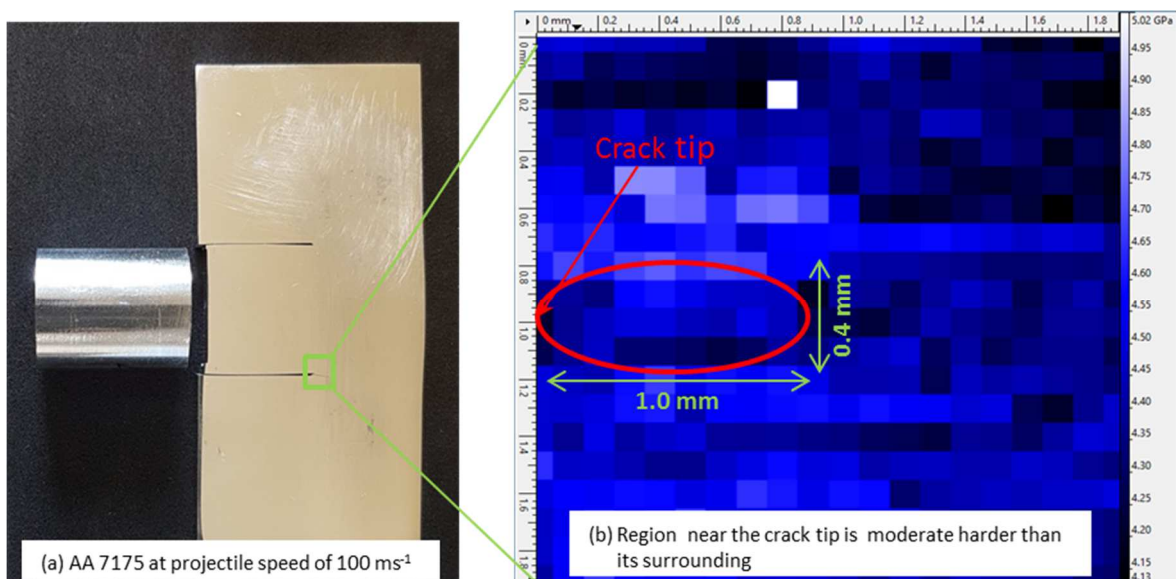
Fig.39 shows nano-hardness mapping for AA7175 after impact speed of 100 m.s⁻¹. The process zone is a narrow ellipse. The average nano-hardness inside and outside the processing zone is 4.4 GPa and 4.5 GPa respectively, i.e. a lower hardness inside the process zone and a higher hardness outside.

Fig.39 : Nanohardness of crack tip for AA 7175 at impacted speed of 100 m.s⁻¹. Light blue for higher hardness value and dark blue for lower hardness value.
