Tracing the seismic history of Sant'Agata del Mugello (Italy, Tuscany) through a cross-disciplinary approach

Tracing the seismic history of Sant'Agata del Mugello (Italy, Tuscany) through a cross-disciplinary approach.

Arnaud MONTABERT^{*1,4,5}, Hélène DESSALES², Andrea ARRIGHETTI³, Julien CLEMENT⁴, Maria LANCIERI⁵, and Hélène LYON-CAEN¹

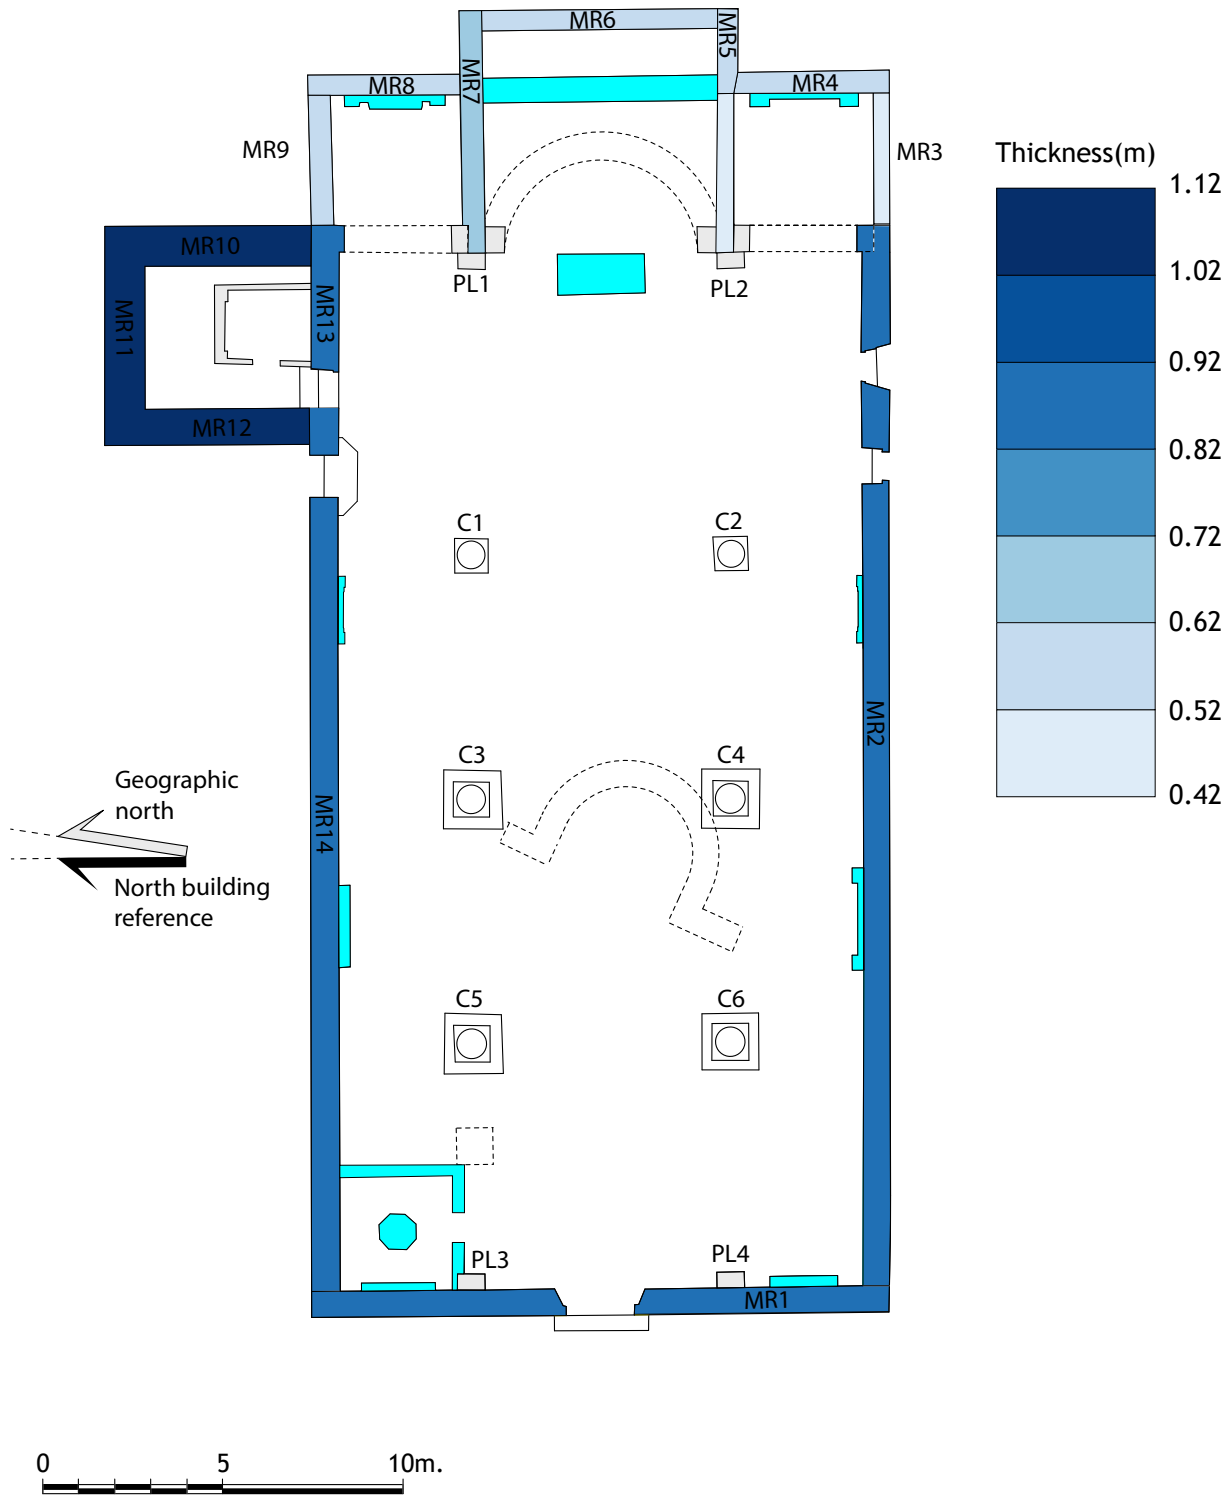
The thickness of both walls at the bottom is different as shown in Figure 16 (77 cm for MR13 and 61 cm for MR9).

Figure 16: Thickness of the church walls going from 0.42 m to 1.12 m. Such a difference characterizes the building evolution of the church over time.

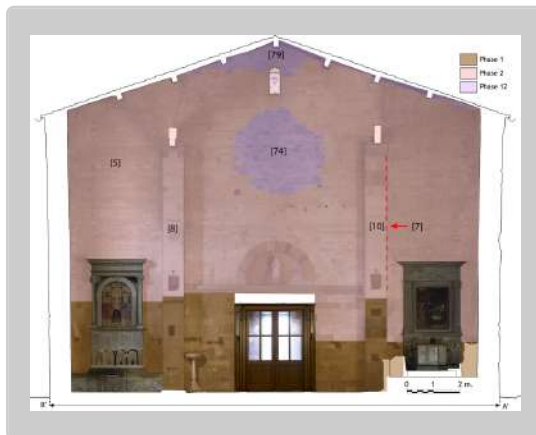
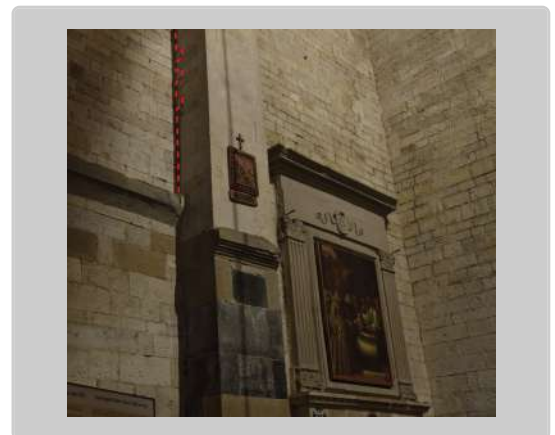
Id. OPUR 8

Localisation SantAgata, , , : Pillar

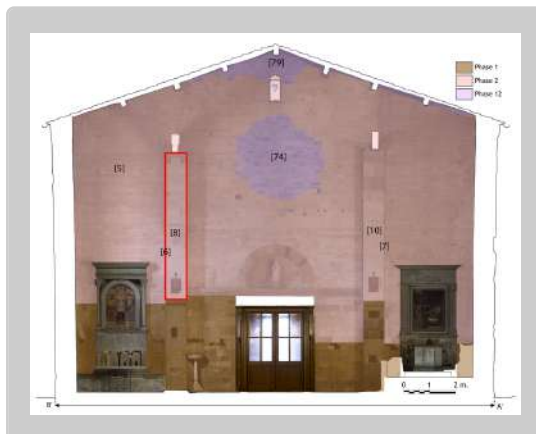
Id. OPUR 9

Localisation SantAgata, , , : Façade wall, load-bearing

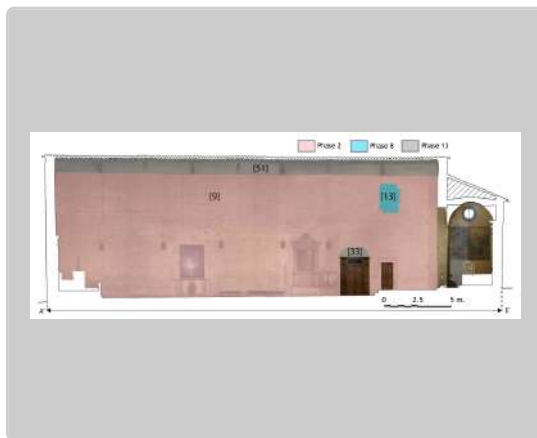
Id. OPUR 10

Localisation SantAgata, , , : Pillar

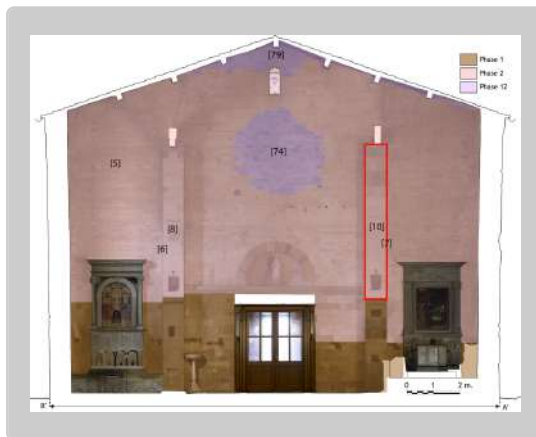
Id. OPUR 11

Localisation SantAgata, , , : Façade wall, load-bearing

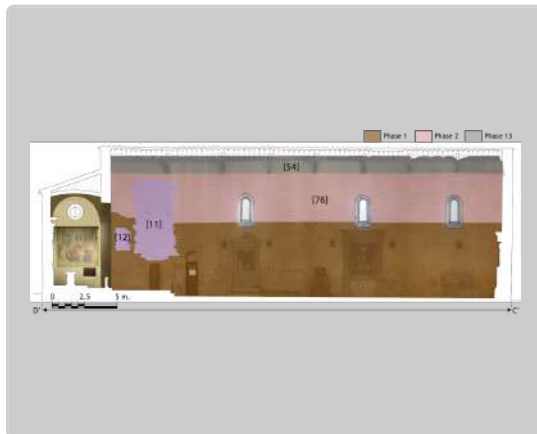
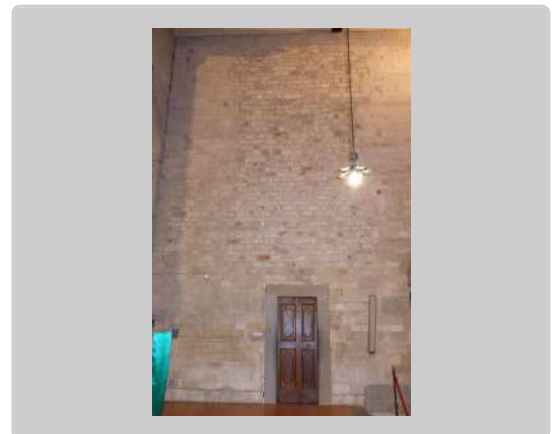
Id. OPUR 12

Localisation SantAgata, , , : Façade wall, load-bearing

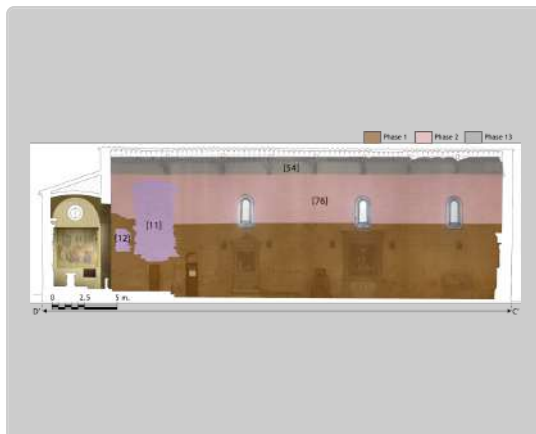
Id. OPUR 13

Localisation SantAgata, , , : Façade wall, load-bearing

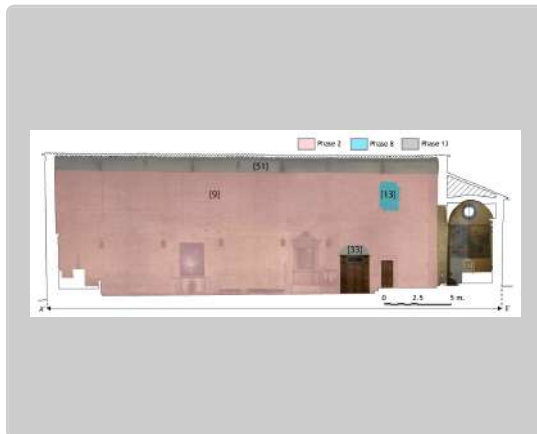
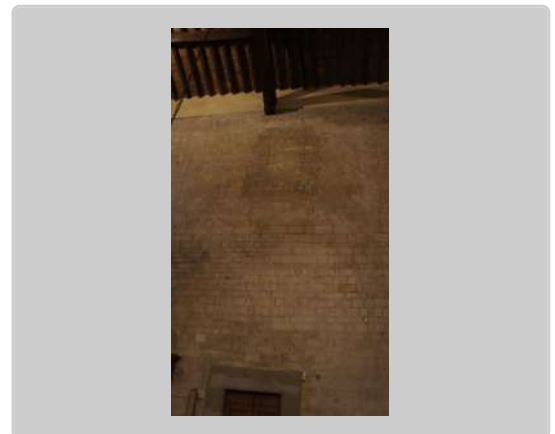
Id. OPUR 14

Localisation SantAgata, , , : Façade wall, load-bearing

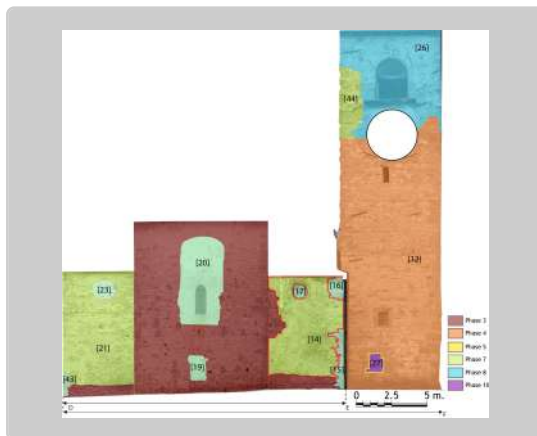
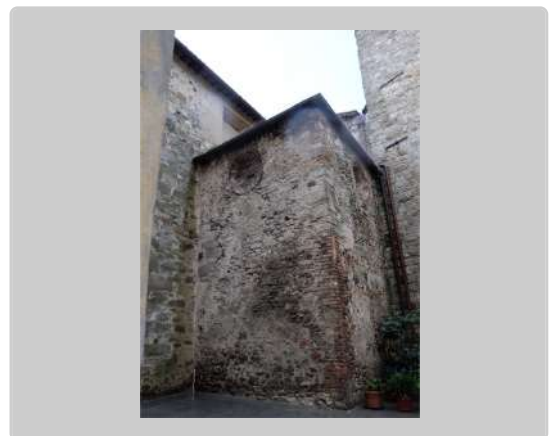
Id. OPUR 15

Localisation SantAgata, , , : Façade wall, load-bearing

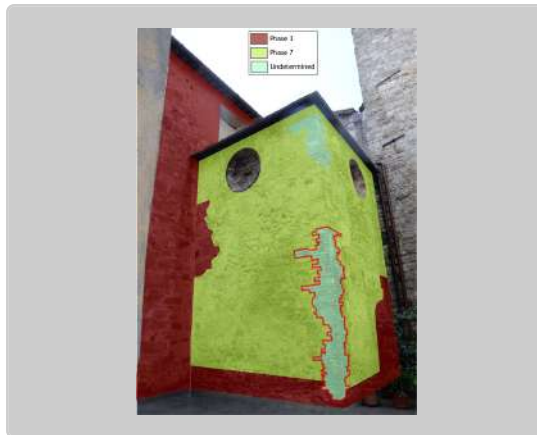
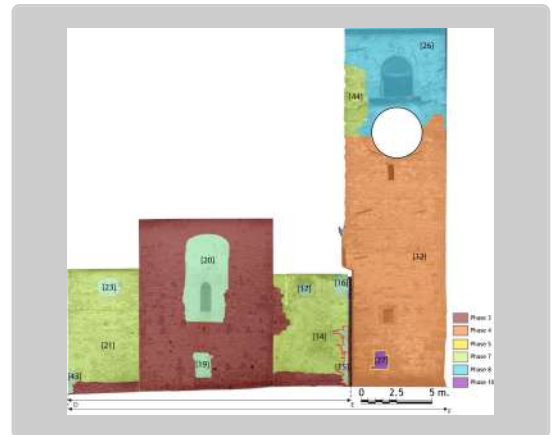
Id. OPUR 16

Localisation SantAgata, , , : Façade wall, load-bearing

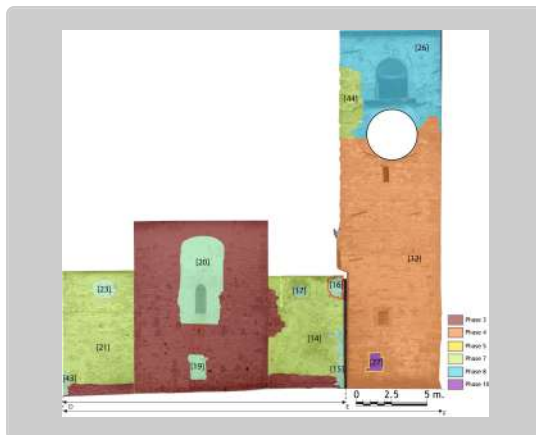
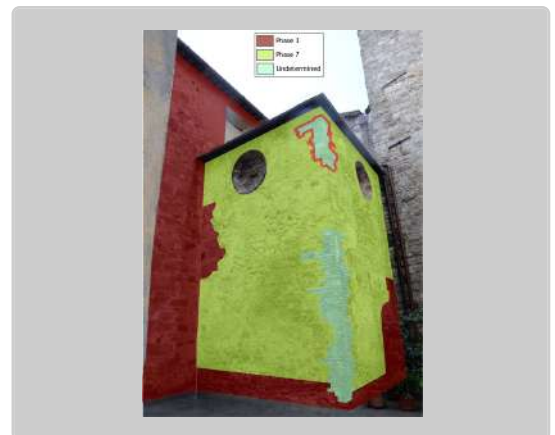
Id. OPUR 17

Localisation SantAgata, , , : Window

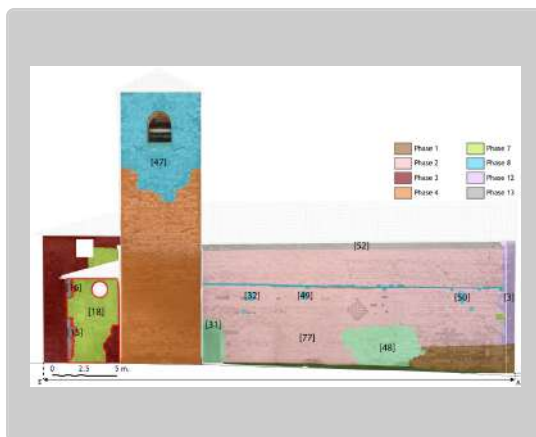
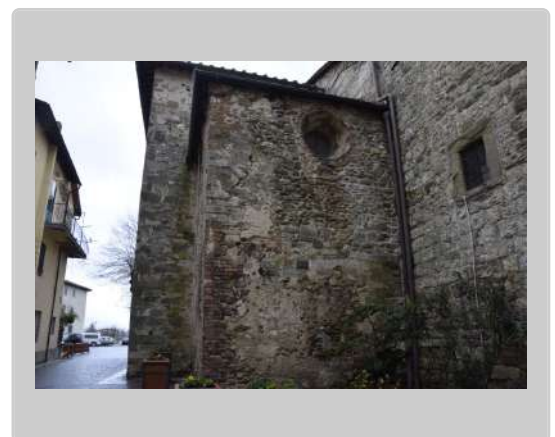
Id. OPUR 19

Localisation SantAgata, , , : Doorway

Hazard **Settling**

Repair **Not indicated**

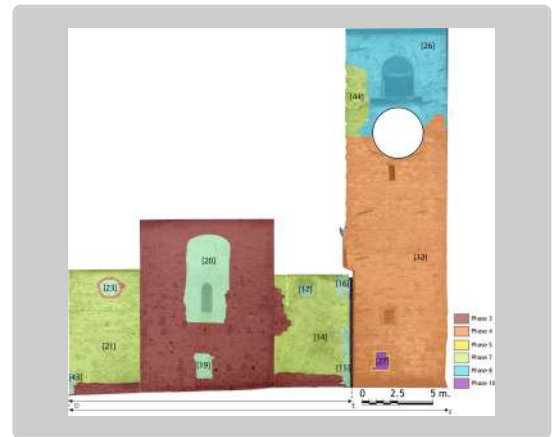
Id. OPUR 24

Localisation SantAgata, , , : Arch

Hazard **Settling**

Repair **Not indicated**

After understanding the building evolution of the church. This unit is no more considered as a repair unit. The two lateral arches have been probably built during the building of the two initial lateral chapels. Bricks are visible under the plaster.

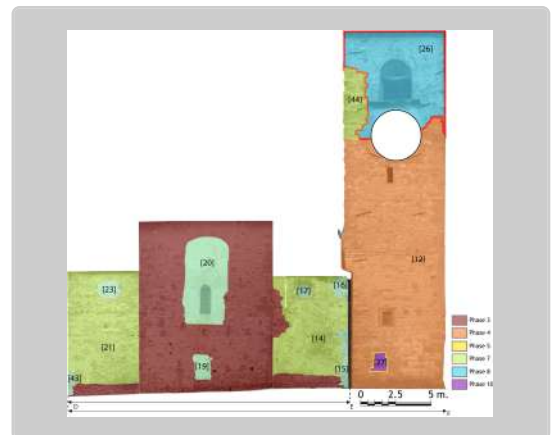
Id. OPUR 27

Localisation SantAgata, , , : Doorway

Hazard

Repair **Not indicated**

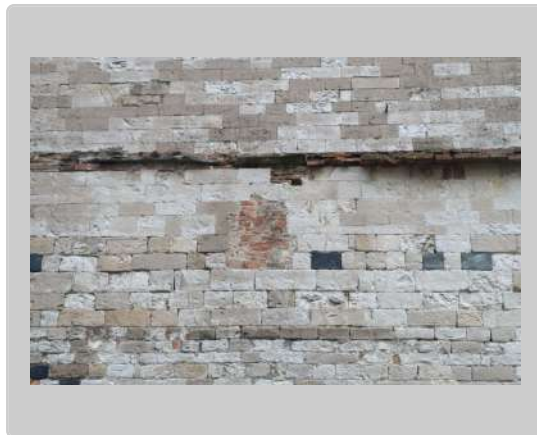
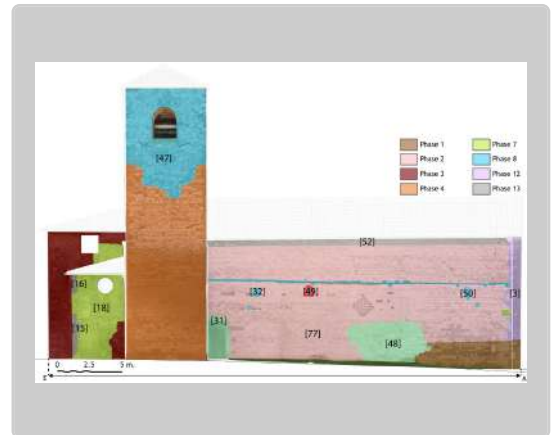
Id. OPUR 50

Localisation SantAgata, , , : Façade wall, load-bearing

Identity **Intervention partial** - ACoR : TCM8
Repaired part(s) : East, West ; Middle part

Hazard **Supposed collapse**
Ancient origin : undetermined - Probability of the event undetermined

Repair **Reconstruction**
Dimensions (cm) : Lenght 582, Height 273
Filling-in : Stone, Terra cotta [Brick], Mortar [Lime and sand]

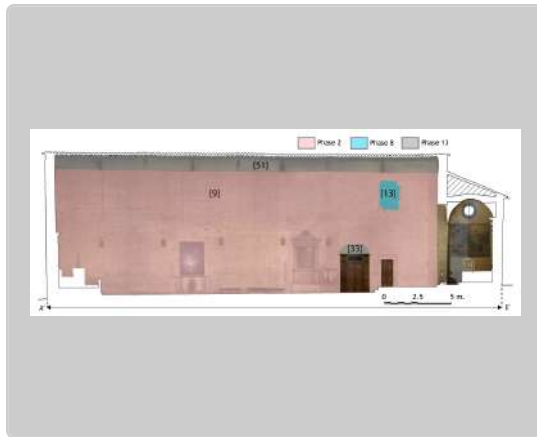
Id. OPUR 52

Localisation SantAgata, , , : Façade wall, load-bearing

Identity **Intervention partial** - ACoR : modern
Repaired part(s) : West, East ; Upper part

Hazard **Settling**
Ancient origin : undetermined - Probability of the event undetermined

Repair **Reconstruction**

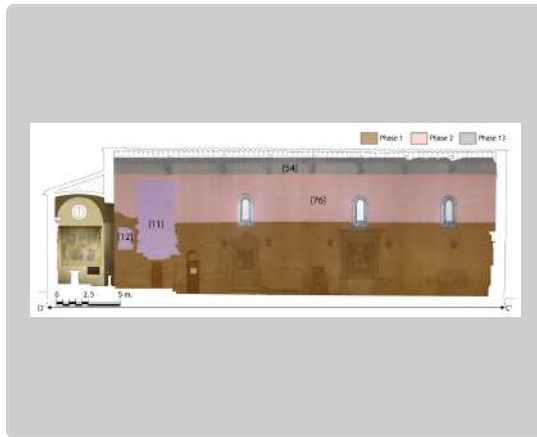
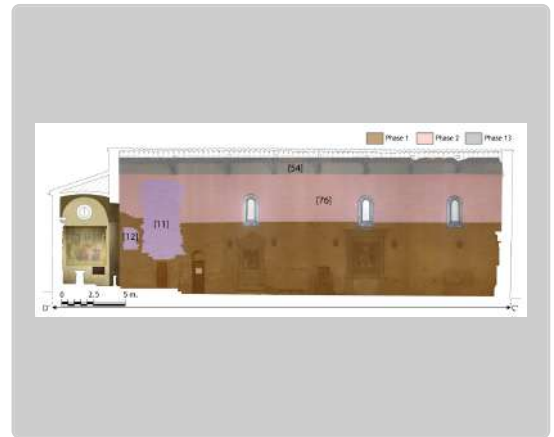
Id. OPUR 55

Localisation SantAgata, , , : Window

Identity **Intervention partial** - ACoR : TCM8
Repaired part(s) : East, West ; Middle part

Hazard **Settling**
Ancient origin : undetermined - Probability of the event undetermined

Repair **Not indicated**
Filling-in, Masonry : Terra cotta [Brick], Mortar [Lime and sand]

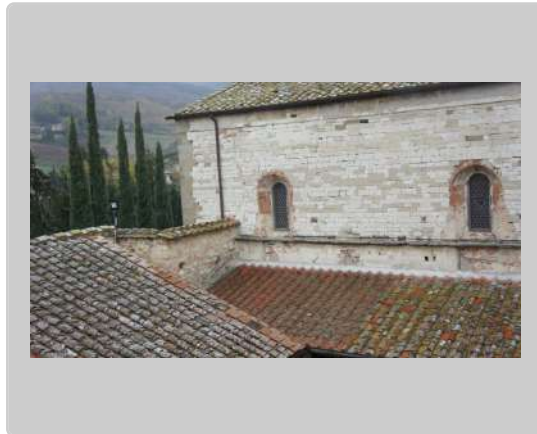
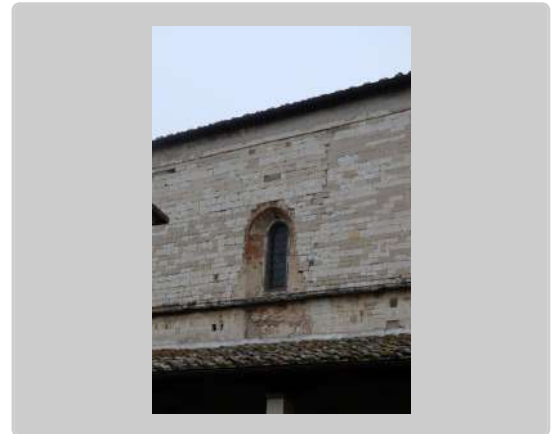
Id. OPUR 56

Localisation SantAgata, , , : Window

Identity **Intervention partial** - ACoR : TCM8
Repaired part(s) : East, West ; Middle part

Hazard **Settling**
Ancient origin : undetermined - Probability of the event undetermined

Repair **Not indicated**
Filling-in, Masonry : Terra cotta [Brick], Mortar [Lime and sand]

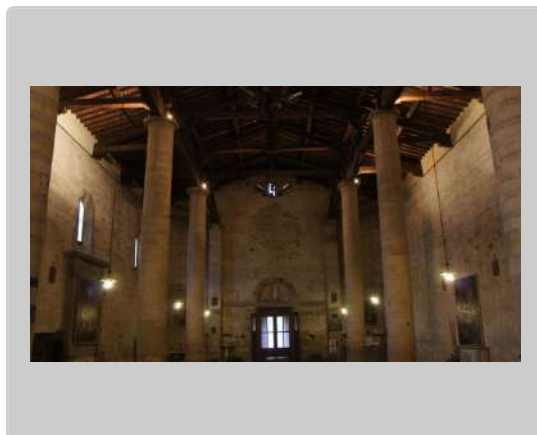
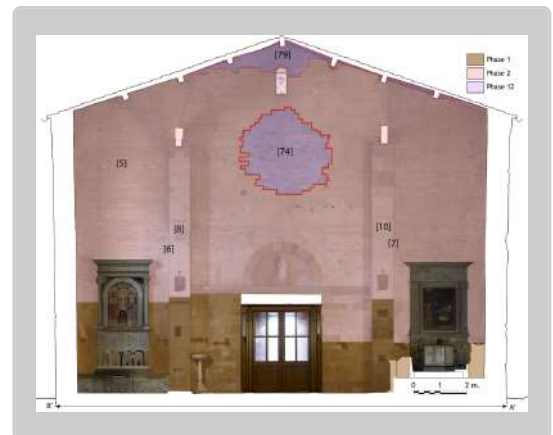
Id. OPUR 75

Localisation SantAgata, , , : Façade wall, load-bearing

Identity **Intervention partial** - ACoR : TCM2
Repaired part(s) : North, South ; Middle part

Hazard **Supposed collapse** (Partial overturning of the wall with rotations axis at the floor level)
Ancient origin : undetermined - Probability of the event undetermined

Repair **Reconstruction**
Dimensions (cm) : Lenght 40, Width 20, Height 20, Thickness 0
Filling-in, Block : Stone, Mortar [Lime and sand]

Other precisions North wall of the church (MR14). External facing of the church. Use of large block of limestone very different to the TCM2 technique used in this part of the wall.
Probably linked to a repair of the corner quoins after the undetermined event which induced the reconstruction of the front wall using technique TCM2. Indeed, the block is not decayed like the middle part of the wall. (related to opur 1)

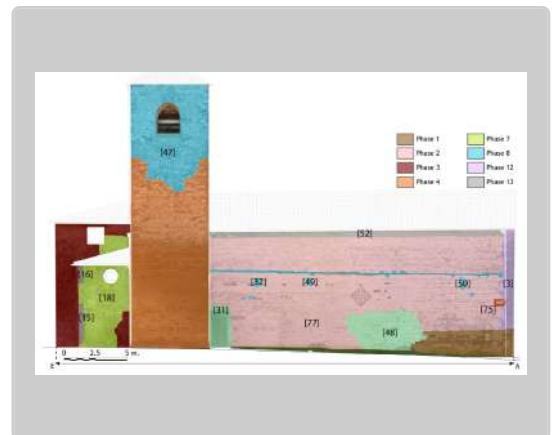
Id. OPUR 76

Localisation SantAgata, , , : Façade wall, load-bearing

Identity **Intervention partial - ACoR** : TCM2
Repaired part(s) : East, West ; Upper part, Middle part

Hazard **Deformation - Supposed collapse - Crack** (Global complex overturning of the façade)
Ancient origin : earthquake - Probability of the event strong

Repair **Reconstruction**
Dimensions (cm) : Lenght 2842, Height 338
Masonry : Stone, Mortar [Lime and sand]

Other precisions Internal facing wall of MR2 (south wall of the nave).
Reconstruction of the wall from the middle (limit with the three windows) until the top of the wall. Use of TCM2 with blocks of limestone having very fine joints. The repair is visible because the wall is straight ahead contrary to the wall below which undulates slightly.

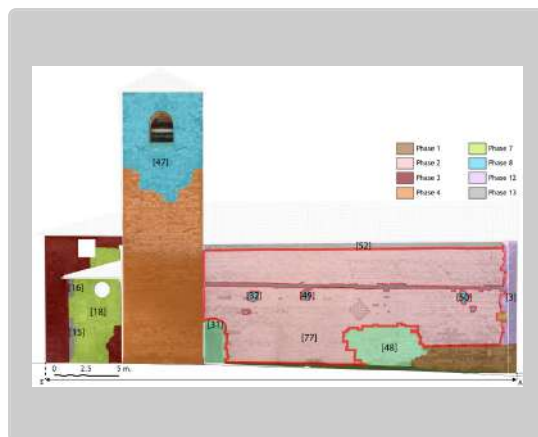
Id. OPUR 78

Localisation SantAgata, , , : Façade wall, load-bearing

Identity **Intervention partial** - ACoR : TCM2
Repaired part(s) : North, South ; Middle part

Hazard **Supposed collapse**
Ancient origin : undetermined - Probability of the event undetermined

Repair **Reconstruction**
Dimensions (cm) : Lenght 50, Height 50, Thickness 75
Masonry, Filling-in : Stone, Mortar [Lime and sand]
