Tracing the seismic history of Sant'Agata del Mugello (Italy, Tuscany) through a cross-disciplinary approach

Tracing the seismic history of Sant'Agata del Mugello (Italy, Tuscany) through a cross-disciplinary approach.

Keywords— historical seismicity, historical sources, building stratigraphy, architecture, structural analysis, damage mechanisms, Central Italy

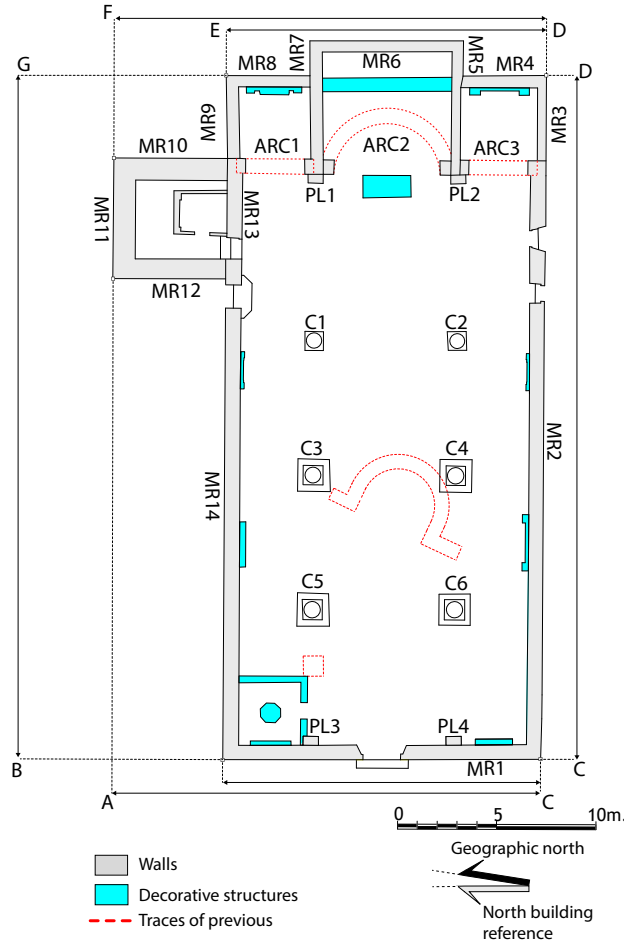
Figure 3: Plan of the church with the location of technical groups: MR for wall, PL for pilaster, C for column and ARC for arch. Labeled lines (AC, CD, ...) are related to interpreted orthophotos presented thereafter.

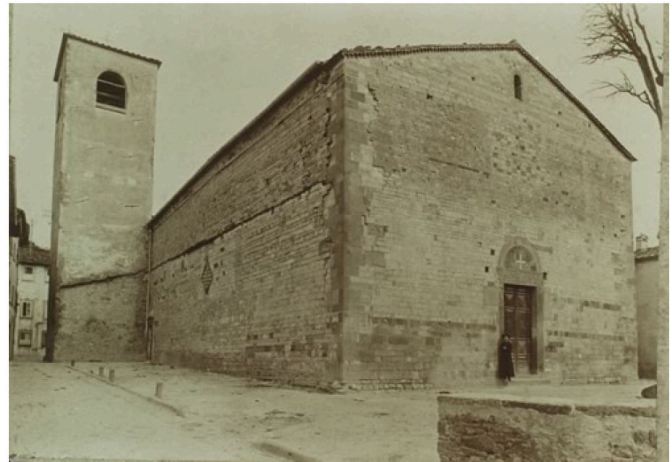
Figure 20: a) View of the church of Sant'Agata in 1802 (Fontani [1802]). b) Photograph of the church in 1905 (personal communication).

The rose window of the church is no more present as shown in Figure 20b contrary to the view shown in Figure 20a. Finally, we note the disappearance of the porch between the picture and the photo.

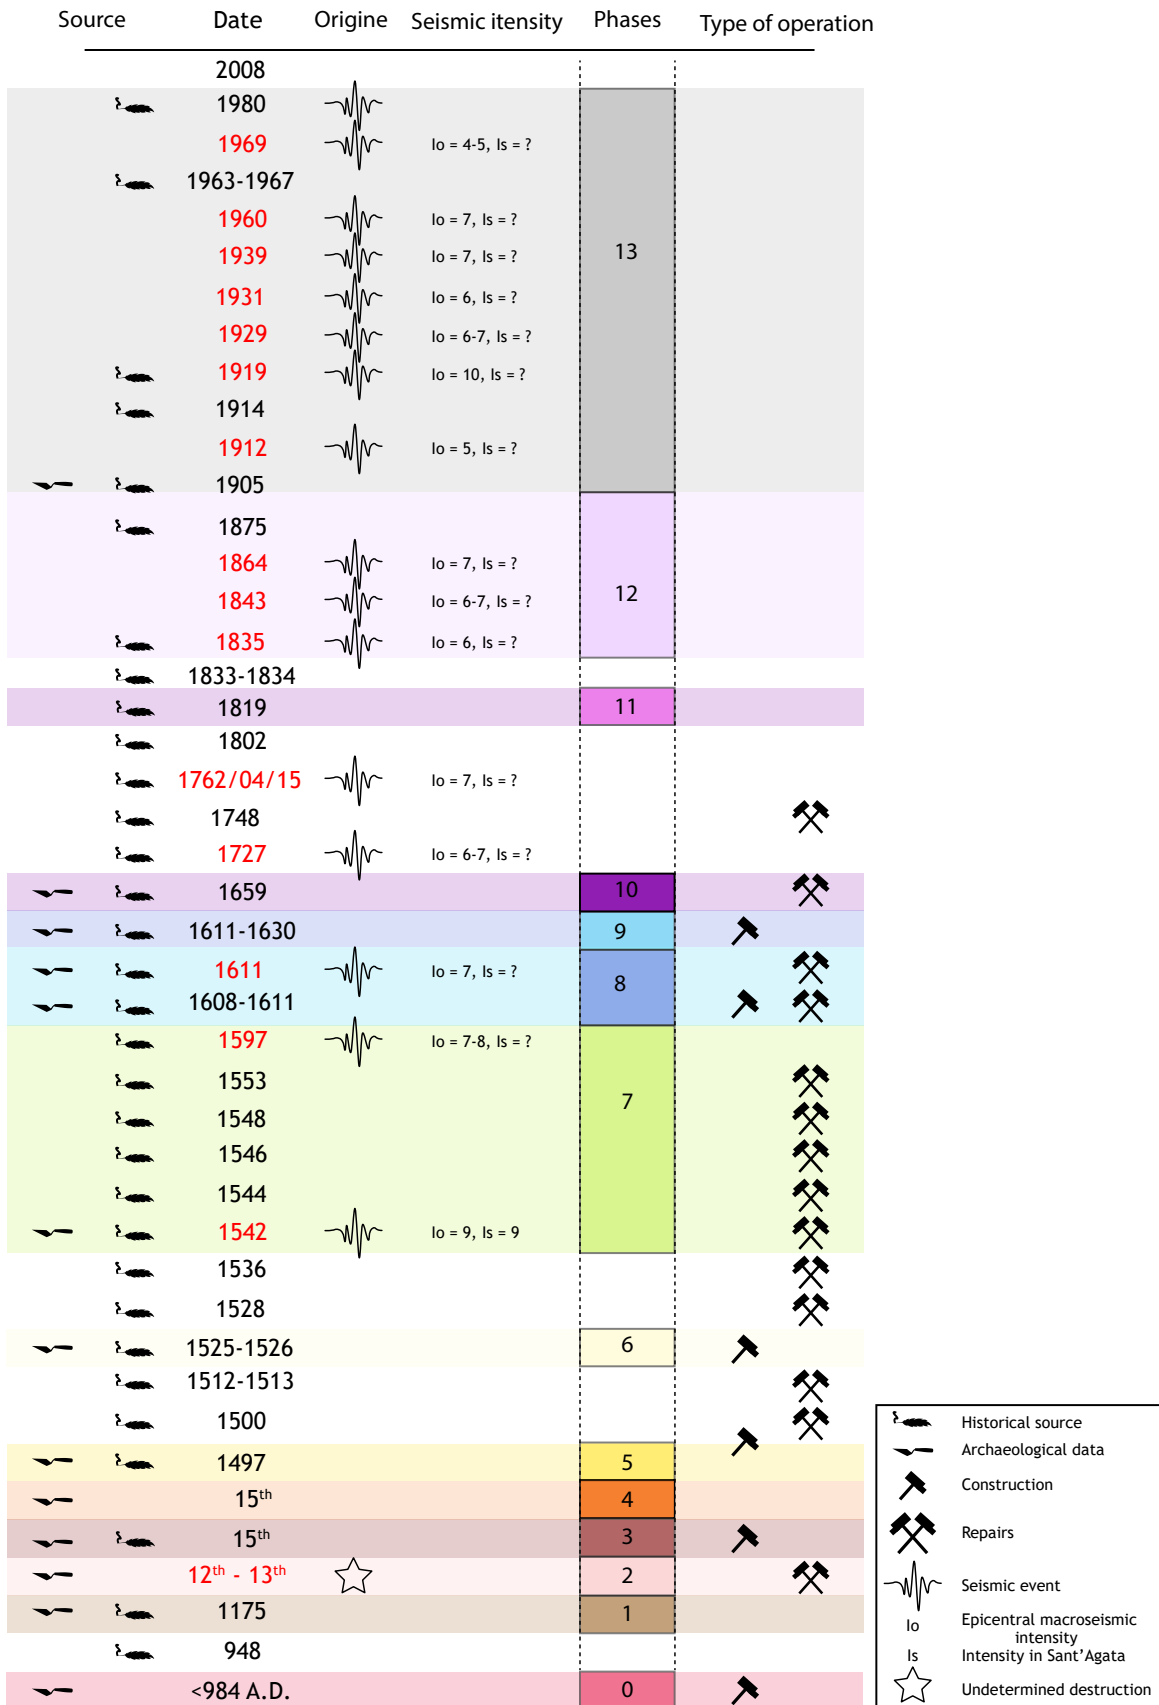
Figure 22: Relative chronology of the construction of the Sant'Agata church crosschecking historical sources and stratigraphic analysis. The figure shows on the left the origin of the data used to identify the construction phases (historical records or stratigraphic analysis).

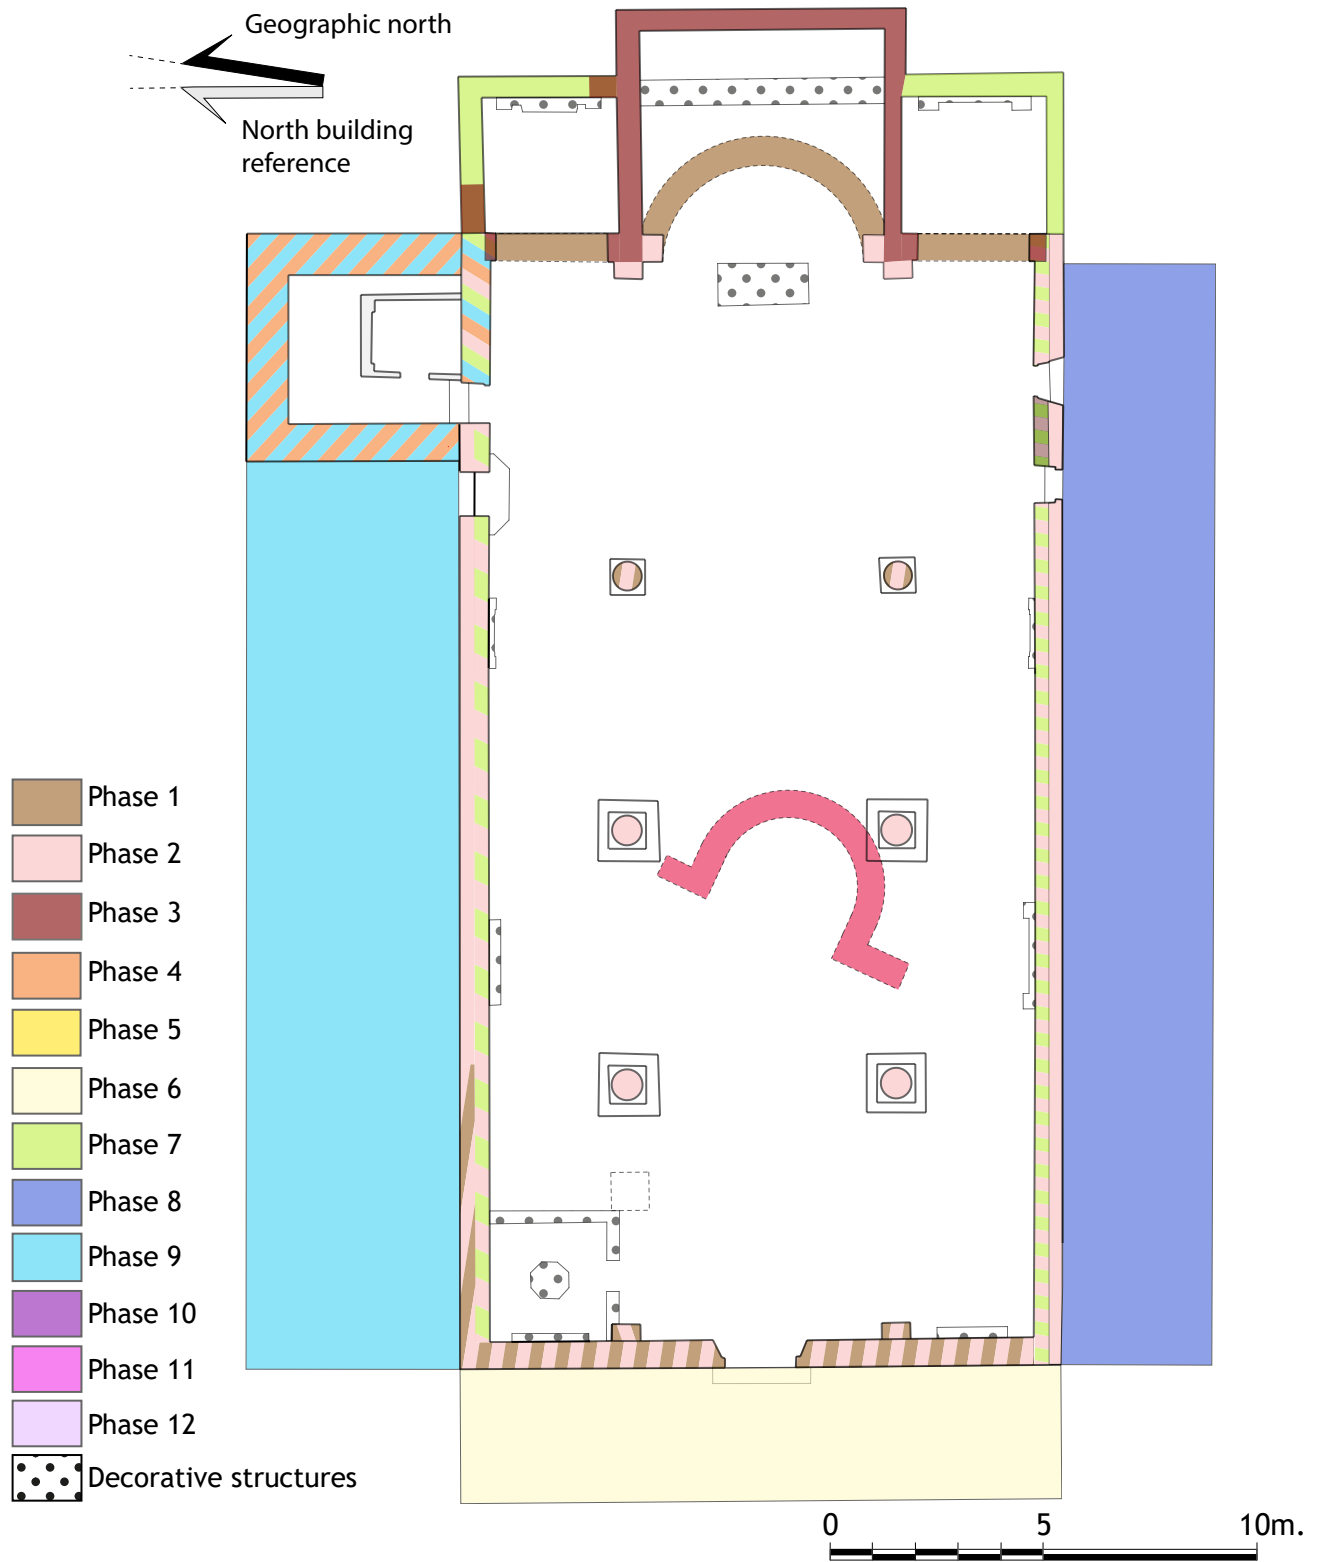
Figure 23: Architectural evolution of the church over time summarizing the assembly of the different aforementioned phases.

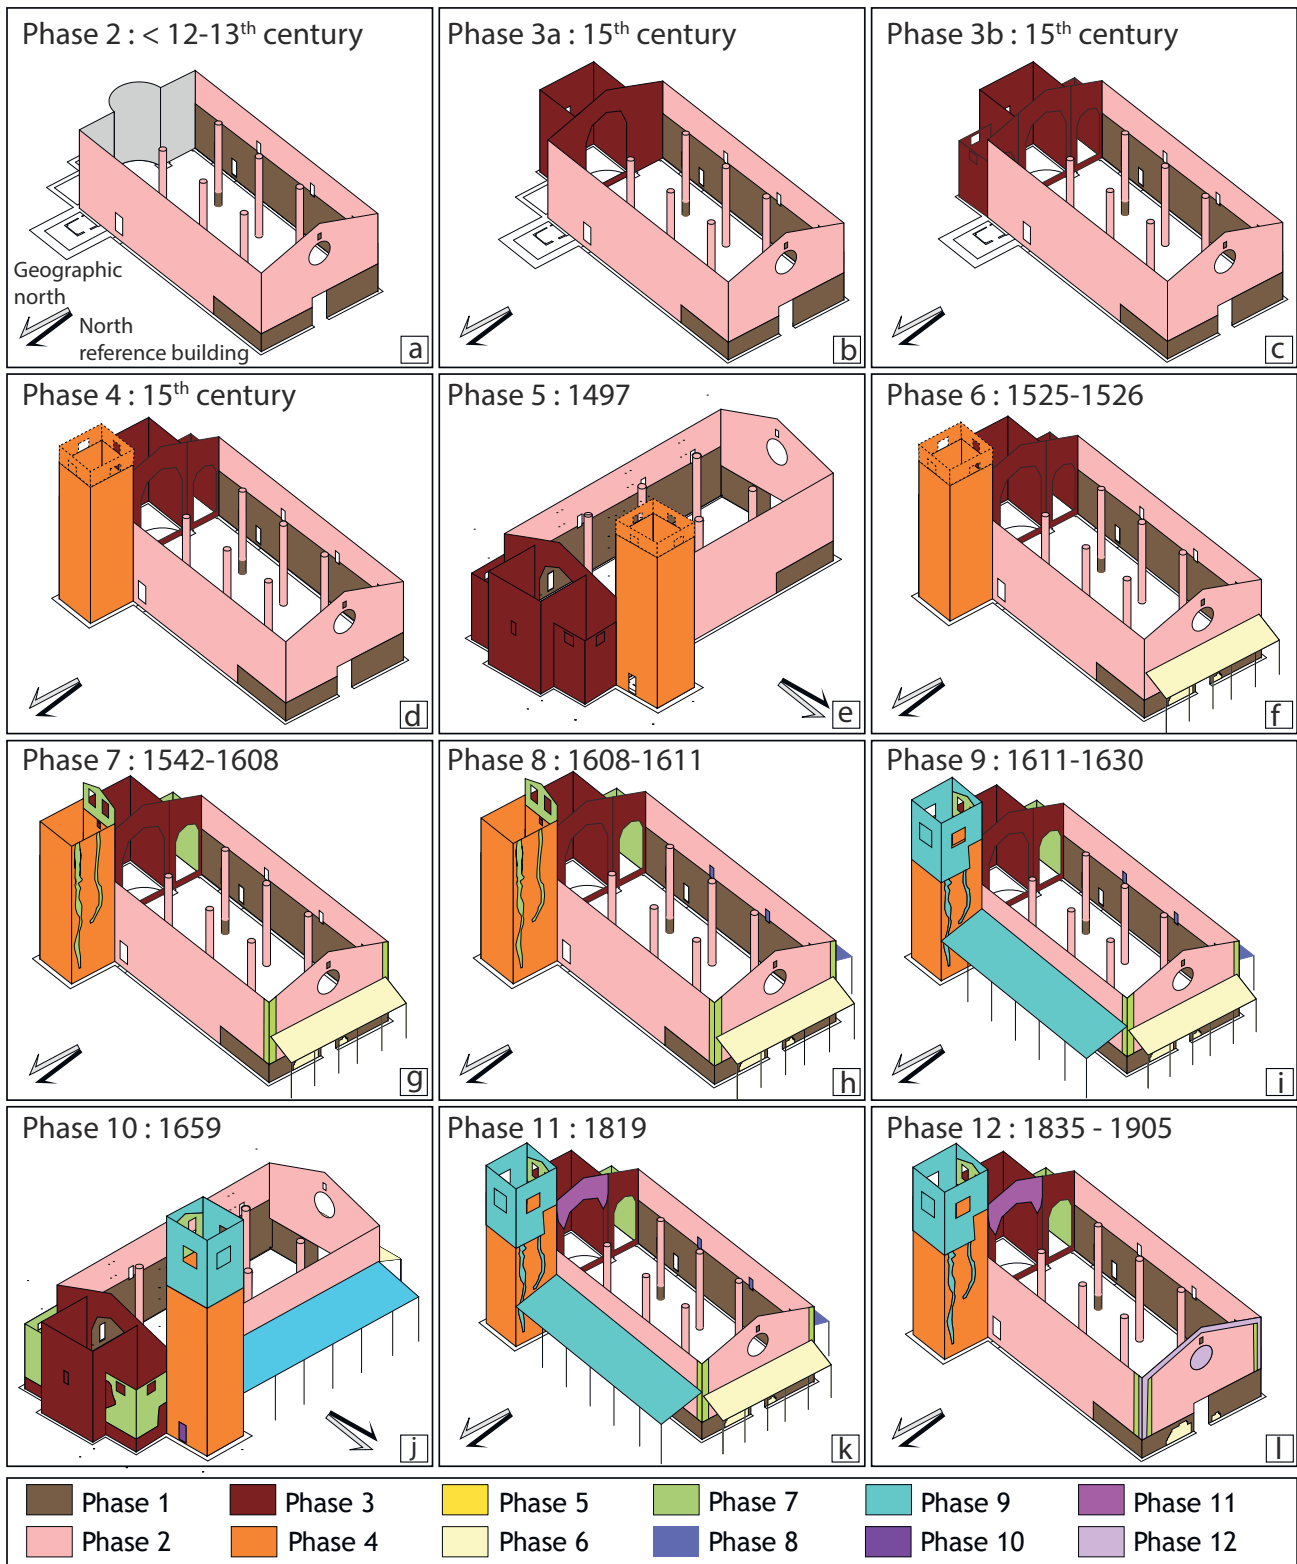
Figure 24: Sketches of the 12 building phases of the church over time.

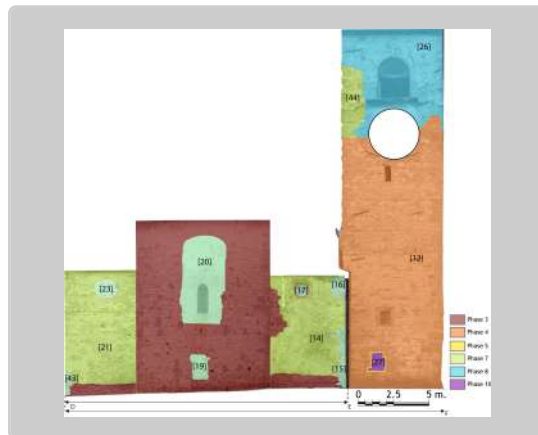
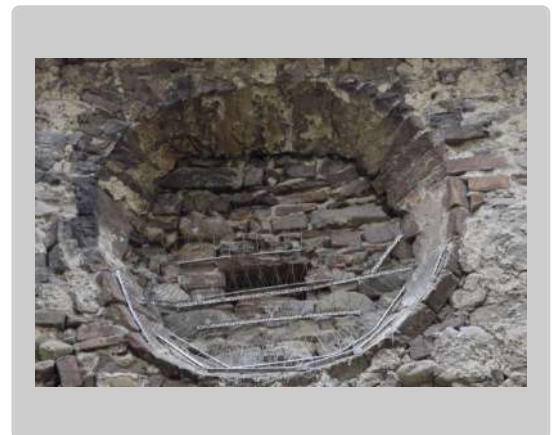
Id. OPUR 18

Localisation SantAgata, , , : Façade wall, non load-bearing

Identity **Intervention partial** - ACoR : TCM10
Repaired part(s) : East, West ; Lower part

Hazard **Supposed collapse** (Corner overturning. Partial complex overturning)
Ancient origin : earthquake - Probability of the event very strong

Other precisions North side chapel (MR9).
Same repair than opur 14 but applied to wall MR9.
Use of a "assise de réglage" in the middle of the wall.

Repair **Corner, Reconstruction**
Dimensions (cm) : **North-South wall** : Lenght 421, Height 608
Masonry : Stone, Mortar [Lime and sand]

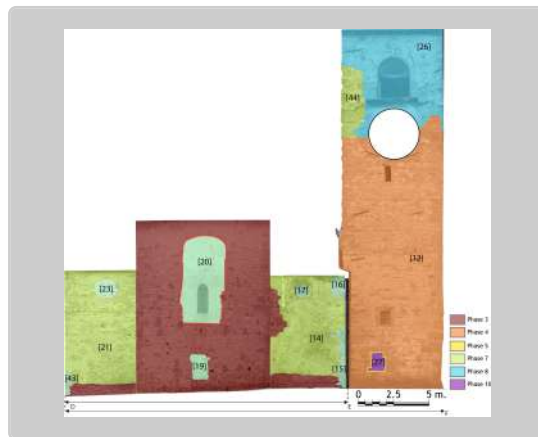
Id. OPUR 21

Localisation SantAgata, , , : Façade wall, non load-bearing

Identity **Intervention partial** - ACoR : TCM10
Repaired part(s) : North, South, East, West ; Upper part, Middle part

Other precisions South side chapel (MR4 east wall of the south chapel).
Same repair than opur 14 but applied to wall MR4.
Use of a "assise de réglage" in the middle of the wall.
The repair work is very similar to the one used for the north chapel.

Repair **Reconstruction**
Dimensions (cm) : Lenght 379, Height 694
Masonry, Block : Stone, Mortar [Lime and sand]

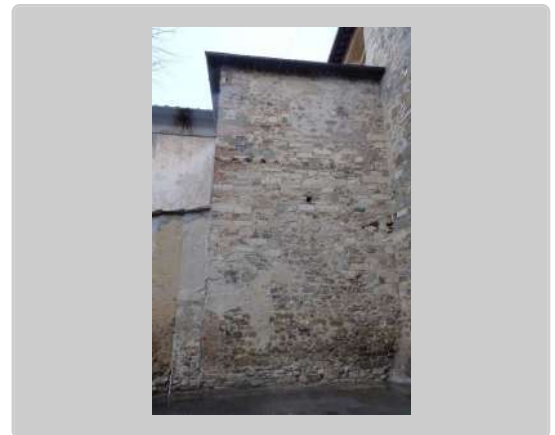
Id. OPUR 22

Localisation SantAgata, , , : Façade wall, non load-bearing

Identity **Intervention partial** - ACoR : TCM10
Repaired part(s) : North, South ; Lower part

Hazard **Supposed collapse** (Corner overturning)
Ancient origin : undetermined

Other precisions South side chapel (MR3 south wall of the south chapel).
Same repair than opur 14 but applied to wall MR3.
Use of a "assise de réglage" in the middle of the wall.
The repair work is very similar to the one used for the north chapel.
A younger building is built against to this repair wall (the cloister).

Repair **Not indicated**
Dimensions (cm) : Width 47, Height 177
Masonry, Block : Stone, terra cotta, Mortar [Lime and sand]

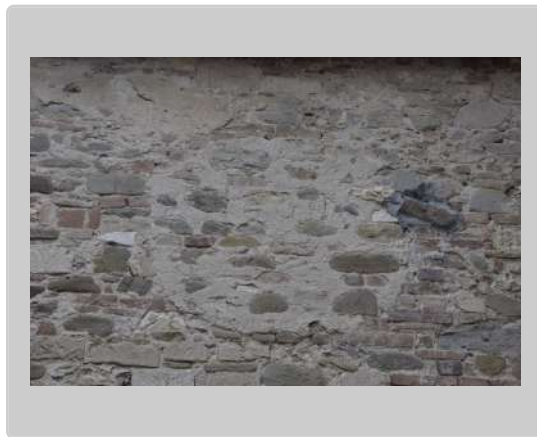
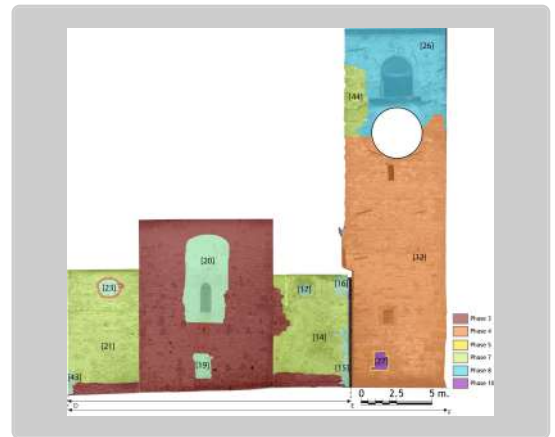
Id. OPUR 24

Localisation SantAgata, , , : Arch

Hazard **Settling**

After understanding the building evolution of the church. This unit is no more considered as a repair unit. The two lateral arches have been probably built during the building of the two initial lateral chapels. Bricks are visible under the plaster.

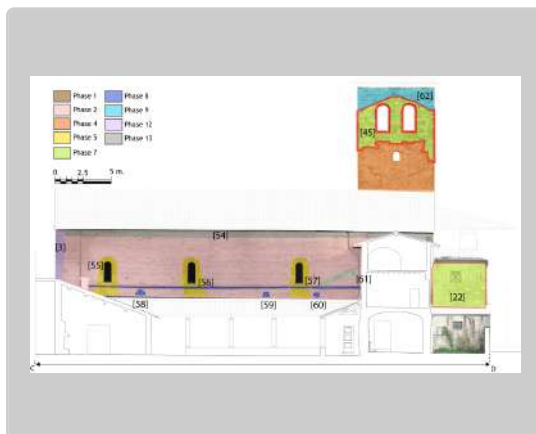
Id. OPUR 46

Localisation Sant'Agata, , , : Façade wall, load-bearing

Identity **Intervention partial** - ACoR : TCM10
Repaired part(s) : Upper part

Hazard **Supposed collapse** (Partial overturning of the wall with rotations axis at the floor level)
Ancient origin : earthquake - Probability of the event strong

Repair **Reconstruction**
Masonry : Stone, Terra cotta [Brick], Mortar [Lime and sand]

Other precisions West wall of the bell tower. External part. Reconstruction of the south corner using technique TCM10.
Corresponds to the repair after the 1542 seismic event. It was done by the population of Sant'Agata before the arrival of Nozzolini in 1608. Only the south part of the wall was rebuilt.

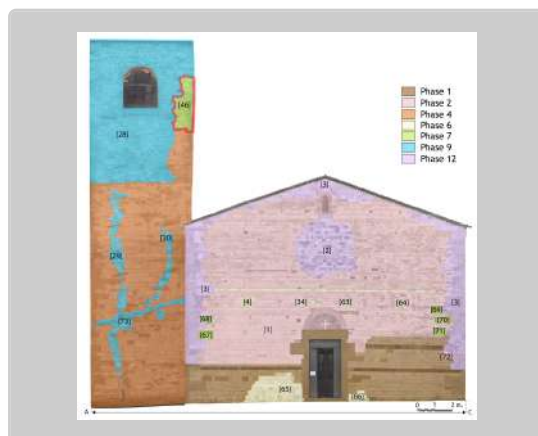
Id. OPUR 47

Localisation SantAgata, , , : Façade wall, load-bearing

Identity **Intervention partial** - ACoR : TCM14
Repaired part(s) : North, South ; Upper part

Hazard **Supposed collapse** (Partial overturning of the wall with rotations axis at the floor level)
Ancient origin : earthquake - Probability of the event strong

Repair **Reconstruction**
Dimensions (cm) : Width 563, Height 502
Masonry : Stone, Terra cotta [Brick], Mortar [Lime and sand]

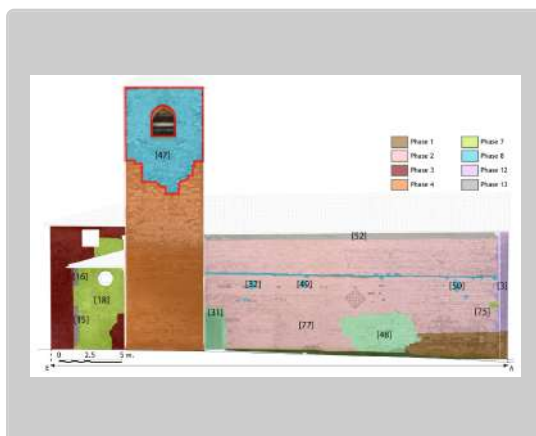
Id. OPUR 48

Localisation Sant'Agata, , , : Façade wall, load-bearing

Identity **Intervention partial** - ACoR : TCM5
Repaired part(s) : East, West ; Lower part

Hazard **Supposed collapse** (Disgregation of masonry)
Ancient origin : earthquake - Probability of the event strong

Repair **Reconstruction**
Filling-in, Masonry : Stone, Mortar [Lime and sand]

Other precisions North wall of the nave. External part of the wall.
Repair of the lower part of the wall which probably collapse. This repair is typical of a disgregation of the masonry.
The so-called *cucci scucci* (PhD thesis by Andrea Arrighetti)

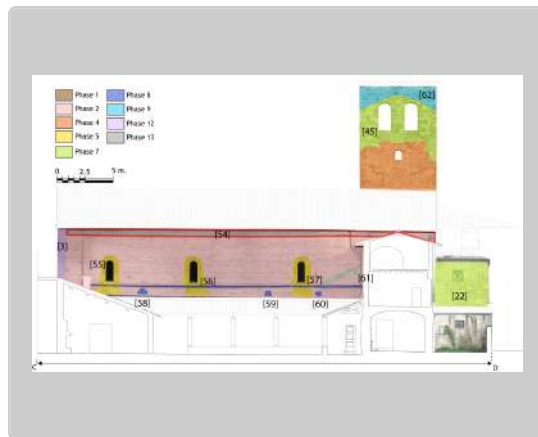
Id. OPUR 54

Localisation SantAgata, , , : Façade wall, load-bearing

Identity **Intervention partial** - ACoR : modern
Repaired part(s) : West, East ; Upper part

Hazard **Settling**
Ancient origin : undetermined - Probability of the event undetermined

Repair **Reconstruction**

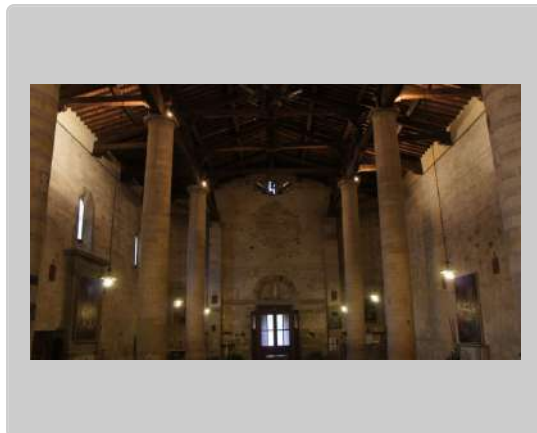
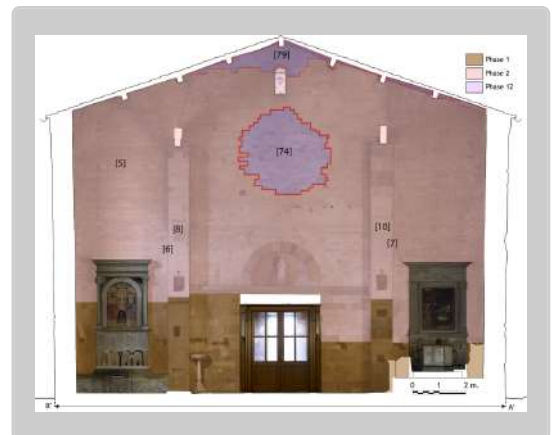
Id. OPUR 74

Localisation Sant'Agata, , , : Façade wall, load-bearing

Identity **Intervention partial** - ACoR : TCM3
Repaired part(s) : North, South ; Upper part

Hazard **Settling**
Ancient origin : undetermined - Probability of the event undetermined

Other precisions Internal facing of the front wall of the church (MR1) : Infilling of the rose window. Use of limestone (Pietra Alberese) and Serpentine course. Decimetric blocks. Undetermined origin. Such an infilling of the previous rose window might be considered as a common reconfiguration work even if it is sometimes made as a postseismic repair.

Repair **Reconstruction**
Dimensions (cm) : Length scanner, Width 339, Height 390
Masonry, Filling-in : Stone, Mortar [Lime and sand] [dimension of elements : about 10°-20 cm]

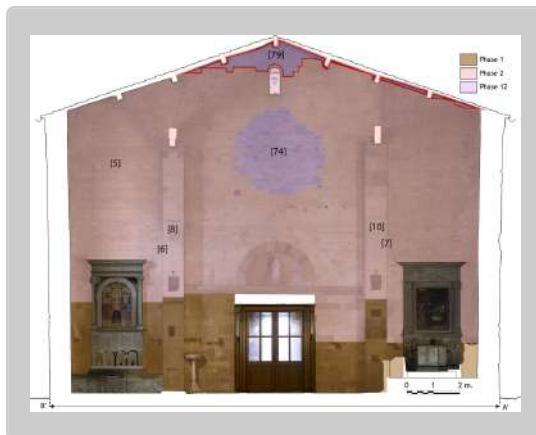
Id. OPUR 79

Localisation SantAgata, , , : Façade wall, load-bearing
