## Tracing the seismic history of Sant'Agata del Mugello (Italy, Tuscany) through a cross-disciplinary approach

# Tracing the seismic history of Sant'Agata del Mugello (Italy, Tuscany) through a cross-disciplinary approach.

Arnaud MONTABERT<sup>\*1,4,5</sup>, Hélène DESSALES<sup>2</sup>, Andrea ARRIGHETTI<sup>3</sup>, Julien CLEMENT<sup>4</sup>, Maria LANCIERI<sup>5</sup>, and Hélène LYON-CAEN<sup>1</sup>

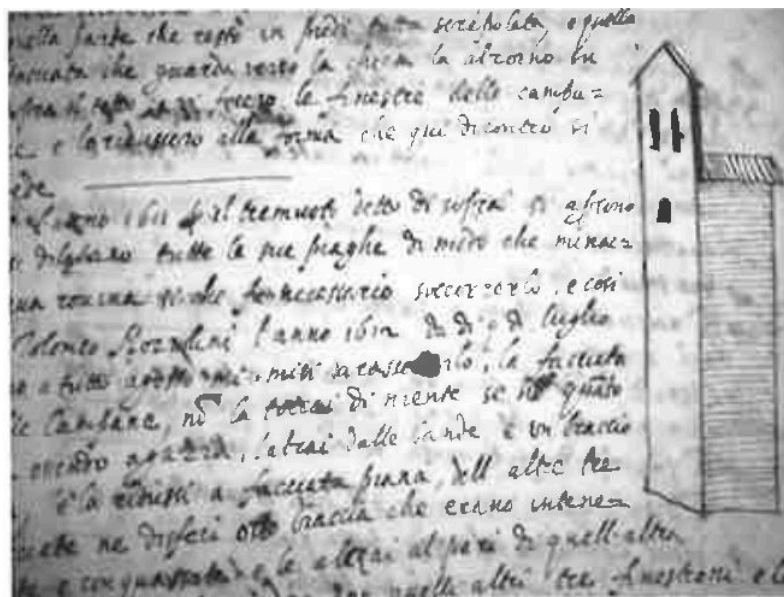
Figure 18: Excerpt of Nozzolini’s archives describing the bell tower in 1608 .

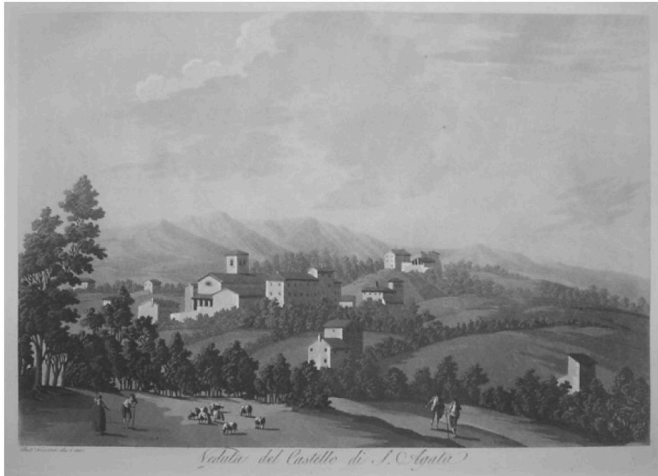
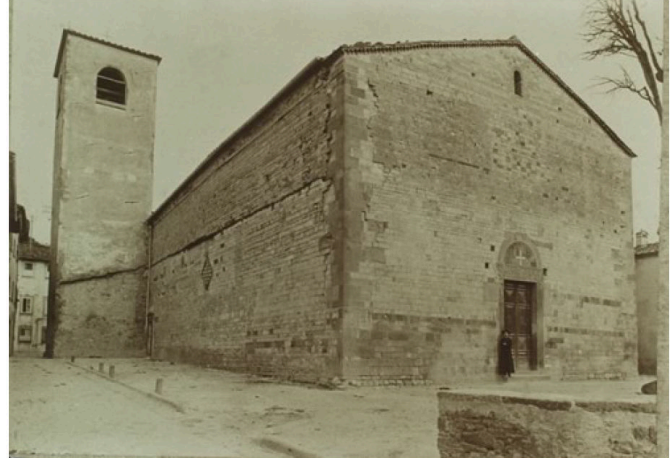
(a) View of the church of Sant'Agata in 1802.

(b) Photo of the church in 1905.

Figure 20: a) View of the church of Sant'Agata in 1802 (Fontani [1802]). b) Photograph of the church in 1905 (personal communication).

The rose window of the church is no more present as shown in Figure 20b contrary to the view shown in Figure 20a. Finally, we note the disappearance of the porch between the picture and the photo.

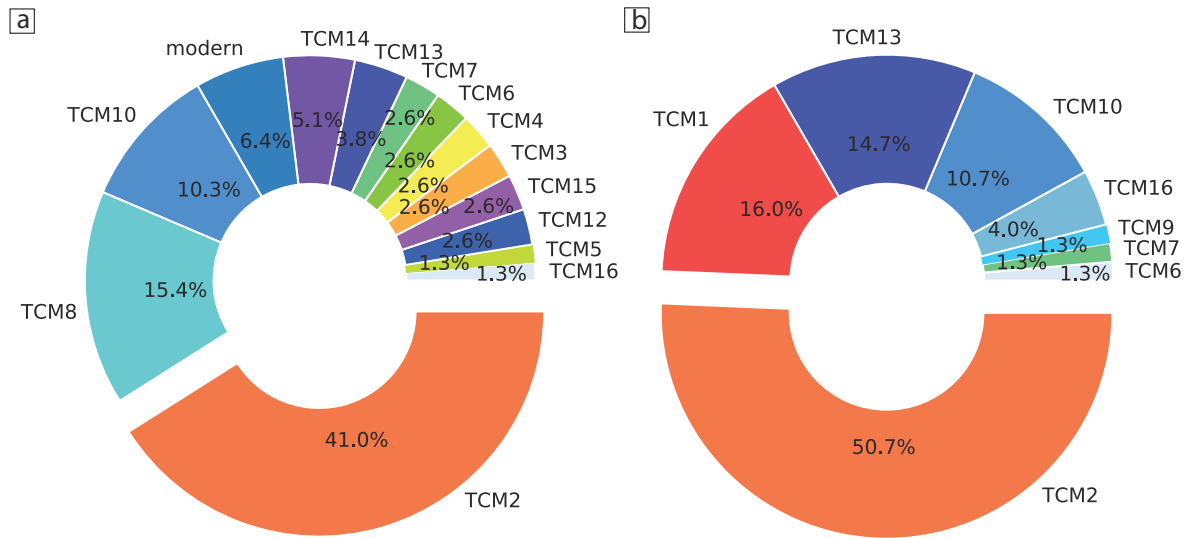
Figure 21 shows the distribution of both the building techniques used in the repair units (Figure 21), and the building techniques which are repaired themselves (Figure 21b). The most commonly used techniques in repairs are TCM2 (41 %) and TCM8 (15.4 %). The most repaired techniques is also TCM2 (50.7 %). It is interesting to note that the building technique TCM2 is mostly repaired by TCM2 itself at different

period of time (mainly for the openings infilling). It shows that ancient builders had the will to make discreet repairs avoiding, for example, to repair blocks of limestone (TCM2) with bricks (TCM8) .

Figure 21: a) Distribution of the building techniques used in the repairs. b) Distribution of building techniques which are repaired.

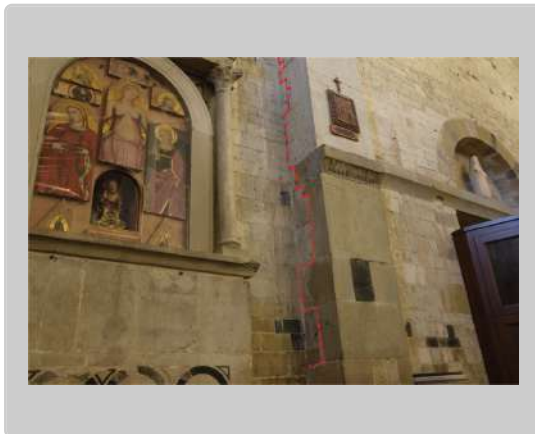
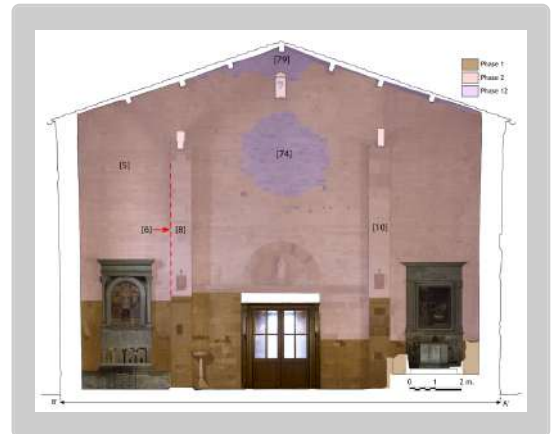
**Id. OPUR** 7

We note the same repair than the north pilaster (PL3).

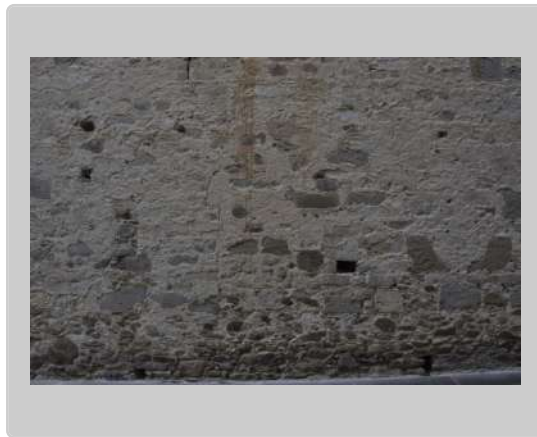
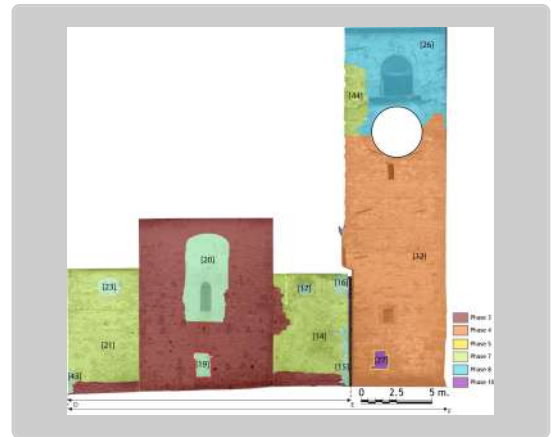
**Id. OPUR** 19

**Localisation** SantAgata, , , : Doorway

**Hazard** **Settling**

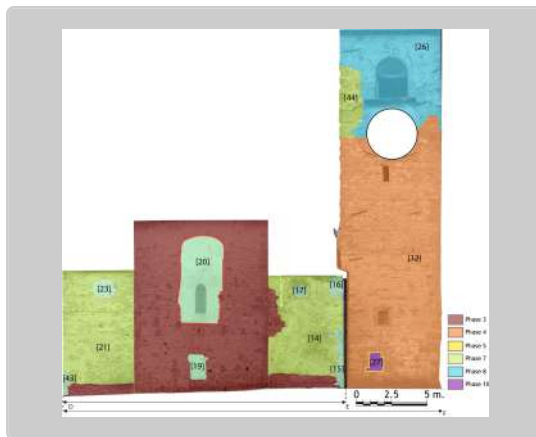
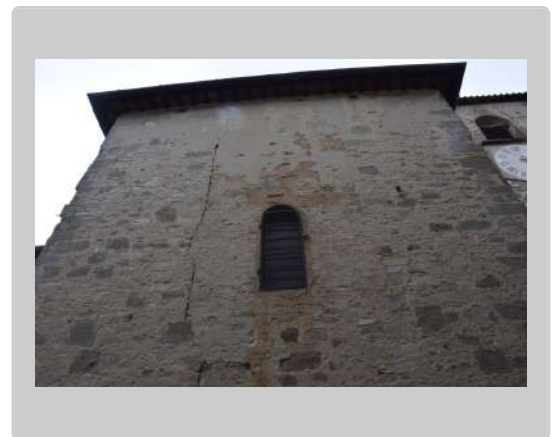
**Id. OPUR** 20

**Localisation** SantAgata, , , : Window

**Hazard** **Settling**

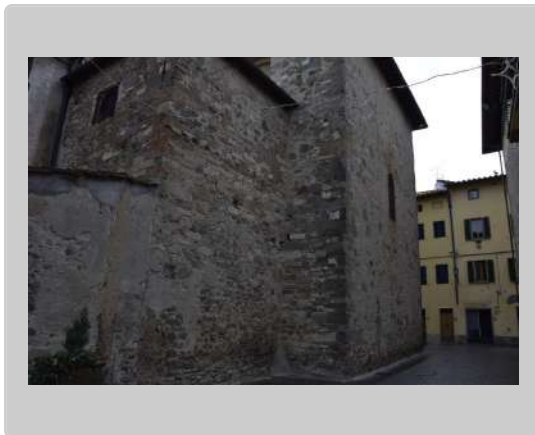
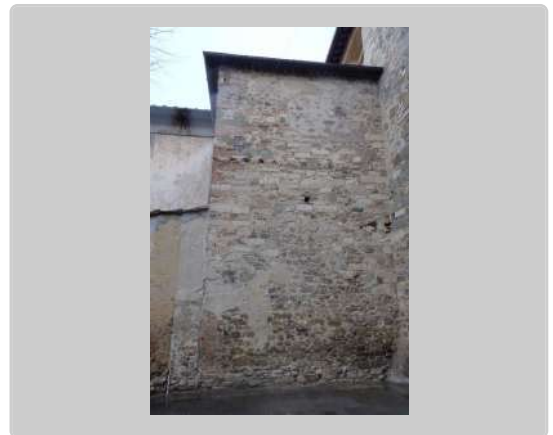
**Id. OPUR** 21

**Localisation** SantAgata, , , : Façade wall, non load-bearing

**Identity** **Intervention partial** - ACoR : TCM10  
Repaired part(s) : North, South, East, West ; Upper part, Middle part

**Other precisions** South side chapel (MR4 east wall of the south chapel).  
Same repair than opur 14 but applied to wall MR4.  
Use of a "assise de réglage" in the middle of the wall.  
The repair work is very similar to the one used for the north chapel.

**Repair** **Reconstruction**  
Dimensions (cm) : Lenght 379, Height 694  
Masonry, Block : Stone, Mortar [Lime and sand]

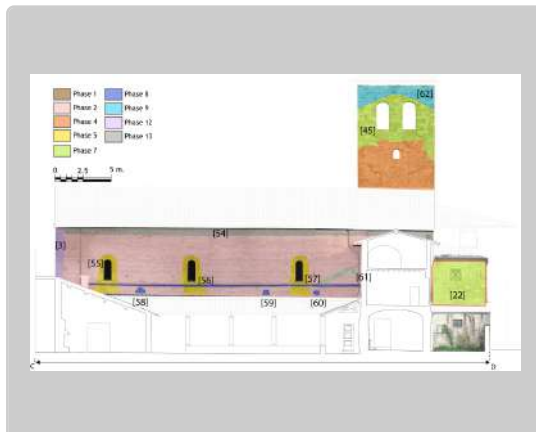
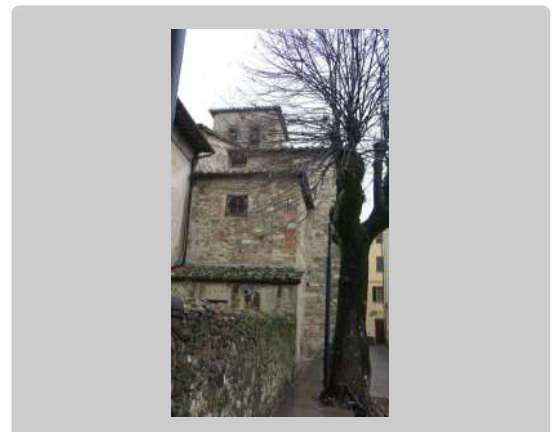
**Id. OPUR** 22

**Localisation** SantAgata, , , : Façade wall, non load-bearing

**Identity** **Intervention partial** - ACoR : TCM10  
Repaired part(s) : North, South ; Lower part

**Hazard** **Supposed collapse** (Corner overturning)  
Ancient origin : undetermined

**Other precisions** South side chapel (MR3 south wall of the south chapel).  
Same repair than opur 14 but applied to wall MR3.  
Use of a "assise de réglage" in the middle of the wall.  
The repair work is very similar to the one used for the north chapel.  
A younger building is built against to this repair wall (the cloister).

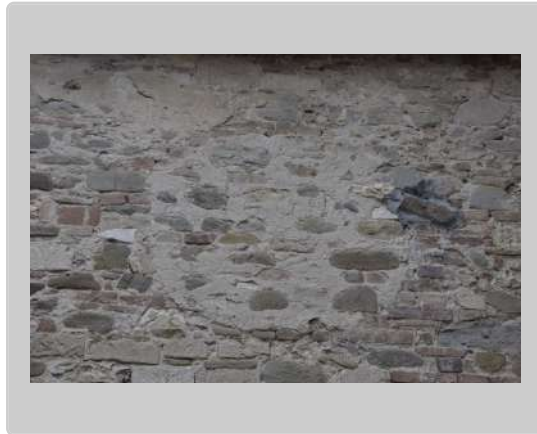
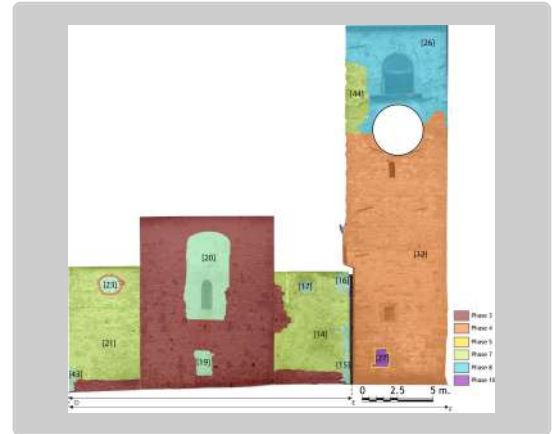
**Id. OPUR** 23

**Localisation** SantAgata, , , : Window

**Identity** **Intervention partial** - ACoR : TCM10  
Repaired part(s) : North, South ; Upper part

**Hazard** **Settling**  
Ancient origin : undetermined

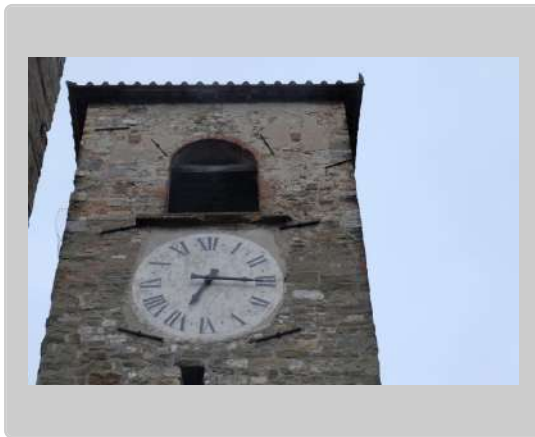
**Id. OPUR** 25

**Localisation** SantAgata, , , : Façade wall, load-bearing

**Identity** **Intervention partial**  
Repaired part(s) : North, South, East, West

**Hazard** **Fracture** (Vertical crack)  
Ancient origin : earthquake - Probability of the event strong

**Other precisions** External east facing wall of the bell tower. 12 iron chains in the wall. A small crack is visible.

**Repair** **Cracks filling**  
Dimensions (cm) : Width 50, Height 170

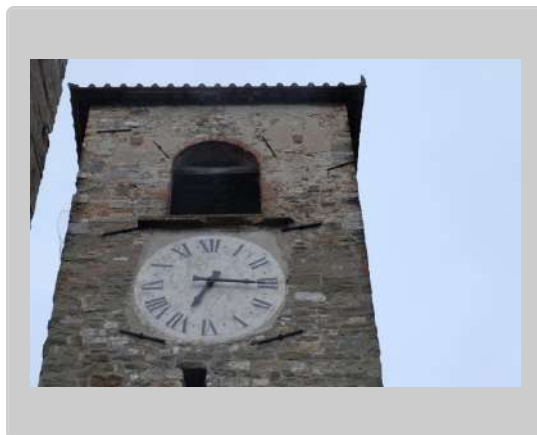
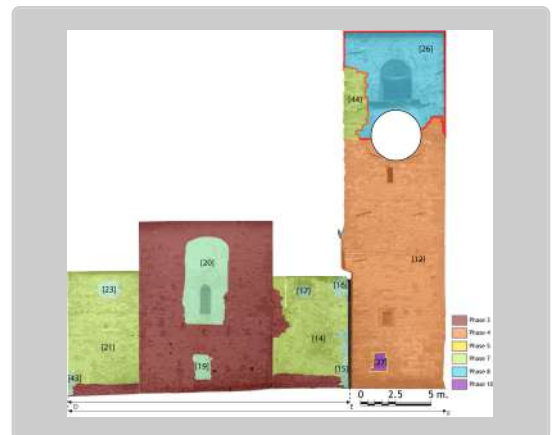
**Id. OPUR** 26

**Localisation** Sant'Agata, , , : Façade wall, non load-bearing

**Identity** **Intervention partial** - ACoR : TCM14  
Repaired part(s) : East, West ; Upper part

**Hazard**  
Ancient origin : earthquake - Probability of the event strong

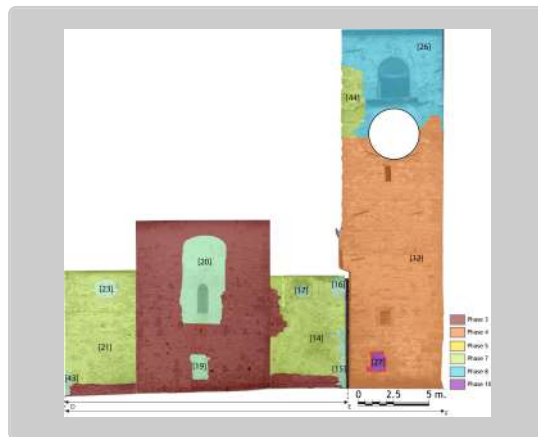
**Id. OPUR** 27

**Localisation** SantAgata, , , : Doorway

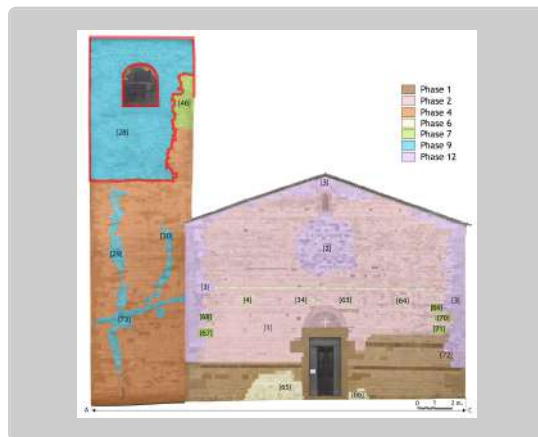
**Id. OPUR** 28

**Localisation** SantAgata, , , : Façade wall, load-bearing

**Identity** **Intervention partial** - ACoR : TCM14  
Repaired part(s) : North, South ; Upper part

**Hazard** **Supposed collapse** (Partial overturning of the wall with rotations axis at the floor level)  
Ancient origin : earthquake - Probability of the event strong

**Repair** **Reconstruction**  
Dimensions (cm) : Width 563, Height 502  
Masonry : Stone, Terra cotta [Brick], Mortar [Lime and sand]

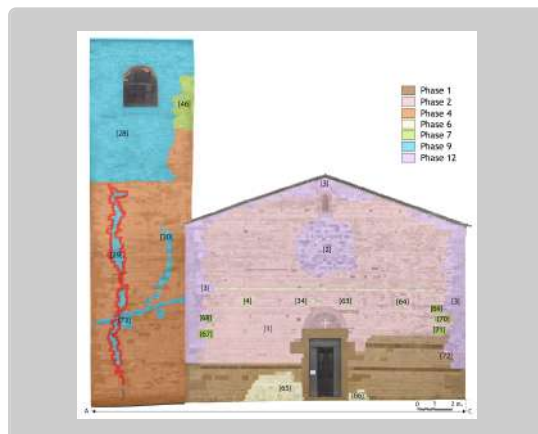
**Id. OPUR** 29

**Localisation** SantAgata, , , : Façade wall, load-bearing

**Identity** **Intervention partial** - ACoR : TCM13  
Repaired part(s) : North, South ; Upper part, Middle part, Lower part

**Hazard** **Fracture** (Vertical crack)  
Ancient origin : earthquake - Probability of the event very strong

**Other precisions** External west facing wall of the bell tower. Infilling of the north crack reinforced using iron chain. TCM13 is used for the repair.

Mur W externe du campanile. Rebouchage de la fissure N en plus des tirants métalliques. Remplissage de la fissure de manière identique que la technique de construction (T-08)  
Stratigraphical analysis in good agreement with the Nozzolini's description.

**Repair** **Cracks filling**  
Dimensions (cm) : Width 20, Height 1070  
Filling-in : Stone, Terra cotta [Brick], Mortar [Lime and sand]

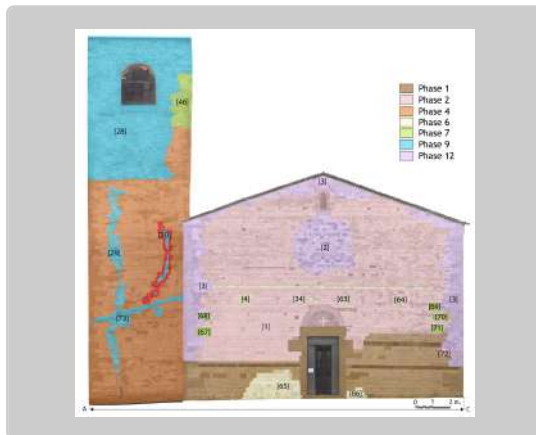
**Id. OPUR** 30

**Localisation** Sant'Agata, , , : Façade wall, load-bearing

**Identity** **Intervention partial - ACoR : TCM13**  
Repaired part(s) : North, South ; Upper part, Middle part, Lower part

**Hazard** **Fracture** (Vertical crack)  
Ancient origin : earthquake - Probability of the event very strong

**Other precisions** External west facing wall of the bell tower. Infilling of the south crack using technique TCM13. Presence of iron chain.

**Repair** **Cracks filling**  
Dimensions (cm) : Width 20, Height 1075  
Filling-in : Stone, Terra cotta [Brick], Mortar [Lime and sand]

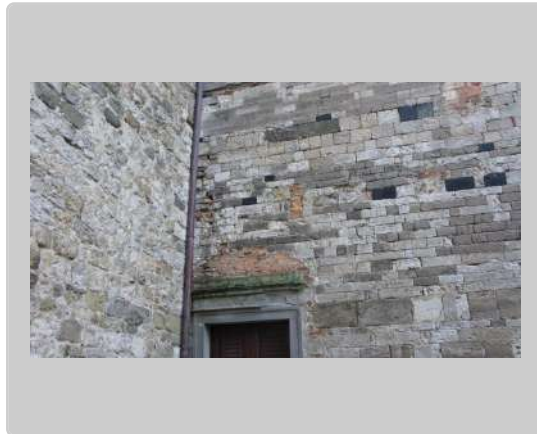
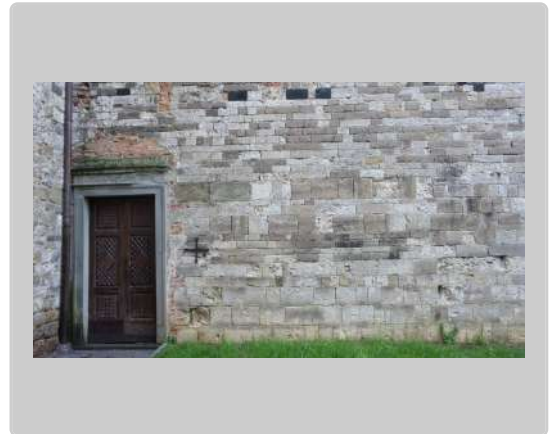
**Id. OPUR** 31

**Localisation** SantAgata, , , : Doorway

**Hazard** **Settling**

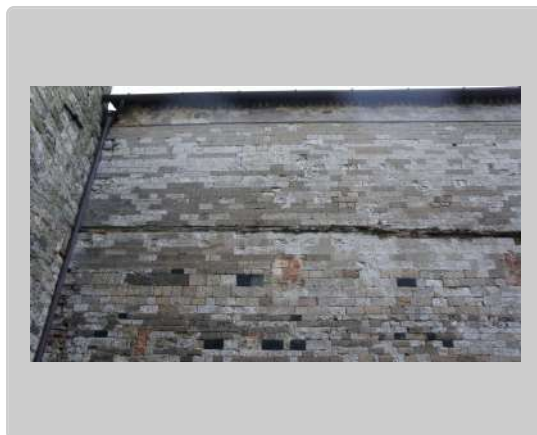
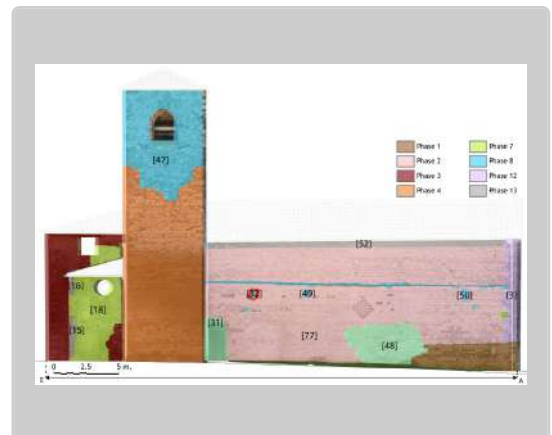
**Id. OPUR** 32

**Localisation** Sant'Agata, , , : Façade wall, load-bearing

**Identity** **Intervention partial** - ACoR : TCM8  
Repaired part(s) : East, West ; Middle part

**Hazard** **Supposed collapse**  
Ancient origin : undetermined - Probability of the event undetermined

**Repair** **Reconstruction**  
Dimensions (cm) : Length 582, Height 273  
Filling-in : Stone, Terra cotta [Brick], Mortar [Lime and sand]

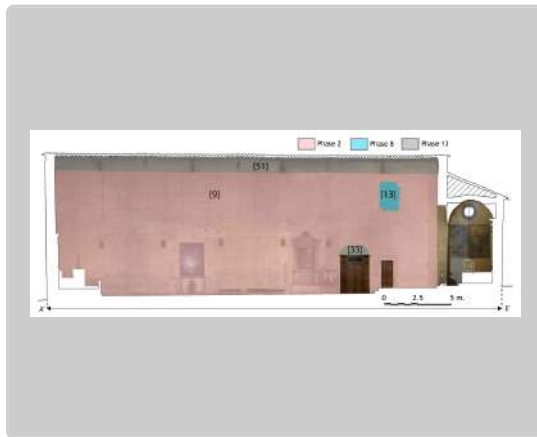
**Id. OPUR** 33

**Localisation** SantAgata, , , : Doorway

**Identity** **Intervention partial** - ACoR : TCM2  
Repaired part(s) : East, West ; Upper part

**Hazard** **Settling**  
Ancient origin : undetermined

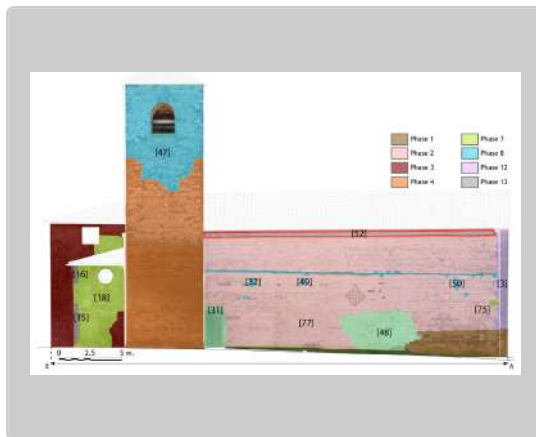
**Id. OPUR** 53

**Localisation** SantAgata, , , : Façade wall, load-bearing

**Identity** **Intervention partial** - ACoR : modern  
Repaired part(s) : West, East ; Upper part

**Hazard** **Settling**  
Ancient origin : undetermined - Probability of the event undetermined

**Repair** **Reconstruction**

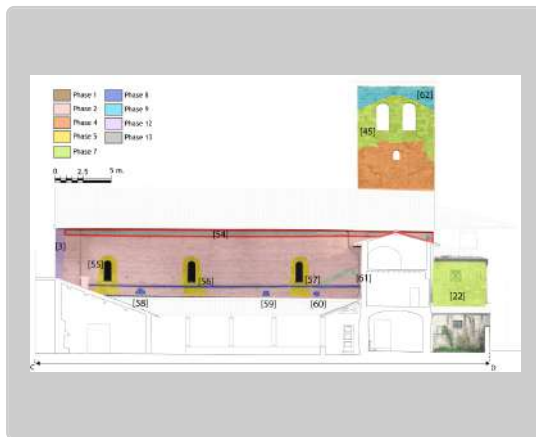
**Id. OPUR** 54

**Localisation** Sant'Agata, , , : Façade wall, load-bearing

**Identity** **Intervention partial** - ACoR : modern  
Repaired part(s) : West, East ; Upper part

**Hazard** **Settling**  
Ancient origin : undetermined - Probability of the event undetermined

**Repair** **Reconstruction**

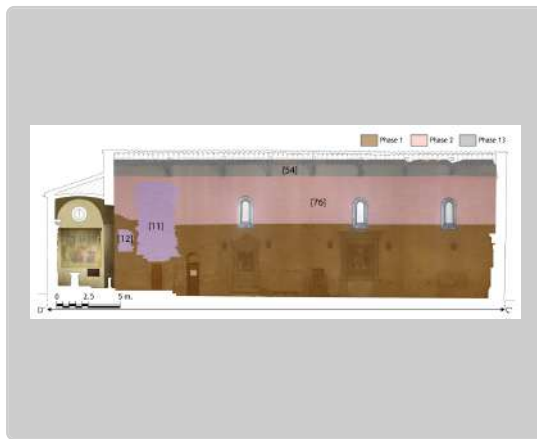
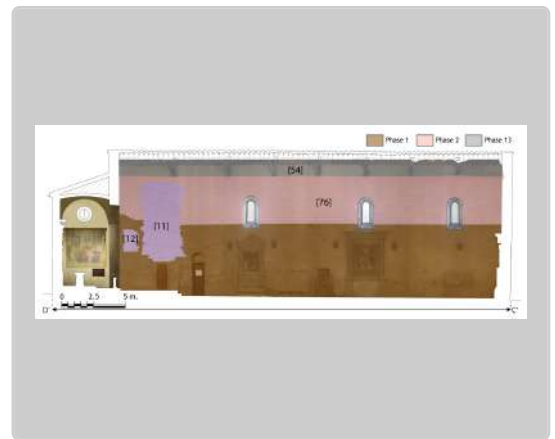
**Id. OPUR** 55

**Localisation** SantAgata, , , : Window

**Identity** **Intervention partial** - ACoR : TCM8  
Repaired part(s) : East, West ; Middle part

**Hazard** **Settling**  
Ancient origin : undetermined - Probability of the event undetermined

**Repair** **Not indicated**  
Filling-in, Masonry : Terra cotta [Brick], Mortar [Lime and sand]

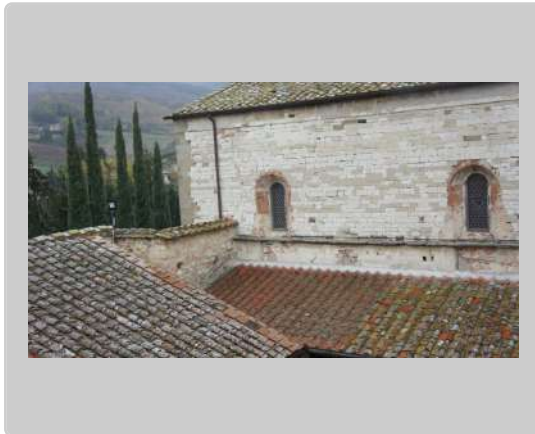
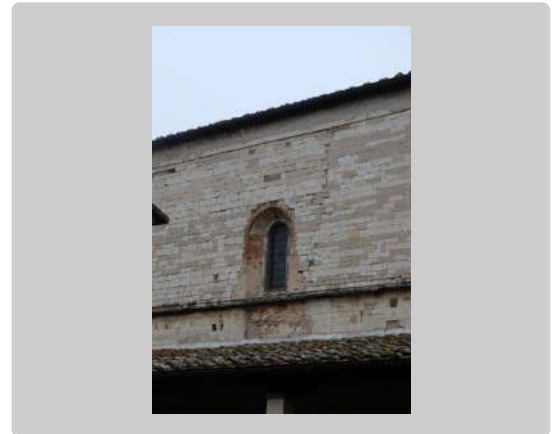
**Id. OPUR** 56

**Localisation** SantAgata, , , : Window

**Identity** **Intervention partial** - ACoR : TCM8  
Repaired part(s) : East, West ; Middle part

**Hazard** **Settling**  
Ancient origin : undetermined - Probability of the event undetermined

**Repair** **Not indicated**  
Filling-in, Masonry : Terra cotta [Brick], Mortar [Lime and sand]

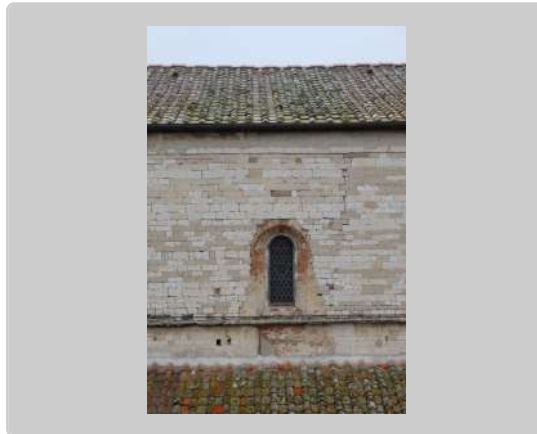
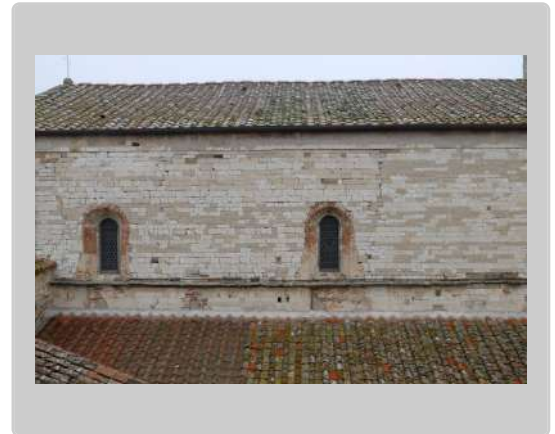
**Id. OPUR** 57

**Localisation** SantAgata, , , : Window

**Identity** **Intervention partial** - ACoR : TCM8  
Repaired part(s) : East, West ; Middle part

**Hazard** **Settling**  
Ancient origin : undetermined - Probability of the event undetermined

**Repair** **Not indicated**  
Filling-in, Masonry : Terra cotta [Brick], Mortar [Lime and sand]

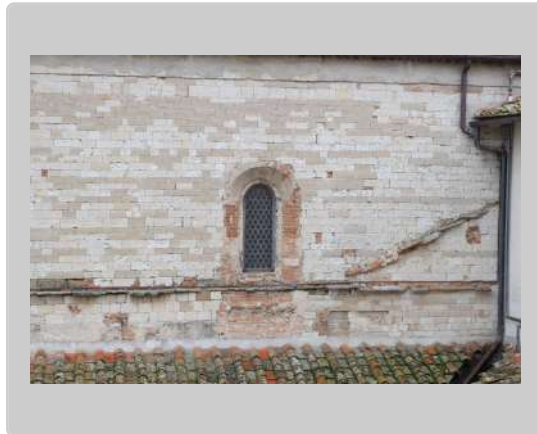
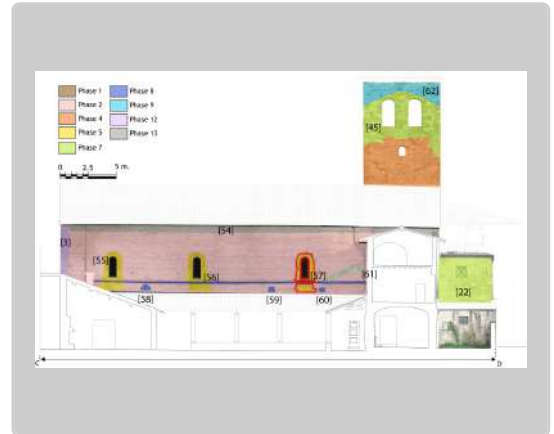
**Id. OPUR** 58

**Localisation** SantAgata, , , : Façade wall, load-bearing

**Identity** **Intervention partial** - ACoR : TCM2  
Repaired part(s) : East, West ; Middle part

**Hazard** **Supposed collapse**  
Ancient origin : undetermined - Probability of the event undetermined

**Repair** **Reconstruction**  
Dimensions (cm) : Lenght 582, Height 273  
Filling-in : Stone, Terra cotta [Brick], Mortar [Lime and sand]

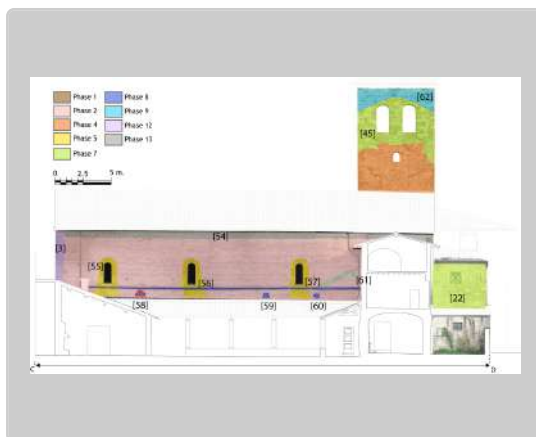
**Id. OPUR** 59

**Localisation** SantAgata, , , : Façade wall, load-bearing

**Identity** **Intervention partial** - ACoR : TCM2  
Repaired part(s) : East, West ; Middle part

**Hazard** **Supposed collapse**  
Ancient origin : undetermined - Probability of the event undetermined

**Repair** **Reconstruction**  
Dimensions (cm) : Lenght 582, Height 273  
Filling-in : Stone, Terra cotta [Brick], Mortar [Lime and sand]

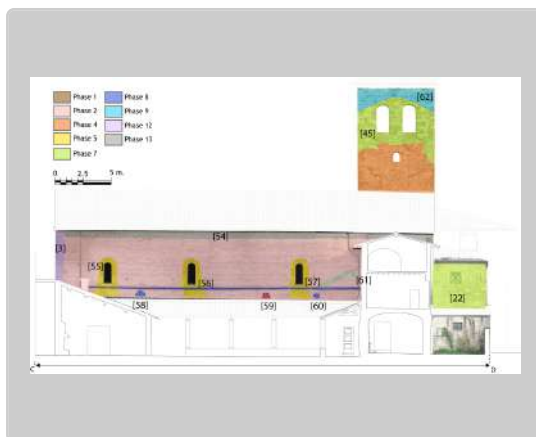
**Id. OPUR** 60

**Localisation** SantAgata, , , : Façade wall, load-bearing

**Identity** **Intervention partial** - ACoR : TCM2  
Repaired part(s) : East, West ; Middle part

**Hazard** **Supposed collapse**  
Ancient origin : undetermined - Probability of the event undetermined

**Repair** **Reconstruction**  
Dimensions (cm) : Lenght 582, Height 273  
Filling-in : Stone, Terra cotta [Brick], Mortar [Lime and sand]

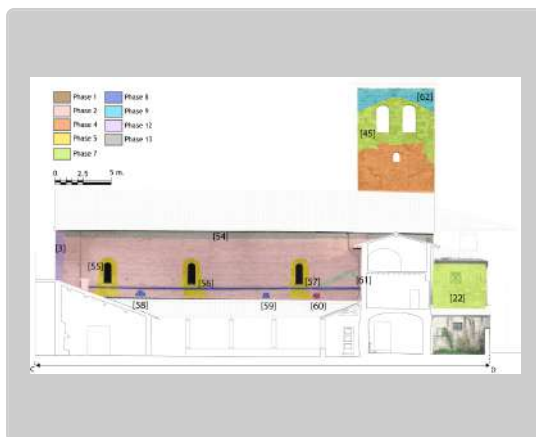
**Id. OPUR** 61

**Localisation** SantAgata, , , : Façade wall, load-bearing

**Identity** **Intervention partial** - ACoR : TCM2  
Repaired part(s) : East, West ; Middle part

**Hazard** **Supposed collapse**  
Ancient origin : undetermined - Probability of the event undetermined

**Repair** **Reconstruction**  
Dimensions (cm) : Lenght 582, Height 273  
Filling-in : Stone, Terra cotta [Brick], Mortar [Lime and sand]

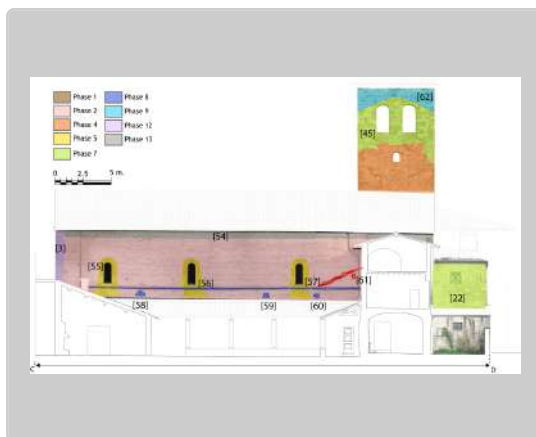
**Id. OPUR** 62

**Localisation** Sant'Agata, , , : Façade wall, load-bearing

**Identity** **Intervention partial** - ACoR : TCM14  
Repaired part(s) : North, South ; Upper part

**Hazard** **Supposed collapse** (Partial overturning of the wall with rotations axis at the floor level)  
Ancient origin : earthquake - Probability of the event strong

**Repair** **Reconstruction**  
Dimensions (cm) : Width 563, Height 502  
Masonry : Stone, Terra cotta [Brick], Mortar [Lime and sand]

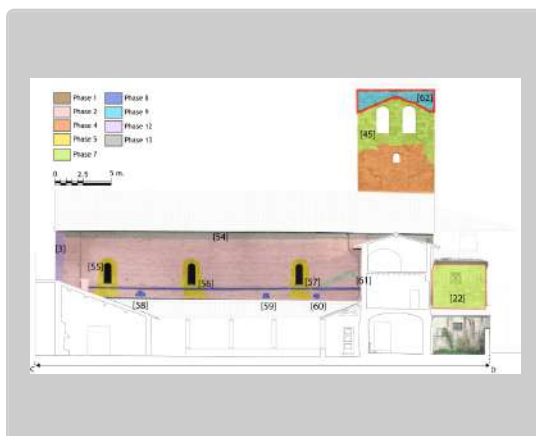
**Id. OPUR** 63

**Localisation** SantAgata, , , : Façade wall, load-bearing

**Identity** **Intervention partial - ACoR** : TCM2  
Repaired part(s) : North, South ; Middle part

**Hazard** **Supposed collapse**  
Ancient origin : undetermined - Probability of the event undetermined

**Repair** **Reconstruction**  
Dimensions (cm) : Lenght 50, Height 50, Thickness 75  
Masonry, Filling-in : Stone, Mortar [Lime and sand]

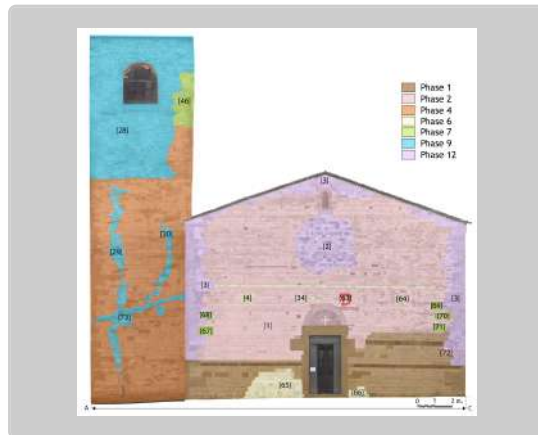
**Id. OPUR** 64

**Localisation** SantAgata, , , : Façade wall, load-bearing

**Identity** **Intervention partial - ACoR** : TCM2  
Repaired part(s) : North, South ; Middle part

**Hazard** **Supposed collapse**  
Ancient origin : undetermined - Probability of the event undetermined

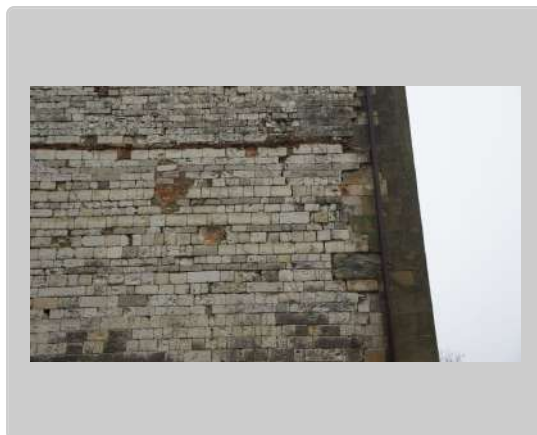
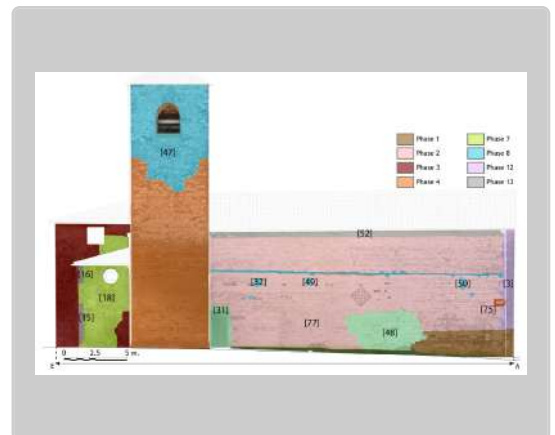
**Id. OPUR** 75

**Localisation** SantAgata, , , : Façade wall, load-bearing

**Identity** **Intervention partial** - ACoR : TCM2  
Repaired part(s) : North, South ; Middle part

**Hazard** **Supposed collapse** (Partial overturning of the wall with rotations axis at the floor level)  
Ancient origin : undetermined - Probability of the event undetermined

**Repair** **Reconstruction**  
Dimensions (cm) : Lenght 40, Width 20, Height 20, Thickness 0  
Filling-in, Block : Stone, Mortar [Lime and sand]

**Other precisions** North wall of the church (MR14). External facing of the church. Use of large block of limestone very different to the TCM2 technique used in this part of the wall.  
Probably linked to a repair of the corner quoins after the undetermined event which induced the reconstruction of the front wall using technique TCM2. Indeed, the block is not decayed like the middle part of the wall. (related to opur 1)

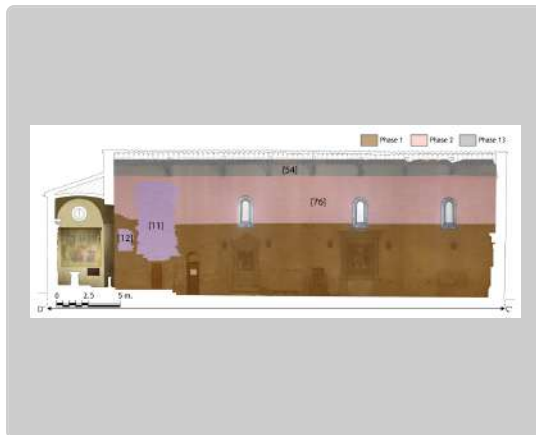
**Id. OPUR** 76

**Localisation** SantAgata, , , : Façade wall, load-bearing

**Identity** **Intervention partial - ACoR** : TCM2  
Repaired part(s) : East, West ; Upper part, Middle part

**Hazard** **Deformation - Supposed collapse - Crack** (Global complex overturning of the façade)  
Ancient origin : earthquake - Probability of the event strong

**Repair** **Reconstruction**  
Dimensions (cm) : Lenght 2842, Height 338  
Masonry : Stone, Mortar [Lime and sand]

**Other precisions** Internal facing wall of MR2 (south wall of the nave).  
Reconstruction of the wall from the middle (limit with the three windows) until the top of the wall. Use of TCM2 with blocks of limestone having very fine joints. The repair is visible because the wall is straight ahead contrary to the wall below which undulates slightly.

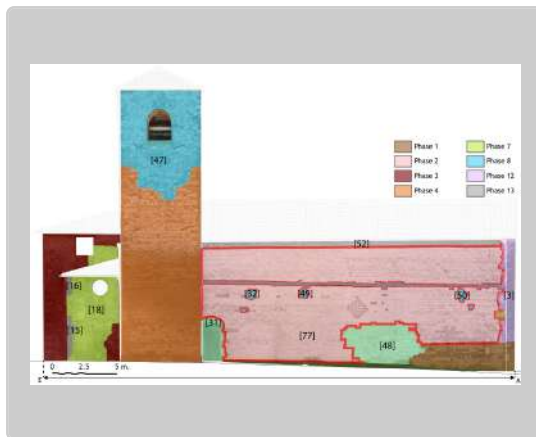
**Id. OPUR** 77

**Localisation** SantAgata, , , : Façade wall, load-bearing

**Identity** **Intervention partial** - ACoR : TCM2  
Repaired part(s) : North, South ; Upper part, Middle part

**Hazard** **Supposed collapse** (Rocking. Partial overturning of the wall with rotations axis at the floor level)  
Ancient origin : undetermined - Probability of the event undetermined

**Repair** **Reconstruction**  
Dimensions (cm) : Lenght 1500 (preserved), Width 1510, Height 1191  
Masonry : Stone, Mortar [Lime and sand]

the technique that is being repaired(TCM1) :  
Use of decimetric and quadrangular blocks of limestone (Pietra Albarese). Maximum length of the block : 25.5cm, Minimum length of the block : 12.3cm. Max width : 72cm, minimum width : 10.5 cm. Blocks edges are roughly cut. Course of serpentinite are used with an ornamental purpose. Dimension of joints : max : 1.2cm,

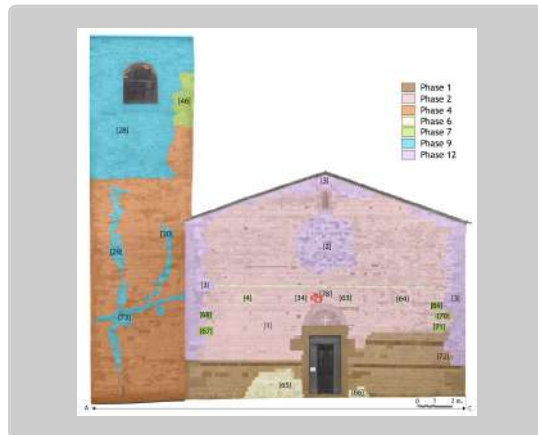
**Id. OPUR** 78

**Localisation** SantAgata, , , : Façade wall, load-bearing

**Identity** **Intervention partial** - ACoR : TCM2  
Repaired part(s) : North, South ; Middle part

**Hazard** **Supposed collapse**  
Ancient origin : undetermined - Probability of the event undetermined

**Repair** **Reconstruction**  
Dimensions (cm) : Lenght 50, Height 50, Thickness 75  
Masonry, Filling-in : Stone, Mortar [Lime and sand]

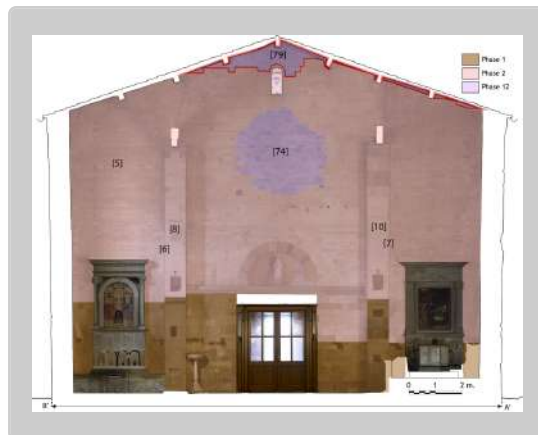
**Id. OPUR** 79

**Localisation** SantAgata, , , : Façade wall, load-bearing

**Identity** **Intervention partial** - ACoR : TCM6  
Repaired part(s) : North, South ; Middle part, Upper part

**Hazard** **Deformation** (Corner overturning)  
Ancient origin : earthquake - Probability of the event strong

**Repair** **Not indicated**  
Dimensions (cm) : Width 123, Height 787  
Masonry, Block : Stone, Mortar [Lime and sand] [dimension of elements : between 20 and 50 cm]

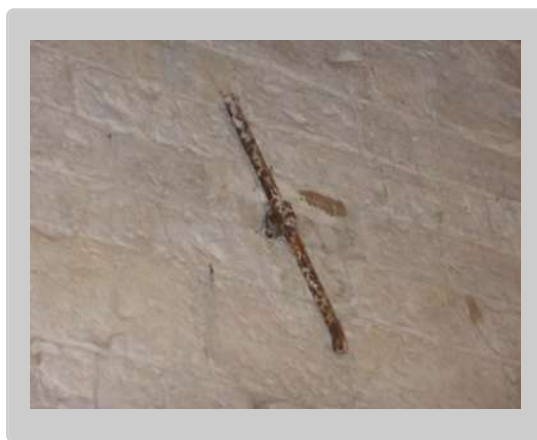
**Id. OPUR** 80

**Localisation** SantAgata, , , : Interior wall, load-bearing
