Tracing the seismic history of Sant'Agata del Mugello (Italy, Tuscany) through a cross-disciplinary approach

Tracing the seismic history of Sant'Agata del Mugello (Italy, Tuscany) through a cross-disciplinary approach.

Keywords— historical seismicity, historical sources, building stratigraphy, architecture, structural analysis, damage mechanisms, Central Italy

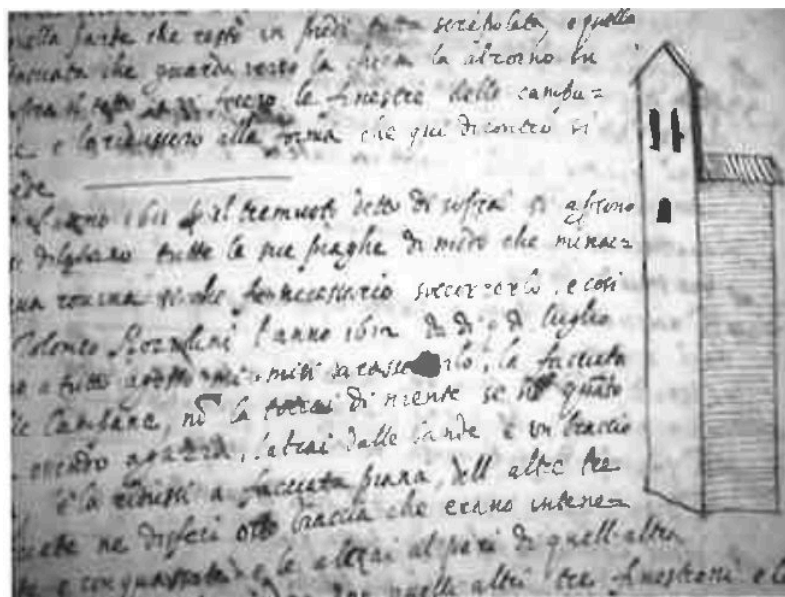
Figure 18: Excerpt of Nozzolini’s archives describing the bell tower in 1608 .

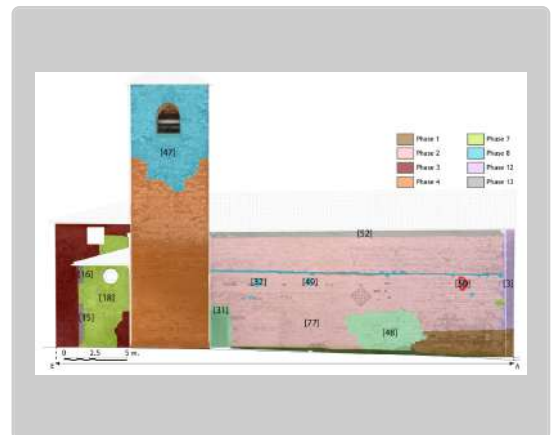
Id. OPUR 51

Localisation SantAgata, , , : Façade wall, load-bearing

Identity **Intervention partial** - ACoR : modern
Repaired part(s) : West, East ; Upper part

Hazard **Settling**
Ancient origin : undetermined - Probability of the event undetermined

Repair **Reconstruction**

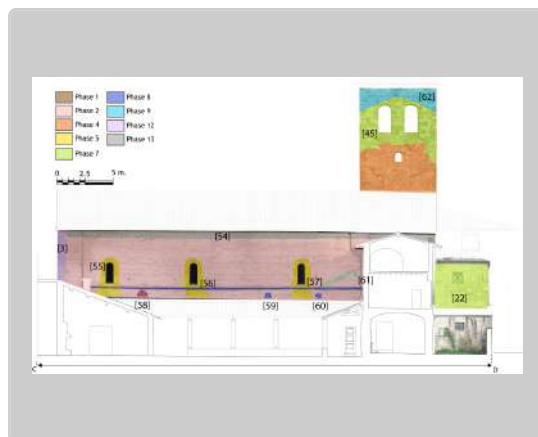
Id. OPUR 59

Localisation SantAgata, , , : Façade wall, load-bearing

Identity **Intervention partial** - ACoR : TCM2
Repaired part(s) : East, West ; Middle part

Hazard **Supposed collapse**
Ancient origin : undetermined - Probability of the event undetermined

Repair **Reconstruction**
Dimensions (cm) : Lenght 582, Height 273
Filling-in : Stone, Terra cotta [Brick], Mortar [Lime and sand]

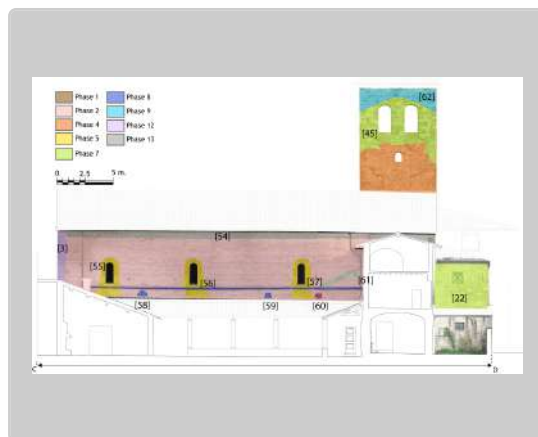
Id. OPUR 61

Localisation SantAgata, , , : Façade wall, load-bearing

Identity **Intervention partial** - ACoR : TCM2
Repaired part(s) : East, West ; Middle part

Hazard **Supposed collapse**
Ancient origin : undetermined - Probability of the event undetermined

Repair **Reconstruction**
Dimensions (cm) : Lenght 582, Height 273
Filling-in : Stone, Terra cotta [Brick], Mortar [Lime and sand]
