Detection and evaluation of barely visible impact damage in woven glass fabric reinforced polyamide 6.6/6 composite using ultrasonic imaging, X-ray tomography and optical profilometry

Nada Miqoi, Pascal Pomarede, Fodil Meraghni, Nico Felicien Declercq,
Laurent Guillaumat, Gael Le Coz, Stéphane Delalande

Abstract

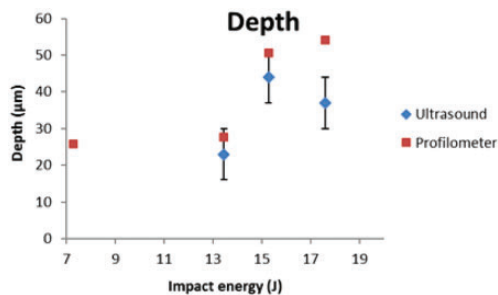
A comparison between the results provided by the two methods, ultrasound-based method, and optical profilometry, is established and represented in Figure 22. The comparison shows a good correlation between the two methods as well as a satisfying accuracy for the ultrasound-based method.

Figure 22. Comparison between the results obtained using both ultrasound-based method and profilometry for the four samples impacted respectively at energies of: 7.30, 13.45, 15.28 and 17.60J.
