## Characterization of an aluminum conductor steel reinforced (ACSR) after 60 years of operation

# Characterization of an aluminum conductor steel reinforced (ACSR) after 60 years of operation

An aluminum conductor steel reinforced (ACSR) extracted from an overhead power line operated in Northern France during more than 60 years was characterized together with a more recent equivalent conductor. Visual inspection, local observation and chemical analysis by Scanning Electron Microscope (SEM) and Energy Dispersive Spectroscopy (EDS) as well as Raman spectroscopy were used to characterize the microstructure of the strands and to evidence signs of corrosion or potential degradation. Analysis of the grease was done by Fourier Transform InfraRed Spectroscopy (FTIR). The mechanical properties of the strands were evaluated by constant strain rate tensile test at ambient temperature. Hardness was measured as well. Partial oxidation of the steel galvanization layer, degradation of the grease – especially oxidation due to ageing – and atmospheric corrosion pits on the external layer of aluminum strands were evidenced. The mechanical properties of the galvanized steel strands were still in a

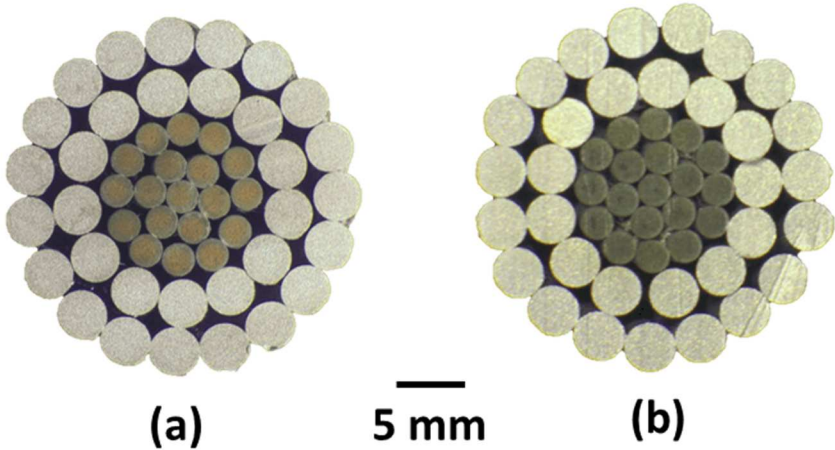
The samples of the studied ACSR conductor were extracted from the Guarbecque-Holque-Woesthyne (GHW) overhead power line, in service since 1950 in northern France. The samples were cut in 2011, after more than 60 years of operation. As presented in Figure 1, this conductor was composed of aluminum and galvanized steel strands: 19 galvanized steel strands with a nominal diameter of 2.4 mm divided into three layers (1 + 6 + 12) in the center part and 32 aluminum strands with a nominal diameter of 3.6 mm distributed in two external layers (13 + 19). The conductor had a nominal outer diameter of 26.4 mm. The overall nominal section was 412 mm<sup>2</sup>. Figure 1 also shows a cross section of a more recent equivalent conductor that was not in operation but was also characterized. This latter conductor, labelled as “modern” in the rest of the study, was used as a reference to highlight potential degradations of the GHW conductor. The two conductors were completely greased, except for the outer layer, which was exposed to the environment.

Figure 1: Cross sections of the studied conductors (a) GHW and (b) modern. The two outer layers were made of aluminum. The internal strands were made of galvanized steel.

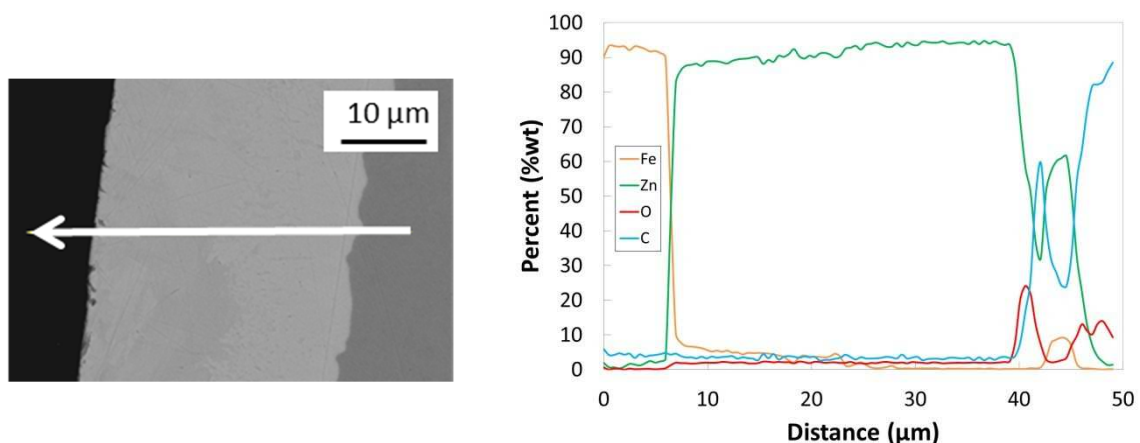
The steel strands were galvanized. The thickness of the galvanization layer of the steel strands of the modern conductor was between 25 and 70  $\mu\text{m}$ . EDS analysis confirmed that the galvanization layer was made of iron and zinc (Figure 2). It consisted of two phases: a zinc-iron inner sublayer containing less than 6 wt% of iron, which is the zeta phase, and a pure zinc outer sublayer, which is the eta phase [30]. The thickness of the sublayers was different from one strand to another and from one position to another. The outer sublayer was thicker than the inner one, which was between 7 and 20  $\mu\text{m}$  thick. The outer sublayer was oxidized up to a few micrometers depth, around 3  $\mu\text{m}$ . The thickness of this ZnO layer never exceeded 5  $\mu\text{m}$ . The amount of carbon detected during this EDS analysis was most certainly related to a contamination by the grease, which – despite degreasing – remained present as a thin film on the samples.

Figure 2: SEM image and EDS analysis of a cross section of the galvanization layer of the modern conductor. Fe is in orange, Zn in green, O in red and C is in cyan.

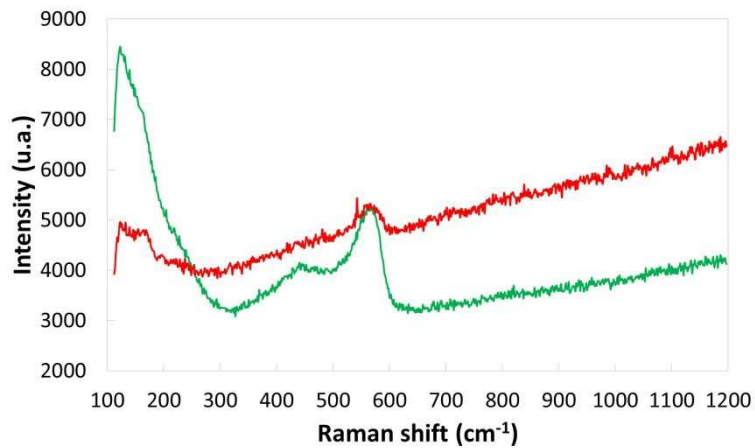
On some strands of the outer layer of the steel part of the conductor, the galvanization layer was locally thicker (up to 30  $\mu\text{m}$ ) than in the general case described previously and presented a supplementary outer sublayer which appeared darker on SEM observations (Figure 3 (b)). EDS analysis showed that this sublayer contained mainly zinc and oxygen. However, the amount of carbon detected by EDS, which was most probably linked to the presence of grease, complicated the identification of this oxide. It was consequently characterized by Raman spectroscopy, which showed that this layer was amorphous or slightly crystallized ZnO with the three following characteristic peaks [31]: 165  $\text{cm}^{-1}$ , 435  $\text{cm}^{-1}$  and 565  $\text{cm}^{-1}$  (Figure 4). Figure 3 (b) also indicated the partial oxidation of the zeta phase.

**Figure 4: Raman spectra obtained on the galvanization layer of a strand from the outer layer of the steel part of the GHW conductor, in the partially oxidized inner sublayer (in red) and in the oxidized outer sublayer (in green).**

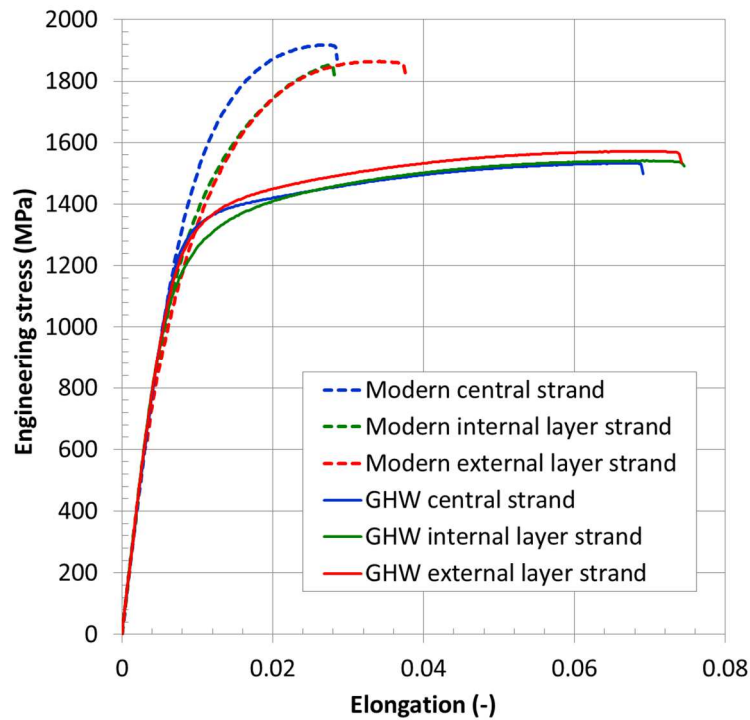
Tensile test results are plotted in Figure 8 and the corresponding mechanical properties are reported in Table 2. The GHW galvanized strands clearly had a lower strength and a higher elongation at fracture than the modern ones. This result is discussed in section 4.2. No clear difference between the mechanical properties of the three GHW tested strands was noticed apart from the reduction area at fracture, which was lower for the central strand (0.28) than for the two other tested strands (0.44).

Figure 8: Tensile test curves obtained on the galvanized steel strands extracted from both the GHW and the modern conductors.

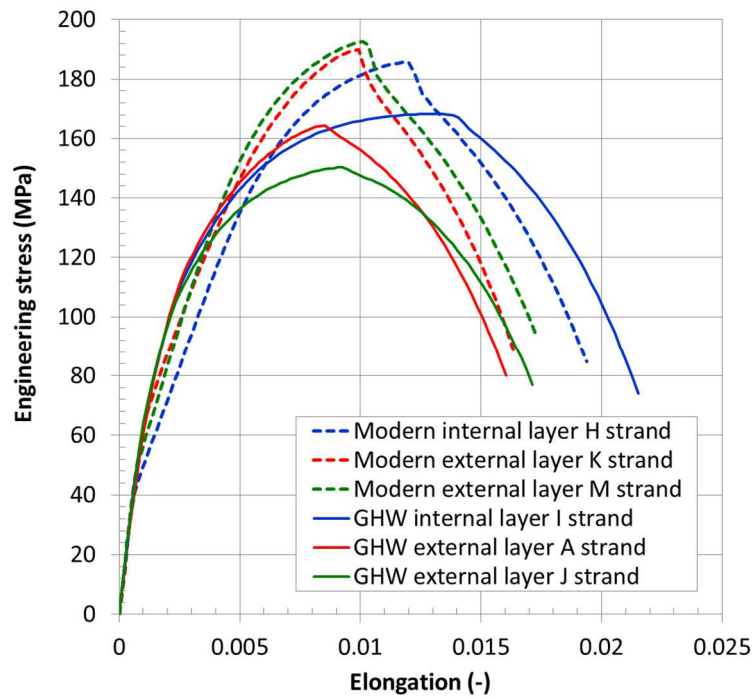
Tensile test curves are presented in Figure 15. Mechanical properties resulting from these tests are reported in Table 3. As expected from the hardness values (*cf.* section 3.2.1), the tensile strength of the aluminum strands extracted from the modern conductor was higher than the one of the strands extracted from the GHW conductor. Noticeable was the important reduction in area ( $> 0.8$ ) and the relatively low total uniform elongation ( $\sim 0.01$ ) of all the tested aluminum strands. The two lowest obtained total uniform elongation values corresponded to the two external layer strands of the GHW conductor.

Figure 15: Tensile test curves obtained on the aluminum strands extracted from both the GHW and the modern conductors.

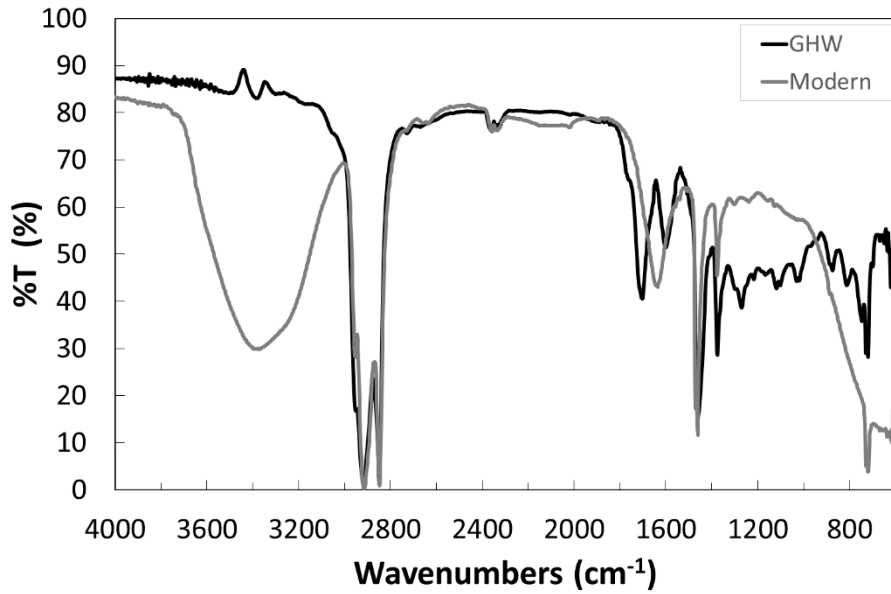
One sample of each conductor was analyzed by FTIR in order to give insight into the grease formulation and its potential ageing. Infrared spectra obtained over the frequency range from 600 to 4000  $\text{cm}^{-1}$  are shown in Figure 18. On both spectra, noticeable were the intense absorption near 2900  $\text{cm}^{-1}$  resulting from asymmetric and symmetric stretching of CH and the peaks at 1460, 720 and 1376  $\text{cm}^{-1}$  corresponding to bending of  $\text{CH}_2$  for the first two and  $\text{CH}_3$  for the last.

In the fingerprint region, a multitude of mainly C-C stretching and C-H bending modes was present resulting in a very dense structure of overlapping lines. These C-C stretching and C-H bending modes peaks were more intense on the spectrum of the GHW sample than on the spectrum of the modern one, which confirmed that the GHW grease did not contain as many -OH groups as the modern grease.

Figure 18: FTIR analysis of the grease of the two conductors.

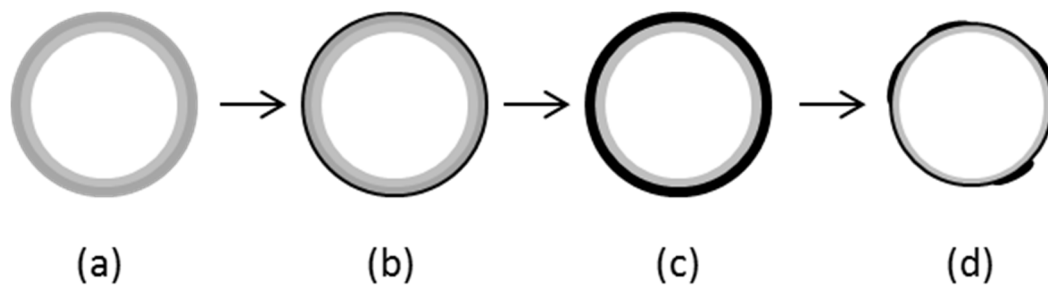
Based on these characterizations, a three-step degradation mechanism of the galvanized steel strands is proposed (Figure 19). At first, the conductor is new and exposed to the environment (Figure 19(a)). Since the grease limits the interaction with the environment, the galvanization layer is only weakly corroded (Figure 19(b)), which results in a thin layer of oxide, as observed on the surface of the modern sample (Figure 2). Then, this corrosion phenomenon progresses until complete oxidation of the eta phase thus forming a zinc oxide layer ZnO (Figure 19(c)). This oxide has a Pilling and Bedworth ratio (PBR) of 1.55 [34], which induces an internal stress and may cause cracking as the thickness increases, making it more brittle and less adherent. Due to this brittleness and to the mechanical loading (macroscopic stress, local stress due to the interaction between the strands and internal stress), the oxidized phase spalls off, leaving the intermetallic sublayer, partially oxidized, with punctual remaining parts of the ZnO layer (Figure 19(d)).

**Figure 19: Diagram of the proposed degradation mechanism of the galvanized steel strands. Steel is represented in white at the center of the strand. The different sublayers of the galvanization layer are represented in gray. The zinc oxide is represented in black. (a) a new strand, (b) strand with a superficial corrosion of the eta layer, (c) the corrosion phenomenon progressed until complete oxidation of the eta phase and (d) the oxidized phase spalled off, leaving the intermetallic sublayer, partially oxidized, with punctual remaining parts of the ZnO layer.**

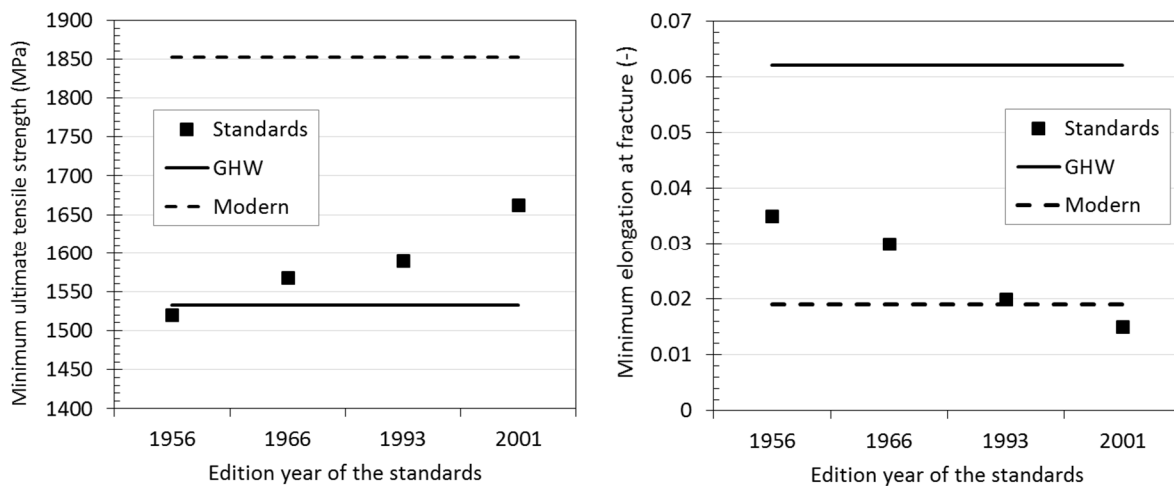
Requirements of the French standards [29, 38-40] regarding the tensile strength and the elongation at fracture of galvanized steel strands are reported in Figure 20 together with the corresponding values obtained on the strands extracted from the GHW and the modern conductors. The minimum required tensile strength increased during the second half of the 20<sup>th</sup> century whereas the minimum

elongation at fracture decreased. This figure also indicates that, after more than 60 years of operation, the galvanized steel strands from the GHW conductor still fulfilled the requirement edited at the time they were brought into operation. The partial corrosion of the galvanized steel strands described in the previous sections was sufficiently superficial not to have affected their mechanical properties. The fracture of the strands did not initiate on corrosion marks. However, these 60 years old strands did not fulfill the more recent and more demanding requirements for the tensile strength (Figure 20). As expected, the galvanized steel strands extracted from the modern conductor had a higher strength and a lower ductility. They fulfilled all the requirements for the tensile strength and the most recent requirements for elongation at fracture but not the older ones (Figure 20).

**Figure 20: Minimum ultimate tensile strength (left) and minimum elongation at fracture (right) measured on the studied galvanized steel strands from the GHW and the modern conductors in comparison to the requirements of the French standards edited in 1956, 1966, 1993 and 2001 [29, 38-40].**
