Characterization of an aluminum conductor steel reinforced (ACSR) after 60 years of operation

F. LEQUIEN^{1*}, Q. AUZOUX¹, G. MOINE¹, M. ROUSSEAU¹, S. PASQUIER-TILLIETTE¹,
A. HOLANDE¹, S. AMMI², S. HEURTAULT² and P. PRIEUR²

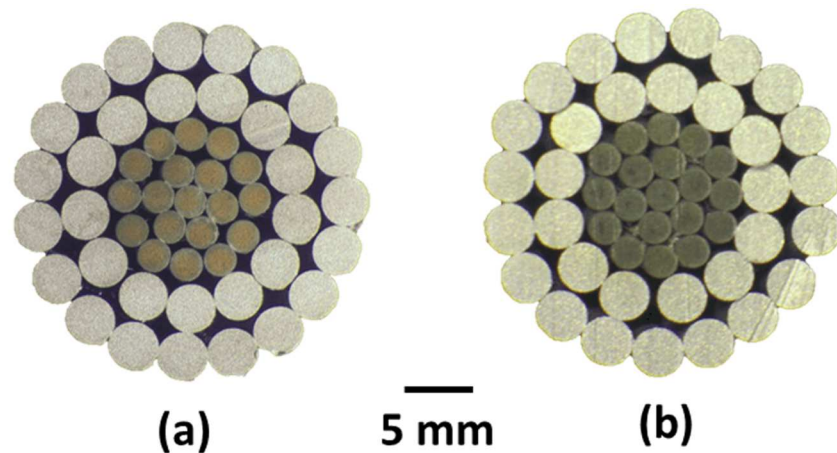
The samples of the studied ACSR conductor were extracted from the Guarbecque-Holque-Woesthyne (GHW) overhead power line, in service since 1950 in northern France. The samples were cut in 2011, after more than 60 years of operation. As presented in Figure 1, this conductor was composed of aluminum and galvanized steel strands: 19 galvanized steel strands with a nominal diameter of 2.4 mm divided into three layers (1 + 6 + 12) in the center part and 32 aluminum strands with a nominal diameter of 3.6 mm distributed in two external layers (13 + 19). The conductor had a nominal outer diameter of 26.4 mm. The overall nominal section was 412 mm². Figure 1 also shows a cross section of a more recent equivalent conductor that was not in operation but was also characterized. This latter conductor, labelled as “modern” in the rest of the study, was used as a reference to highlight potential degradations of the GHW conductor. The two conductors were completely greased, except for the outer layer, which was exposed to the environment.

Figure 1: Cross sections of the studied conductors (a) GHW and (b) modern. The two outer layers were made of aluminum. The internal strands were made of galvanized steel.

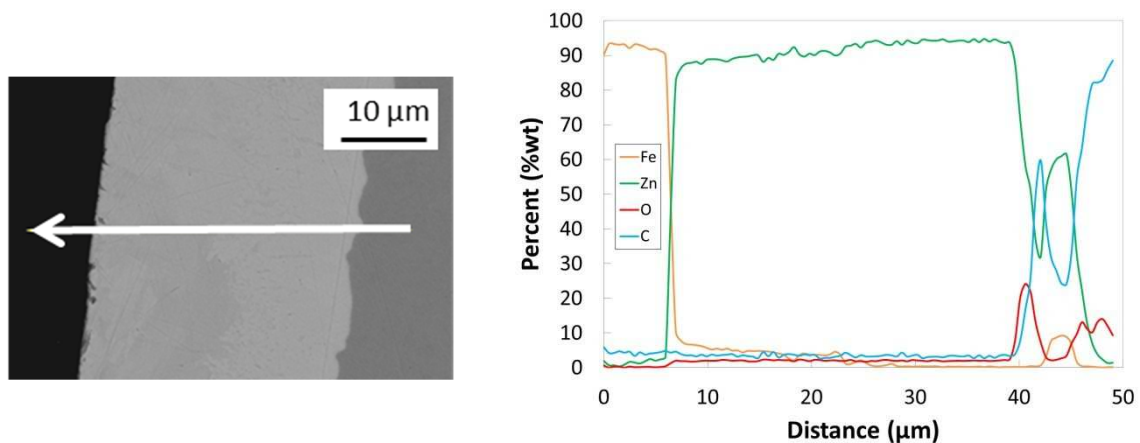
The steel strands were galvanized. The thickness of the galvanization layer of the steel strands of the modern conductor was between 25 and 70 μm . EDS analysis confirmed that the galvanization layer was made of iron and zinc (Figure 2). It consisted of two phases: a zinc-iron inner sublayer containing less than 6 wt% of iron, which is the zeta phase, and a pure zinc outer sublayer, which is the eta phase [30]. The thickness of the sublayers was different from one strand to another and from one position to another. The outer sublayer was thicker than the inner one, which was between 7 and 20 μm thick. The outer sublayer was oxidized up to a few micrometers depth, around 3 μm . The thickness of this ZnO layer never exceeded 5 μm . The amount of carbon detected during this EDS analysis was most certainly related to a contamination by the grease, which – despite degreasing – remained present as a thin film on the samples.

Figure 2: SEM image and EDS analysis of a cross section of the galvanization layer of the modern conductor. Fe is in orange, Zn in green, O in red and C in cyan.

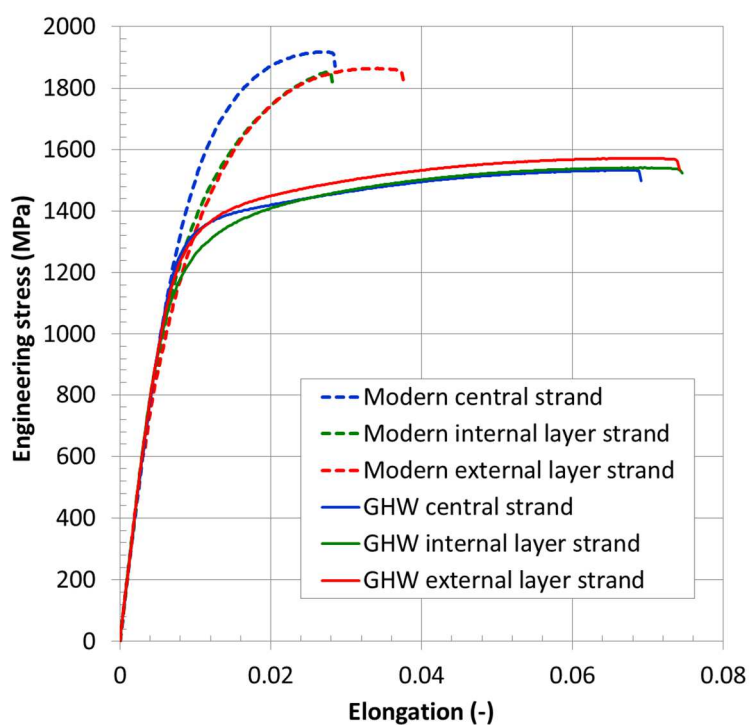
Tensile test results are plotted in Figure 8 and the corresponding mechanical properties are reported in Table 2. The GHW galvanized strands clearly had a lower strength and a higher elongation at fracture than the modern ones. This result is discussed in section 4.2. No clear difference between the mechanical properties of the three GHW tested strands was noticed apart from the reduction area at fracture, which was lower for the central strand (0.28) than for the two other tested strands (0.44).

Figure 8: Tensile test curves obtained on the galvanized steel strands extracted from both the GHW and the modern conductors.

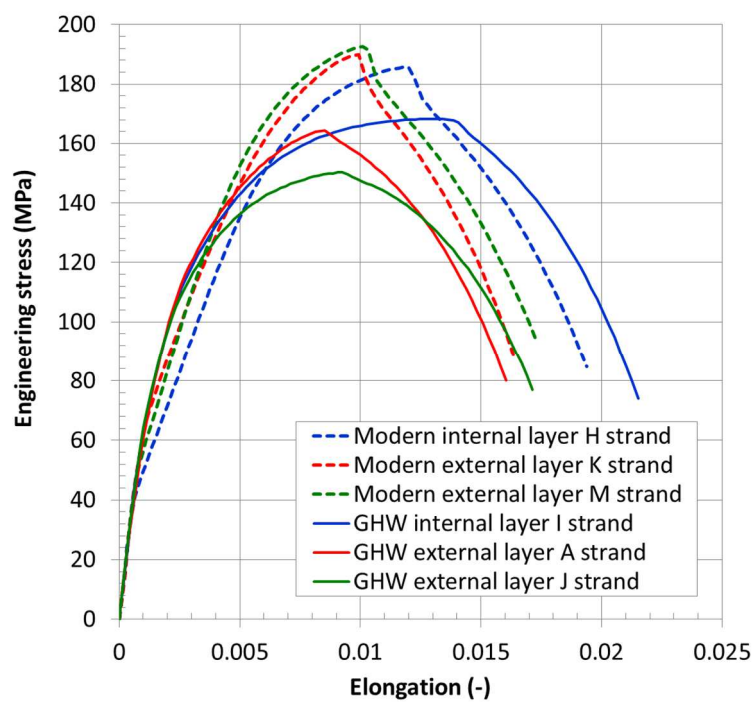
Tensile test curves are presented in Figure 15. Mechanical properties resulting from these tests are reported in Table 3. As expected from the hardness values (*cf.* section 3.2.1), the tensile strength of the aluminum strands extracted from the modern conductor was higher than the one of the strands extracted from the GHW conductor. Noticeable was the important reduction in area (> 0.8) and the relatively low total uniform elongation (~ 0.01) of all the tested aluminum strands. The two lowest obtained total uniform elongation values corresponded to the two external layer strands of the GHW conductor.

Figure 15: Tensile test curves obtained on the aluminum strands extracted from both the GHW and the modern conductors.

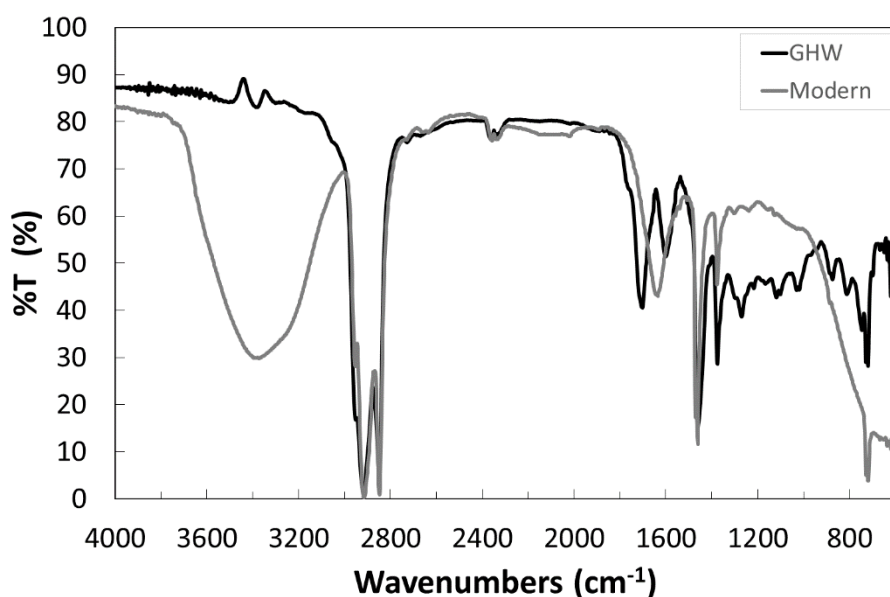
One sample of each conductor was analyzed by FTIR in order to give insight into the grease formulation and its potential ageing. Infrared spectra obtained over the frequency range from 600 to 4000 cm^{-1} are shown in Figure 18. On both spectra, noticeable were the intense absorption near 2900 cm^{-1} resulting from asymmetric and symmetric stretching of CH and the peaks at 1460, 720 and 1376 cm^{-1} corresponding to bending of CH_2 for the first two and CH_3 for the last.

In the fingerprint region, a multitude of mainly C-C stretching and C-H bending modes was present resulting in a very dense structure of overlapping lines. These C-C stretching and C-H bending modes peaks were more intense on the spectrum of the GHW sample than on the spectrum of the modern one, which confirmed that the GHW grease did not contain as many -OH groups as the modern grease.

Figure 18: FTIR analysis of the grease of the two conductors.

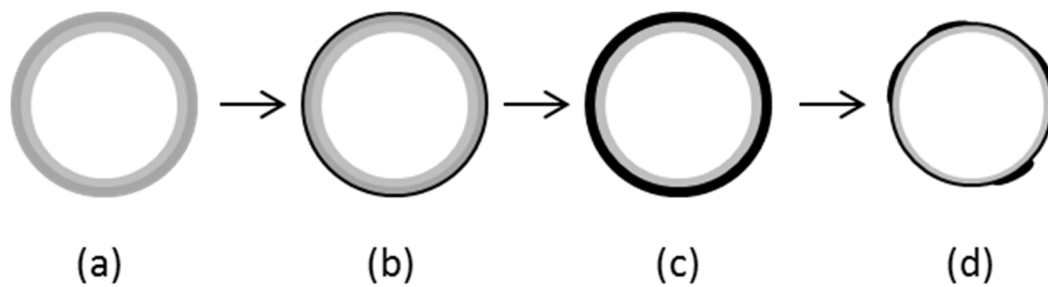
These two hypotheses are not antagonistic and show that in both cases an electrolyte was created, which can lead to a corrosion phenomenon. Graedel showed that the corrosion of a zinc surface takes place in several stages. The first product formed is zinc hydroxide $\text{Zn}(\text{OH})_2$ [36]. This hydroxide tends to dehydrate to form ZnO . On the other hand, from the data of the literature, a galvanic coupling between aluminum and zinc is possible. The gravity of the galvanic corrosion, however, can not be predicted from the potential values of the constituents of the couple, which only reflect the electrochemical aspect of the galvanic corrosion. However, this galvanic coupling could explain why the aluminum strands were not corroded (apart from the atmospheric corrosion of the external side).

Figure 19: Diagram of the proposed degradation mechanism of the galvanized steel strands. Steel is represented in white at the center of the strand. The different sublayers of the galvanization layer are represented in gray. The zinc oxide is represented in black. (a) a new strand, (b) strand with a superficial corrosion of the eta layer, (c) the corrosion phenomenon progressed until complete oxidation of the eta phase and (d) the oxidized phase spalled off, leaving the intermetallic sublayer, partially oxidized, with punctual remaining parts of the ZnO layer.

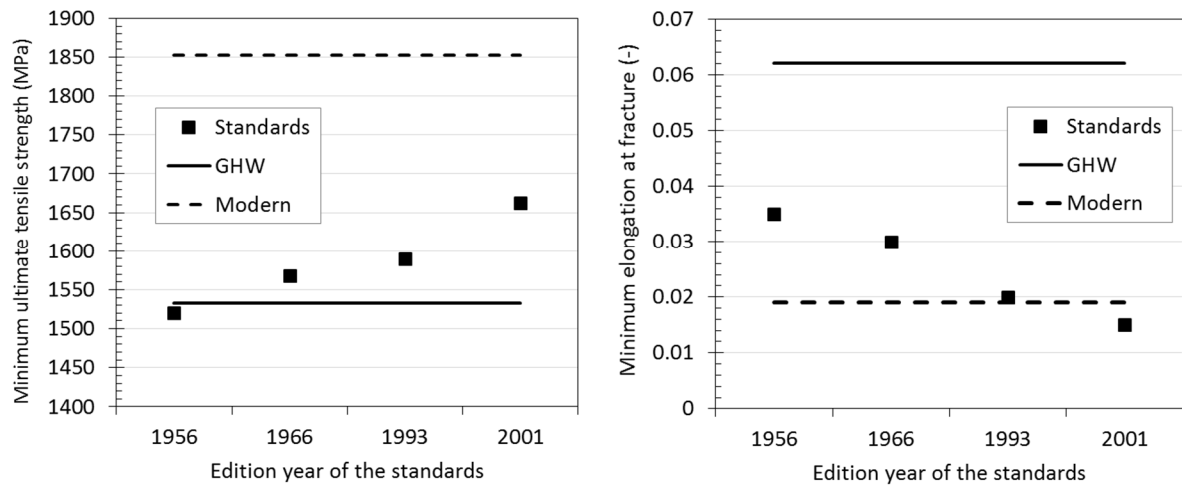
Requirements of the French standards [29, 38-40] regarding the tensile strength and the elongation at fracture of galvanized steel strands are reported in Figure 20 together with the corresponding values obtained on the strands extracted from the GHW and the modern conductors. The minimum required tensile strength increased during the second half of the 20th century whereas the minimum

elongation at fracture decreased. This figure also indicates that, after more than 60 years of operation, the galvanized steel strands from the GHW conductor still fulfilled the requirement edited at the time they were brought into operation. The partial corrosion of the galvanized steel strands described in the previous sections was sufficiently superficial not to have affected their mechanical properties. The fracture of the strands did not initiate on corrosion marks. However, these 60 years old strands did not fulfill the more recent and more demanding requirements for the tensile strength (Figure 20). As expected, the galvanized steel strands extracted from the modern conductor had a higher strength and a lower ductility. They fulfilled all the requirements for the tensile strength and the most recent requirements for elongation at fracture but not the older ones (Figure 20).

Figure 20: Minimum ultimate tensile strength (left) and minimum elongation at fracture (right) measured on the studied galvanized steel strands from the GHW and the modern conductors in comparison to the requirements of the French standards edited in 1956, 1966, 1993 and 2001 [29, 38-40].
