Metal-as-Insulation HTS Insert for Very-High-Field Magnet: A Test Report After Repair

Metal-as-Insulation HTS Insert for Very-High-Field Magnet: A Test Report after Repair

Abstract—This study is a sequel to our previous study on a 38 mm diameter cold bore metal-as-insulation (MI) HTS insert that reached 32.5 T in a 18 T background magnetic field. For refurbishing, 7 MI double-pancake (DP) coils were re-wound with used REBCO tapes to just replace the damaged HTS pieces by new ones at inner junctions. 2 DP coils were fully fabricated using new REBCO tapes. The new assembled insert was then tested under various background magnetic fields at 4.2 K. The key focuses of this paper are: 1) the damages in the DP coils; 2) their repair; 3) the characteristics resistance change of the insert; 4) the resistance value of each DP coil; 5) the maximum field of the HTS-resistive hybrid magnet; and 6) the field stability estimation of the hybrid by NMR characterization.

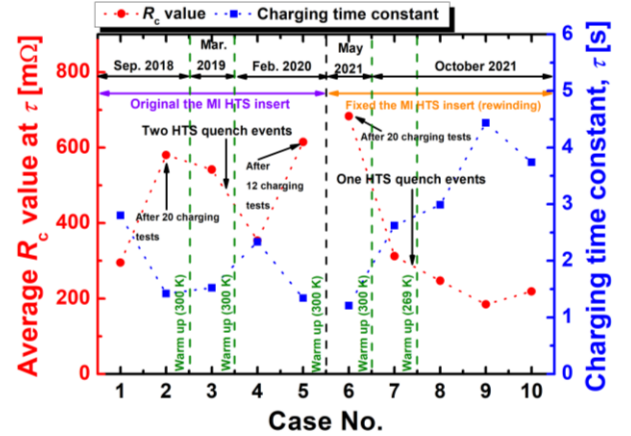
we also performed this time SD tests from 0 to 15 T. Note that although the screening current induced fields were included in the HTS insert after charging/discharging tests, constant inductance value (0.82 H) of the insert was used for estimation of R_c regardless of existence of them. Fig. 6 shows the measured τ and estimated R_c values in SF at 4.2 K. As seen in this Fig. 6, R_c varies continuously ranging from 185 to 683 m Ω . The initial R_c value of the insert increased probably because the turn-to-turn contact resistivity increased along with the cryogenic work hardening of copper stabilizer under repetitive magnetic pressure load [5], [20]. Meanwhile, after repair, the range of the R_c change is slightly larger but does not deviate significantly.

Fig. 6. The measured τ and estimated R_c values of the insert in SF at 4.2 K.

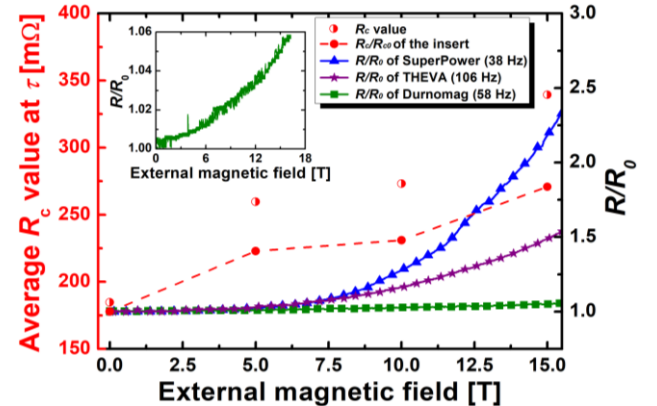
Left of y-axis in Fig. 7 shows estimated R_c values at $B_{\text{ext}} = 0, 5, 10, 15$ T. The R_c values in SF and 15 T were 185 and 339 m Ω , respectively, indicating that the R_c value increased by 83 %. One of several possibilities for this phenomenon might be the magneto-resistance (MR) of the REBCO tape. MRs of samples prepared in 6 mm \times 4 mm size were measured with an alternating current of 5 mA amplitude at 4.0 K. The direction of current and magnetic field applied to the samples are perpendicular and parallel, respectively. For accurate MR measurements, each sample was measured at an optimal frequency that exhibits an in-phase state between output and input phases. Note that AC loss can be negligible because: 1) the directions of magnetic field applied to nonmagnetic samples are parallel; and 2) 5 mA amplitude is quite small to generate AC loss component.

Fig. 7. R_c of the MI insert and normalized magneto-resistance of Durnomag SS tape, THEVA and SuperPower REBCO tapes from $B_{\text{ext}} = 0$ to 15 T.

The right of y-axis in Fig. 7 shows the normalized MR curves as a function of B_{ext} at 4.0 K for the Durnomag tape and, the THEVA and SuperPower REBCO tapes.

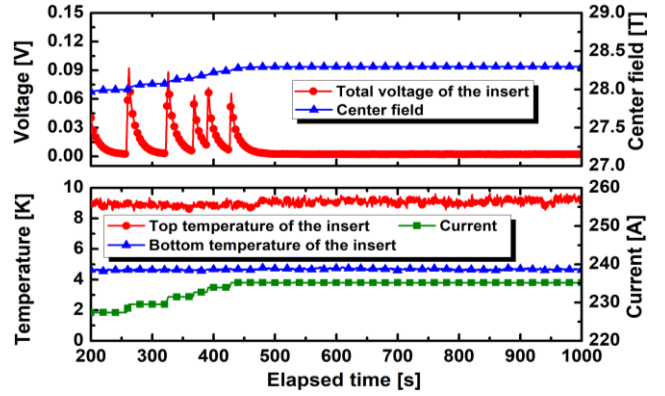
Fig. 9 shows a charging test of the MI HTS insert at a current ramp rate of 0.5 A/s under $B_{\text{ext}} = 18$ T at 4.2 K. The repaired MI insert generated a field of 10.2 T at 235 A under $B_{\text{ext}} = 18$ T, which means a total field strength of 28.2 T as indicated by our central Hall sensor. The coil constants of original and repaired inserts were 44.0 and 43.4 mT/A [5], respectively, implying that there is no by-passing current within the repaired DP coils. Note that the coil constant of the refurbished

Fig. 9. Charging test results of the repaired MI insert under B_{ext} of 18 T.

insert is slightly smaller than that of original one because a few turns of tapes were removed for repair at the inner and the outer junctions. Some instrumentation wires of the insert suddenly showed abnormal signals like short behavior from 27.7 T. This behavior occurs only at high field and may be linked to an insulation break of our voltage taps when the mechanical pressure increased with the field. It should be noted that at high field, the cooling condition for the repaired insert were more unstable than those for the original one. This might be due to the probe modification letting much less space for liquid helium circulation in the inner bore of the insert because of the additional SS tube. A more stable condition is achieved by pumping on the helium bath. However, the top temperature of the repaired insert increased up to 9 K most probably due to trapped helium bubbles as already observed during other HTS insert tests [20], [21]. Therefore, taking all these issues into account, we decided to stop charging the insert for more higher field.

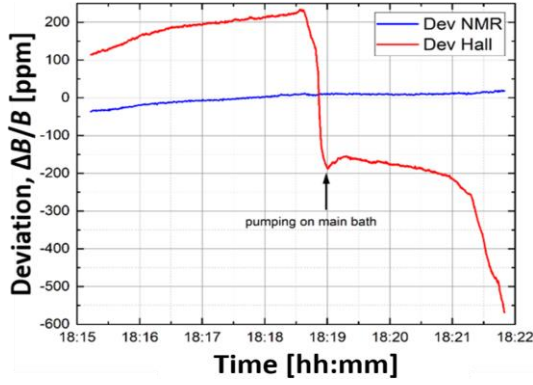
In the case of the NMR measurement, the central magnetic field fluctuation and drift were 5-10 ppm and 5 ppm/min, respectively. Apart from an offset, both measurements agree we start to pump on the helium bath to stabilize the cryogenic condition because the top temperature of the insert was increasing. We observed at this occasion that, as the NMR remained almost stable, the Hall sensor signal is affected by the change of cryogenic condition. Hall records are thus less reliable to estimate the field stability if a change of temperature occurs concurrently. Therefore, the field stability of our resistive-HTS hybrid magnet was only estimated by NMR under high magnetic field.

Fig. 10. Time record of field stability measured by Hall sensor and NMR characterization at a total magnetic field of 20 T.

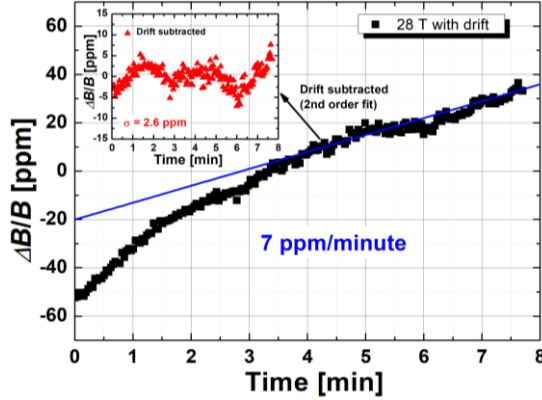
Fig. 11. Field deviation measured by NMR as function of time at a total magnetic field of 28 T at 4.2 K.

Fig. 11 shows $\Delta B/B$ measured by NMR as a function of time at $B_{\text{tot}} = 28$ T at 4.2 K. After 4 minutes, the central magnetic field drift of the hybrid magnet was 7 ppm/min. In addition, the standard deviation (σ) of field fluctuations after subtracting a second order drift term (small figure in Fig. 11) was 2.6 ppm. The field drift of 7 ppm/min is mainly due to magnetic field induced by transient screening currents, as the NMR record started immediately after reaching the target field. Weijers et al. from NHMFL, Tallahassee reported that the central magnetic field drift changed from 10 ppm/min to 0.5 ppm/min (their power supply drift level) after one hour at 32 T [23].

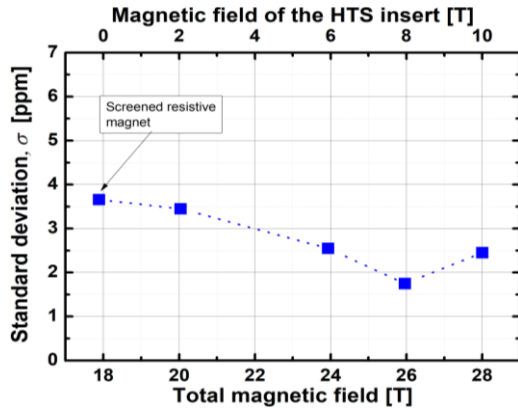
Fig. 12. NMR standard deviation as a function of magnetic field (top axis: HTS contribution, bottom axis: total field) after subtraction of drift term.

Fig. 12 shows σ of field fluctuation as a function of B_{tot} . σ values of field fluctuation at $B_{\text{tot}} = 18, 20, 24, 26,$ and 28 T were 3.65, 3.45, 2.55, 1.75, and 2.45 ppm, respectively, which decreased as the field of the HTS insert increased until $B_{\text{tot}} = 26$ T. At $B_{\text{tot}} = 28$ T, instead of an expected σ decreasing, we observed a higher value. Several factors are involved such as the unstable cryogenic conditions mentioned previously (He bubbles) or the stability of the power supplies.
