Moenjodaro UNESCO Emergency Mission Following Disastrous Rainfall in 2022: 1st Mission Report

1st Mission Report

1st Mission Report 21 - 29 October 2022

Thierry Joffroy, CRAterre-ENSAG
joffroy.t@grenoble.archi.fr

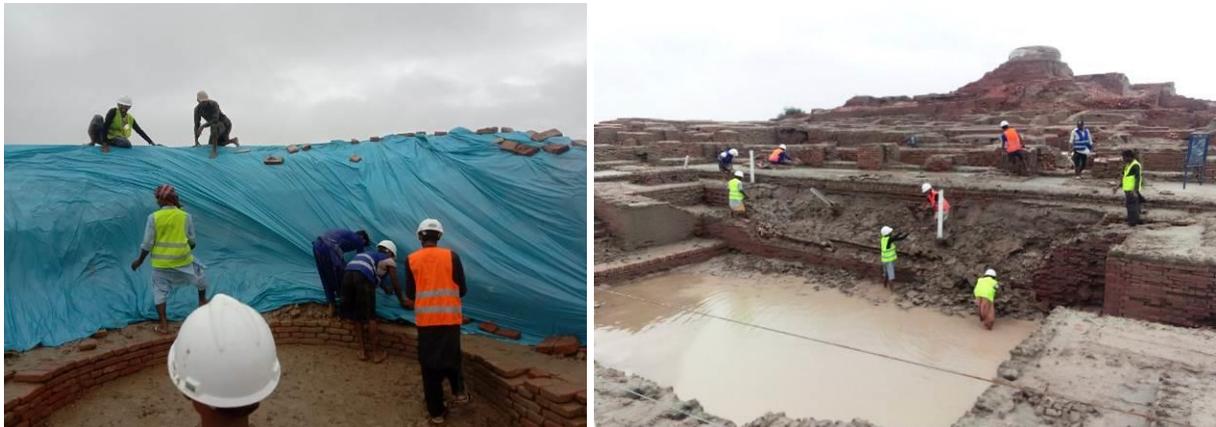
However, what appeared to have been sufficient in terms of monsoon preparedness until this year was unfortunately only partially efficient under such exceptional rainfall. Very concerned by the situation, the Antiquities staffs were mobilized to do their best to protect what could be, even if their own houses were being flooded by that time. It is an effort important to acknowledge. That included setting of tarpaulin on the top of the stupa, pumping water (even at night) in flooded rooms, repair of drainage canals, etc.

Pictures by Arch. N. A. Sangha: Left, installing tarpaulin on top of the stupa; Right, the Great bath when flooded

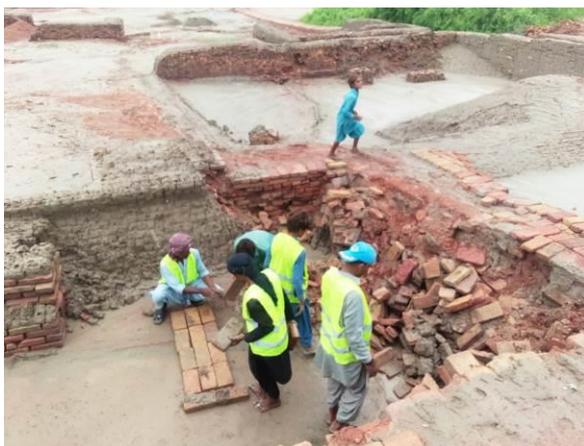
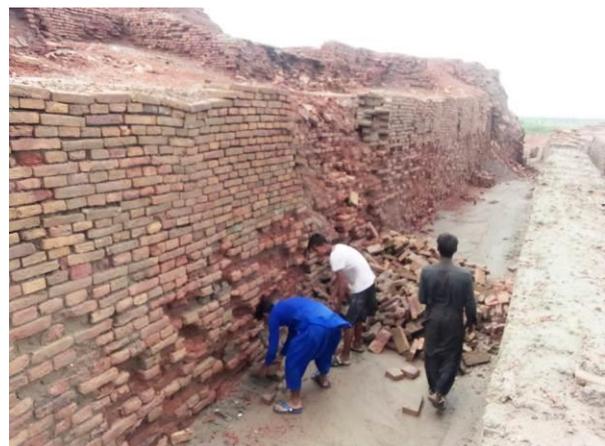
Pictures by Arch. N. A. Sangha: Cleaning of debris in SD (Citadel) area immediately after rains

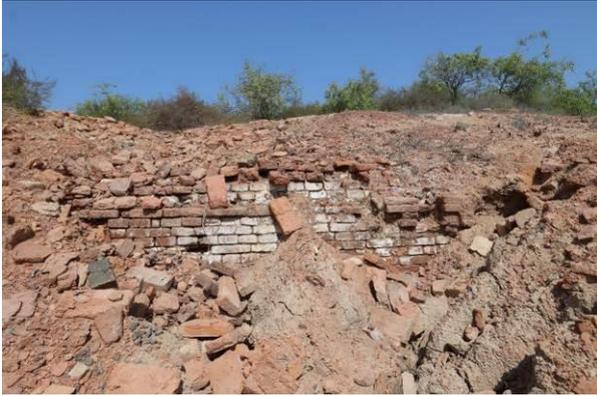
Finally, an important issue has also been observed, representing an additional opportunity for scientific research. As a result of the heavy rains, erosion gullies have developed deeply on some of the many untouched archaeological mounds. This has resulted in revealing some unknown archaeological assets (see pictures hereunder). Some of those appear to have specific interest (e.g. east side of the citadel) as a new archaeological corpus. It will also be important to analyze some situations that may require preventive measures (avoiding degradations in case of new heavy rains).

Probably a portion of city wall (near HR area)

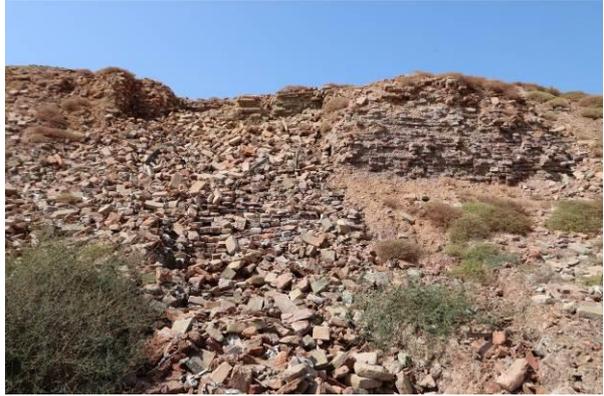
At the east side of the citadel: traces of a staircase?

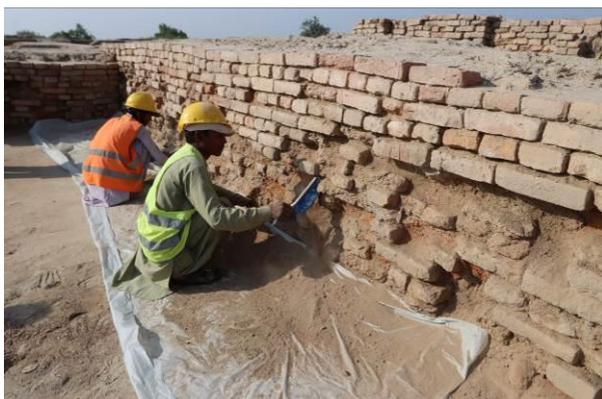
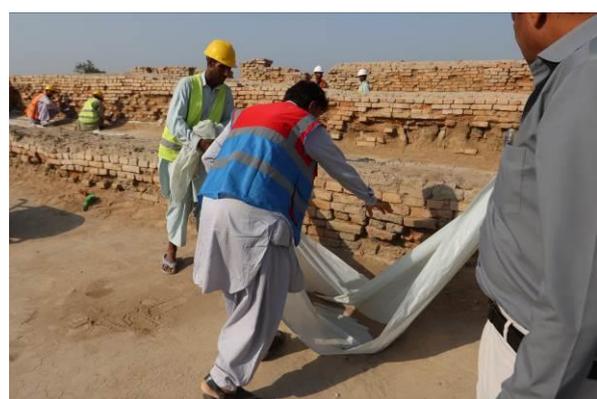
These measures are fully part of what is being done at the site today by the conservation team and on regular basis. Though salt presence and related decays appear to be still very much present. One of the hypotheses for this is that the efforts made up to now do not insist enough on salt removal. The removal was done, but probably insufficiently. As an example, it was witnessed at the beginning of the mission that the undergoing brushing of salty sacrificial mud slurry is not linked to removal from the site. That led to suggest that a system would be set so that the slurry dust would be collected and dropped outside the archaeological site perimeter. This measure was immediately adopted by the director of Moenjodaro Conservation Office (MCO).

Removal of salty mud slurry, SD Area, using geotextile to collect and transport dust away from the site, 22.11

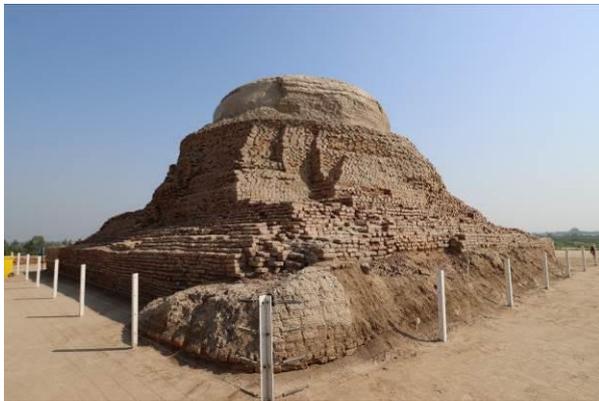
Stupa from south west side

The stupa is part of the structures which have been affected during the August 2022 rains, though what has been collapsing is from the top cupola and appears to be only a little part of the protection that has been built around the original structure. The situation does not appear to be dramatic, probably the result of the care by Moenjodaro Conservation Office during rains which has made the effort to protect the whole cupola with a tarpaulin. Today, the situation appears to be stabilized with the old structural remains still protected by the geotextile layer.

Though time was too short during the mission to make a serious condition survey of this important heritage asset, a specific condition survey of this structure will be undertaken during the second UNESCO expert mission that will require organizing easier access (ladders or scaffolding) so as to be able to check the condition of the part under the geotextile.

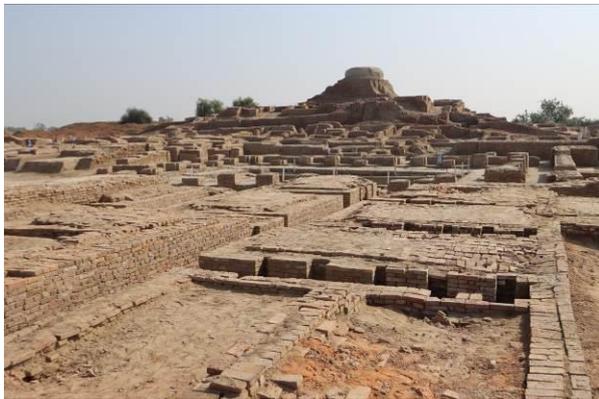
Stupa from L area

If a more detailed condition survey of these walls (type of leaning and visibility of cracks in the perpendicular walls) could give an indication, it would be good to check whether it is not the overall mass of the citadel which tend to settle down.

In fact, this could be the result of the presence of humidity inside the core of the citadel under the stupa, made more than possible by the flooring system (bricks on a sand layer) installed also at the upper platform which represents a huge water collection area while being very much exposed to rains. And two months after the heavy rains of August, many of the walls, including on the south side (better exposed to sun) were showing darker zones indicating the presence of damp.

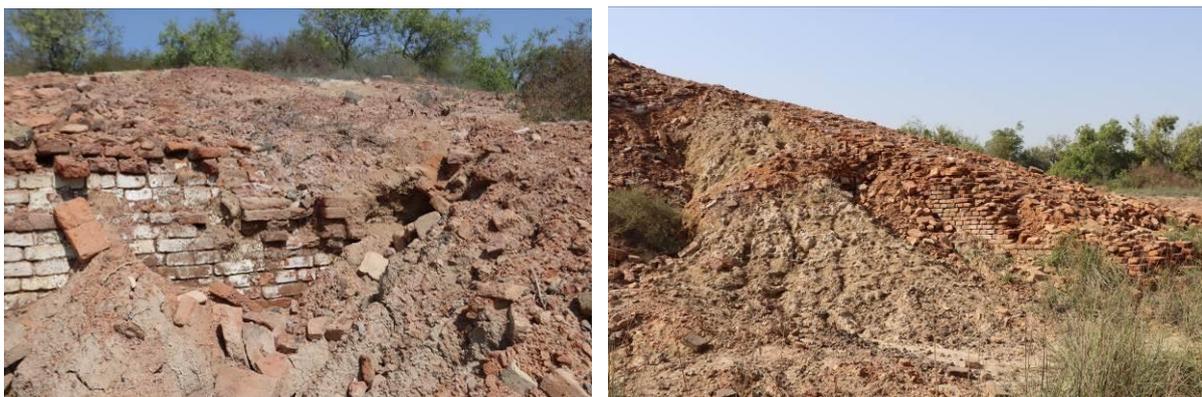
As a result, there are numerous places where structures have been revealed and are now quite visible. Some appear to have become at risk when new monsoon seasons will be coming. That would be quite a loss, knowing the potential that those still buried structures represents, as being fully original while those now visible at most of the areas (those open to the public) have been restored several times. However today, there are some difficulties to differentiate the original from the new.

Two examples of newly revealed structures that can be seen in various places at the site

Taking stock of that situation, the proposal is that a survey of these places be made (listing, mapping, minimum characterization), possibly by students of the archaeological dpt. of Sindh Universities under the supervisor of their professors and overall coordination by MCO staff. Criteria should be set so that a plan of action may also concern these newly revealed structures so as to ensure that those who would need preventive protection could be treated.
