# Over-voltage and cross-conduction hard switching stress on schottky gate-type p-GaN HEMT in half-bridge operation. Experimental and physical approaches

L. Ghizzo, David Trémouilles, Frédéric Richardeau, S. Vinnac, F. Jamin, G. Guibaud

L. Ghizzo, David Trémouilles, Frédéric Richardeau, S. Vinnac, F. Jamin, et al.. Over-voltage and cross-conduction hard switching stress on schottky gate-type p-GaN HEMT in half-bridge operation. Experimental and physical approaches. *Microelectronics Reliability*, 2023, 150, pp.115172. 10.1016/j.microrel.2023.115172 . hal-04242294

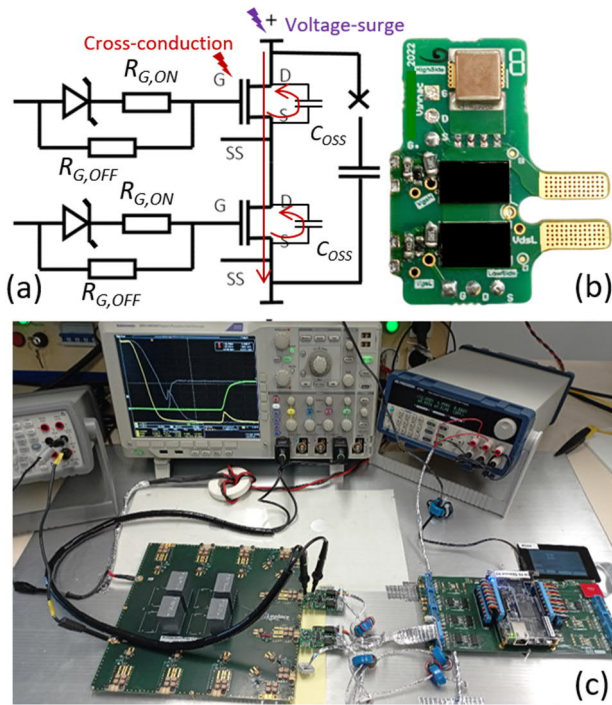
Figure 1: (a) Schematic of the half bridge daughterboard composed of a decoupling ceramic capacitor connected to two HEMTs, one high-side and one low-side, and their gate control circuit with gate resistors  $R_{G,ON}$  and  $R_{G,OFF}$ . The capacitor can be easily disconnected to perform characterization measurements (b) daughterboard. (c) Test bench composed of the main motherboard (12 legs in parallel) and 2 daughterboards. Gate driver boards are connected to feed gate voltages by a FPGA board with a user interface where stress parameters can be selected.

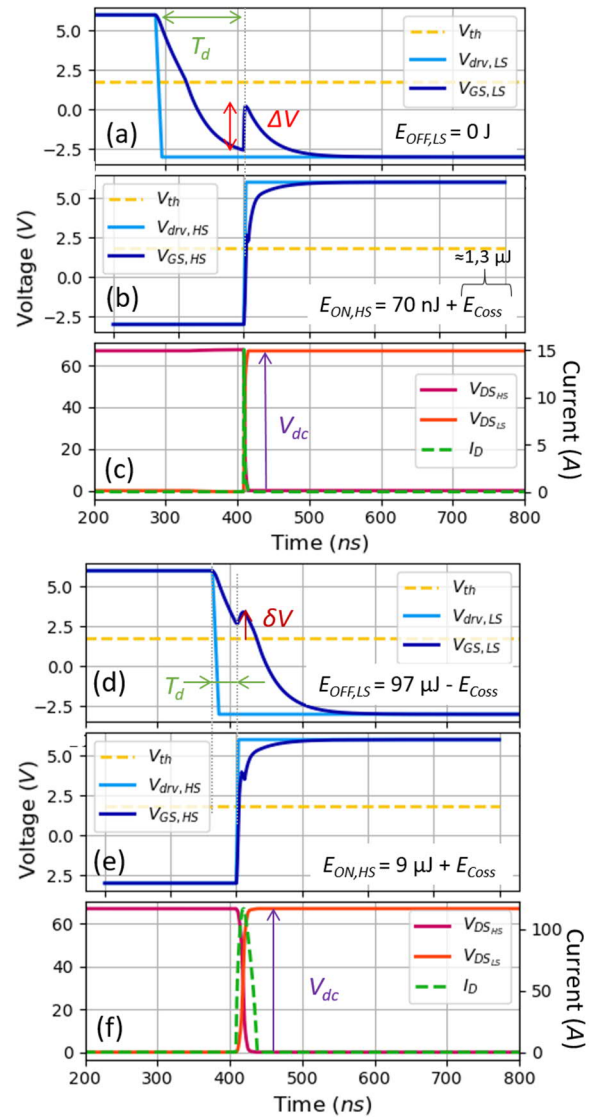
Figure 2: (a) LTspice simulated waveforms of the driver voltage  $V_{drv}$  and gate voltage  $V_{GS}$  at the turn-off of the LS transistor. (b) driver voltage  $V_{drv}$  and gate voltage  $V_{GS}$  at the turn-on of the HS transistor, the threshold voltage  $V_{th}$  is in dashed line. (c) LS and HS transistors'  $V_{DS}$  and drain current. (d)  $V_{drv}$ ,  $V_{GS}$  at the turn-off of the LS transistor with a small  $T_d$  that generates cross-conduction. (e) driver voltage  $V_{drv}$  and gate voltage  $V_{GS}$  at the turn-on of the HS transistor, (e) LS and HS transistors'  $V_{DS}$  and drain current (multiplied by 10) in the case of cross-conduction.

The waveforms of Fig.2 illustrate the main parameters of interest. All stress parameters are matched to their respective daughterboards' numbers in table 1. Two main stress parameters are studied. The switched voltage  $V_{dc}$ , on the transistors of boards #4 and #5 for  $V_{dc}$  chosen voluntarily high (120 % of the rating) and on boards #7 and #11 for a smaller value ( $V_{dc} = 67V$ : 2/3 of the rating). The cross-conduction will be studied (with a small  $T_d$  and high  $R_{G,OFF}$ ) on boards #1,#2,#3 for a high  $V_{dc}$  value and
