Conservation of a WWII Supermarine Spitfire section wing

EVE PAILLAUX¹
 SOTIRIS BAMPITZARIS¹
 JANE ECHINARD¹
 GILLES BARON¹
 CESAR ESCOBAR-CLAROS¹  
 MAGALI BRUNET²  
 LUC ROBBIOIA³  
 ELODIE GUILMINOT^{1*}

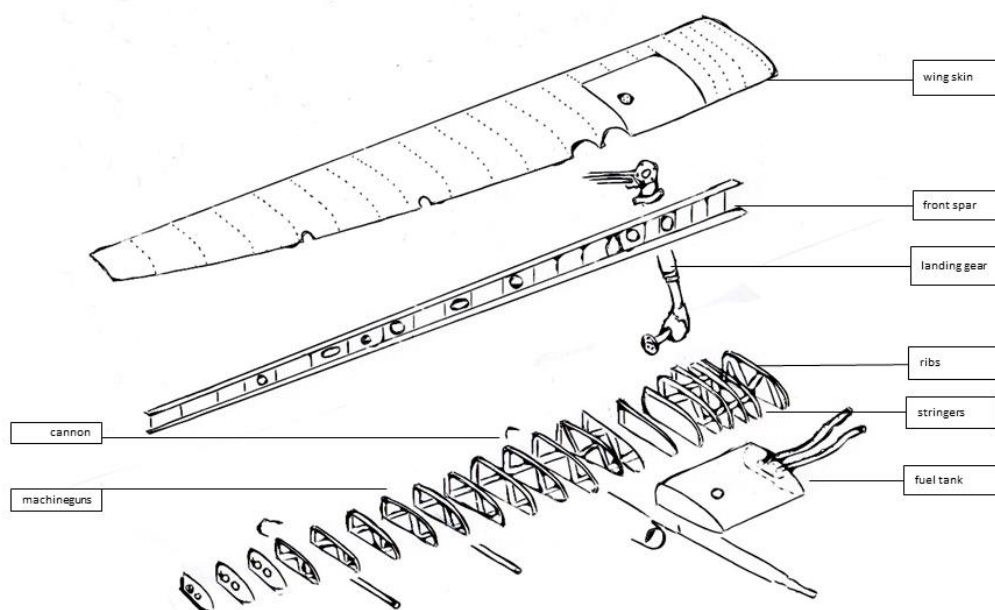
Figure 2. Exploded view of the Spitfire Mk VII wing fragment.

The wing skin was in relatively good condition but required cleaning. Due to corrosion of the Duralumin, internal structure parts were in really poor condition, particularly the front spar and stringers (Figure 2). The front spar is the major structural element and this required urgent remedial conservation treatment (Figure 4d) as it had developed extensive exfoliation. Stringers needed consolidation, while some ribs that were too severely degraded had to be removed (about 10 %).

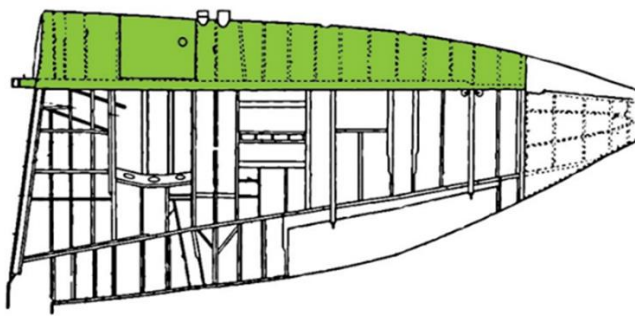
Description	Scheme
<p>Fragment location scheme</p> <p>The recovered fragment is colored in green on this diagram which shows a Spitfire wing in its entirety</p>

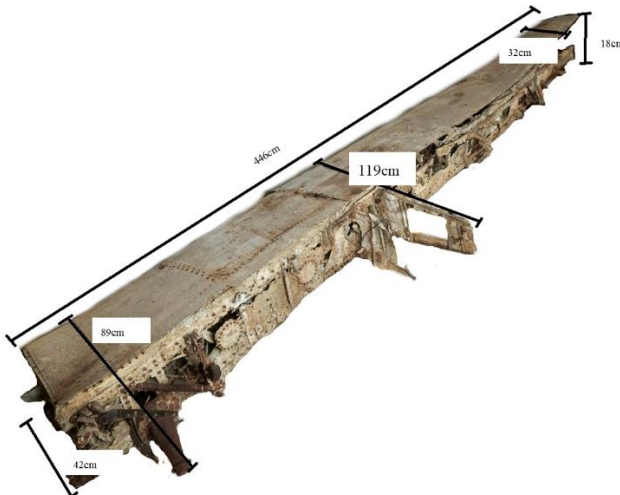
<p>Size Recovered dimensions:</p> <p>Length: 446 cm High: 18 to 42 cm Width: 32 to 119 cm</p>
