Conservation of a WWII Supermarine Spitfire section wing

Eve Paillaux, Sotiris Bampitzaris, Jane Echinard, Gilles Baron, Cesar Escobar-Claros, Magali Brunet, Luc Robbiola, Elodie Guilminot

1. GPLA-Arc'Antique, Département de Loire Atlantique, France

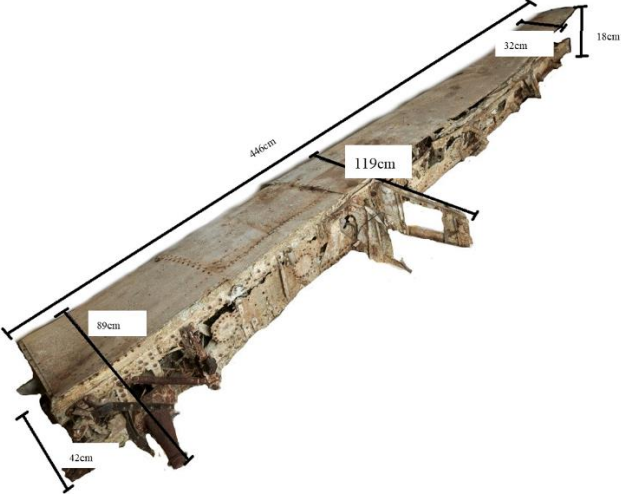
Size Recovered dimensions: Length: 446 cm High: 18 to 42 cm Width: 32 to 119 cm
