Conservation of a WWII Supermarine Spitfire section wing

Eve Paillaux, Sotiris Bampitzaris, Jane Echinard, Gilles Baron, Cesar Escobar-Claros, Magali Brunet, Luc Robbiola, Elodie Guilminot

Eve Paillaux, Sotiris Bampitzaris, Jane Echinard, Gilles Baron, Cesar Escobar-Claros, et al.. Conservation of a WWII Supermarine Spitfire section wing. *Conservar Património*, 2023, 10.14568/cp28355 . hal-04268504

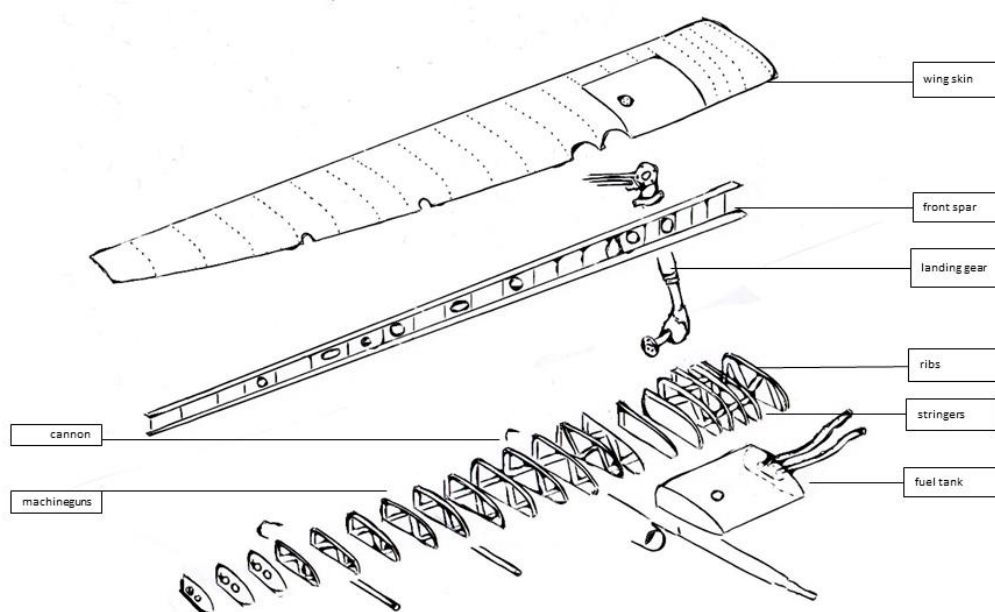
Figure 2. Exploded view of the Spitfire Mk VII wing fragment.

The wing skin was in relatively good condition but required cleaning. Due to corrosion of the Duralumin, internal structure parts were in really poor condition, particularly the front spar and stringers (Figure 2). The front spar is the major structural element and this required urgent remedial conservation treatment (Figure 4d) as it had developed extensive exfoliation. Stringers needed consolidation, while some ribs that were too severely degraded had to be removed (about 10 %).
