SiC MOSFET micro-explosion due to a single event burnout: analysis at the device and die levels

SiC MOSFET micro-explosion due to a Single Event Burnout: analysis at the device and die levels

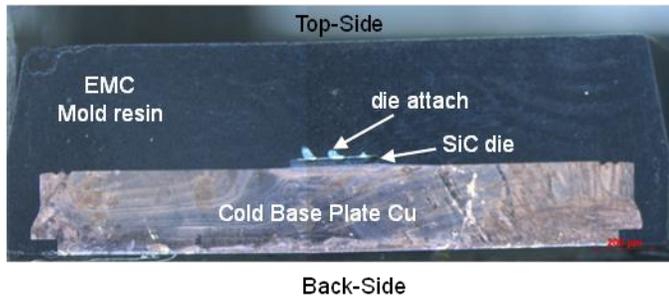
The structure of the studied package is shown in the optical view of a device in cross section. This optical view is obtained on a sacrificial device from the same batch. The nature of the materials can be distinguished (Fig.8): mold EMC (Epoxy Moulding Component) for packaging, SiC die with the die attaches and the copper base plate at the back side.

Figure 8: Cross sectional view of a sacrificial device
