SiC MOSFET micro-explosion due to a Single Event Burnout: analysis at the device and die levels

Abstract

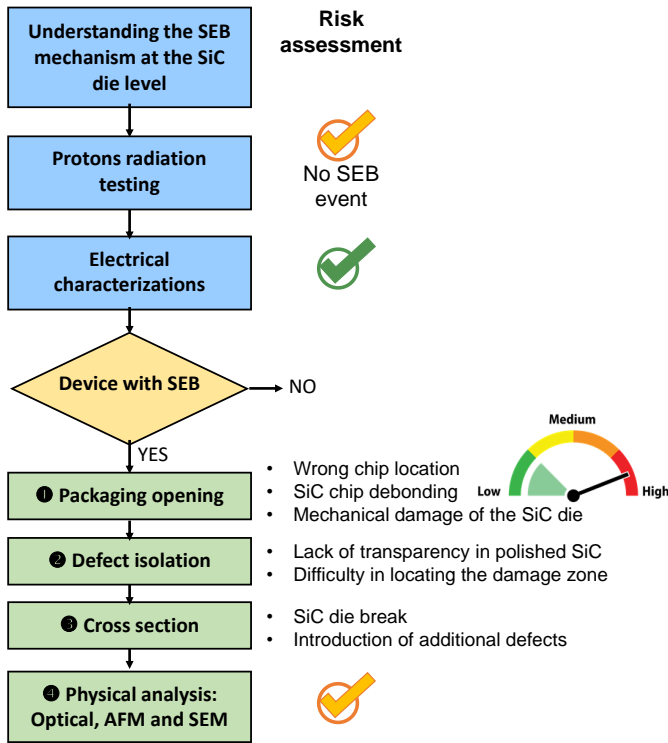
For a thorough understanding of the SEB mechanism induced by the primary proton at the SiC device and die levels, the proposed experimental flow chart (Fig.1) presents two main parts: first, an experimental statistic procedure is used to create the SEB for the irradiated devices and the electrical characteristics of the irradiated device are monitored. Second, the failure analysis itself is carried out to reveal the type of defect at the die level. In addition, at each step of the flow chart, the risk assessment level for the success is evaluated. For the analysis at the die level, the challenge is to open the packaging to identify the failure location. For this, the failure flow chart presents several steps: 1) opening of the package for the SiC die location in an unknown device geometry, 2) identification and isolation of the damage area induced by the protons, 3) preparation of a cross section surface for the SEM microscope, 4) the characterization. The sample preparation steps (1-3) are those with the highest risk. In fact, during sample preparations, mechanical stresses and strains are necessary to obtain the access to the damaged areas. SiC is of high mechanical strength (800 MPa), very hard (hardness of 2800 Kg/mm² and a fracture toughness KIC of 4.6 MPa.m^{1/2}), but also a very fragile material. Therefore, it was necessary to identify adapted

techniques and sample treatments, in order to single out the damaged area without inducing supplementary mechanical damage during the sample preparation. At the different stages risks are assessed: a wrong chip location, debonding of the SiC die, additional defects created by the mechanical preparation, milling tool breakage, difficulty in precisely locating the damage zone or the SiC die break.

Figure 1: Failure analysis flow chart to determine the mechanism of the SEB in a packaged SiC MOSFET. Steps of the flow chart and risk assessment are indicated

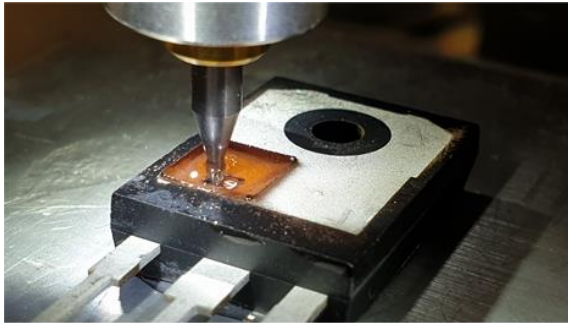
For the SiC die inspection, the device package is opened from the back side with a micro milling machine. The photo of the Fig. 7 illustrates the milling step, which consists to decapsulate de device.

Figure 7: Illustration of the milling step for a similar power SiC device (trial on similarly packaged device).

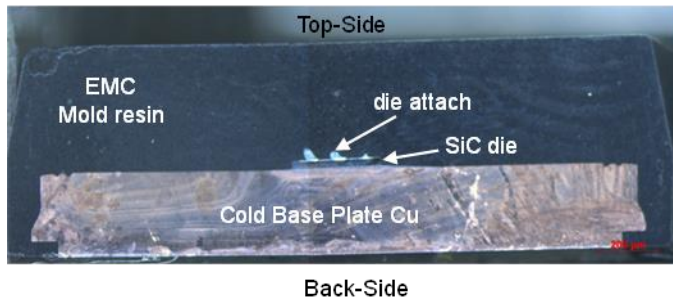
The structure of the studied package is shown in the optical view of a device in cross section. This optical view is obtained on a sacrificial device from the same batch. The nature of the materials can be distinguished (Fig.8): mold EMC (Epoxy Moulding Component) for packaging, SiC die with the die attaches and the copper base plate at the back side.

Figure 8: Cross sectional view of a sacrificial device
