Backside Fault Localization and Defect Physical Analysis of Degraded Power HEMT p-GaN Transistors Stressed in DC and AC Switching Modes

Backside fault localization and defect physical analysis of degraded power HEMT p-GaN transistors stressed in DC and AC switching modes

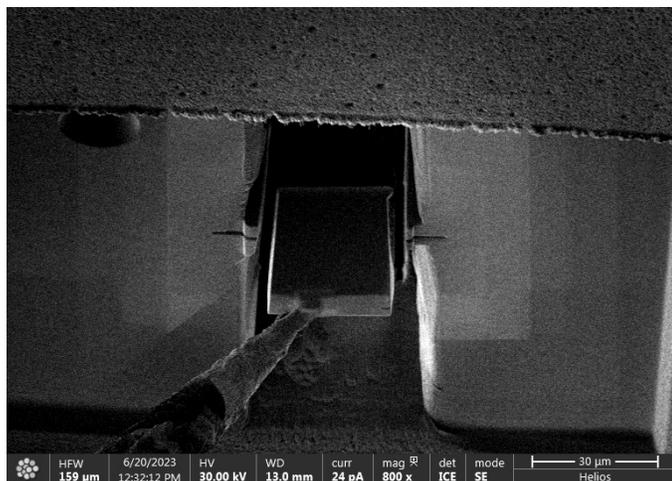
The TEM lamella preparation of device #2 on a drain defect is shown in figure 11. The degraded region delimited by optiFIB markings is first covered by platinum to protect it. FIB boxes are milled on each side of marking. The unthinned lamella is lifted-out with an Omniprobe micromanipulator and attached on a TEM grid (Fig.11) where the final FIB thinning takes place to obtain a sample of thickness no greater than 100 nm (Fig. 13).

Figure 11: (a) TEM lamella extraction in the area delimited by the optiFIB markings after milling and side cuts.

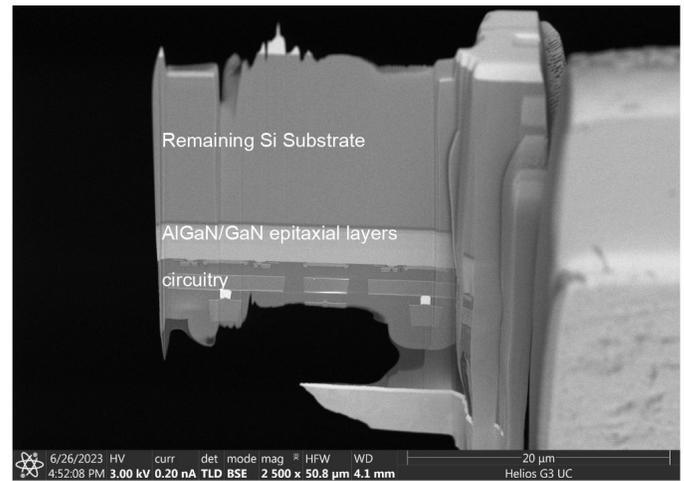
Figure 12: (a) TEM lamella thinned to 100 nm in the defect region before observation.

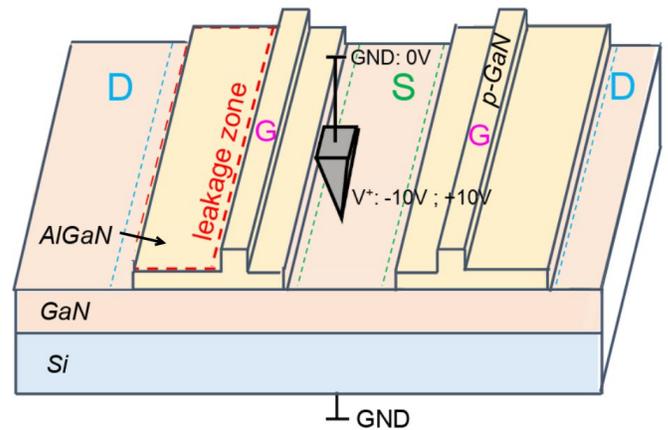
Figure 17: Setup of conductive AFM experiment performed. The probe is electrically polarized between -10V and +10V. The blue squares are the previous drain metal region and the green ones are the previous source metal regions.

The use of AFM in electric mode will allow to polarize a few dislocations on the two devices to evaluate if there are conductive or not. The leakage current goes through the AlGaN barrier and then reaches laterally the source electrode through the 2DEG. The AFM will point the zone near the p-GaN cap to measure the conduction. The zone of interest is between gate and drain previous location which is the expected current leakage zone and the most degraded region for the applied stress (see the red square in figure 17 and 18). The observed dislocations seem to be in both AlGaN and GaN layer.
