# Fretting Wear Anomaly of Final CubeSat Ejection Tests: Expertise, Solution Testing, and Lessons Learnt

# FRETTING WEAR ANOMALY OF FINAL CUBESAT EJECTION TESTS: EXPERTISE, SOLUTION TESTING, AND LESSONS LEARNT

## ABSTRACT

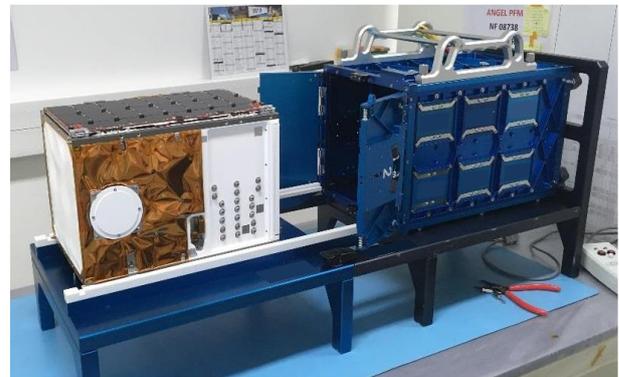
Figure 1: ANGELS and its deployer

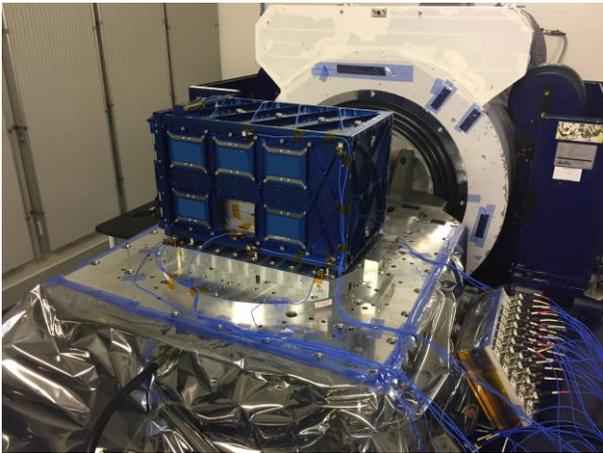
Both satellite dummy and deployer QM were submitted to a full mechanical vibrations qualification sequence (@qual level for 2 minutes, cf. Figure 15). Grease behaviour was observed during vibrations on bottom rails through an opening in the deployer. A grease bulge was observed and confirmed a satisfying grease circulation in the contact (cf. Figure 16).

Figure 15 Deployer QM with satellite dummy on MID shaker

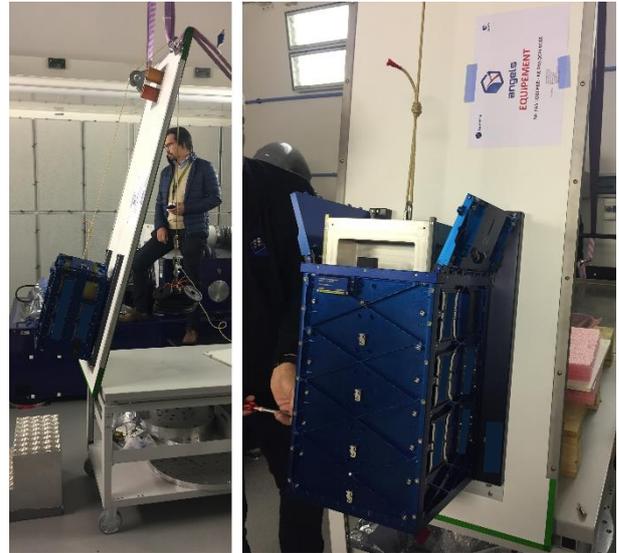
An ejection test was then performed at 75° (cf. Figure 17) in order to limit gravity effect on friction (with 1g compensation). A particular care has been paid in transporting the deployer on the ejection test GSE to avoid “unsticking” the satellite from the rails. Satellite dummy was successfully ejected from the deployer with satisfying margin. In addition, no wear or fretting marks

Figure 17 ejection test configuration
