# Hydrological & geomorphological analysis of the Upper Trusan River to assess remediation for riverbank integrity. WWF-Malaysia Project Report

**WWF-Malaysia Project Report**

Report Produced Under Project SW010603-831-CORP SCP-CIMB

Long Semadoh Riverbank Instability and Erosion Project

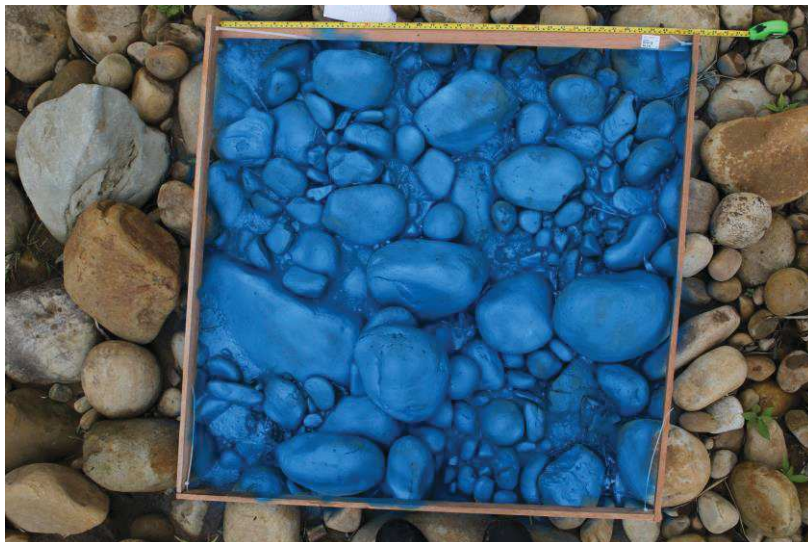
Plate 1. Photograph of the surface sediments on an exposed bar, River Trusan, 4 February 2018. For scale, all pictures were taken with a ruler visible within the frame.

Additional patches on the bars were delineated using the quadrat and painted, and used to help estimate bed mobility, thus stability. These were painted (i.e. traced) and photographed on the first field campaign and then re-photographed during the second campaign (see example in Plate 1). Grain-sizes were computed using DGS software and compared between dates to determine the sizes of material lost from or accumulated on the patches and assess changes in the GSDs of each patch. When it was evident that scour had occurred, the area around each patch was searched and the maximum displacement distance of clasts was recorded, along with the size of the clast that was displaced furthest.

calculated from digital photographs. For this, a patch on an exposed bar was delineated using a quadrat (1.3 m x 1.3 m) and a photograph taken (Plate 1). Patches free of vegetation were used, to improve the digital size characterization of grain-sizes. All clasts containing paint (by definition, surface material) were then removed, exposing the shallow subsurface (paint-free) layer. A photograph was then taken of this subsurface material. The  $D_{50}$  of material in each layer was calculated using the DGS software (Buscombe, 2013). AR is given here for general contextualisation of the results; care should be taken when interpreting these values, given that they were computed from photographs rather than empirically and so may be subjected to certain bias.

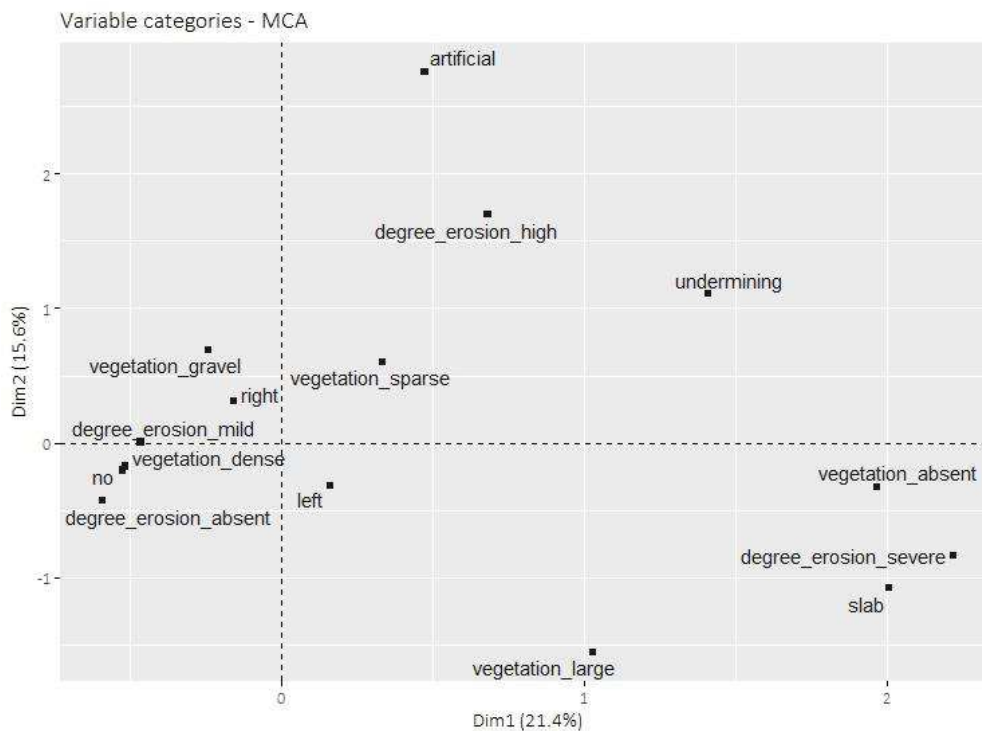
Figure 20. Results of the Multiple Component Analysis of bank erosion data.

Results from the MCA show that severe erosion is strongly correlated with the absence of vegetation (dots for these two parameters are located close to each other on the graph (Figure 20). Similarly, modification of banks (i.e. alteration by access with diggers or cattle) is statistically associated with high erosion. Conversely, locations with mild and no erosion have their banks protected by gravel bars or dense vegetation. Interestingly, erosion (either its absence or presence) is not strongly correlated with the presence of bands of large trees (i.e. forest-like density); thus, while locations with a high density of vegetation experience limited erosion, having large mature trees does not further prevent bank erosion. To assess whether erosion was generally more prevalent on one bank or the other, 'left' and 'right' were used in the analysis. The fact that dots for these dummy variables plot close to zero-zero (the origin) indicates that when considered along the whole of the 5.2 km section, the degree of erosion is not influenced by which side of the channel a location happens to be on.

3. The multivariate analysis provides overwhelming evidence that clearance of riparian trees is a major factor contributing to observed erosion.

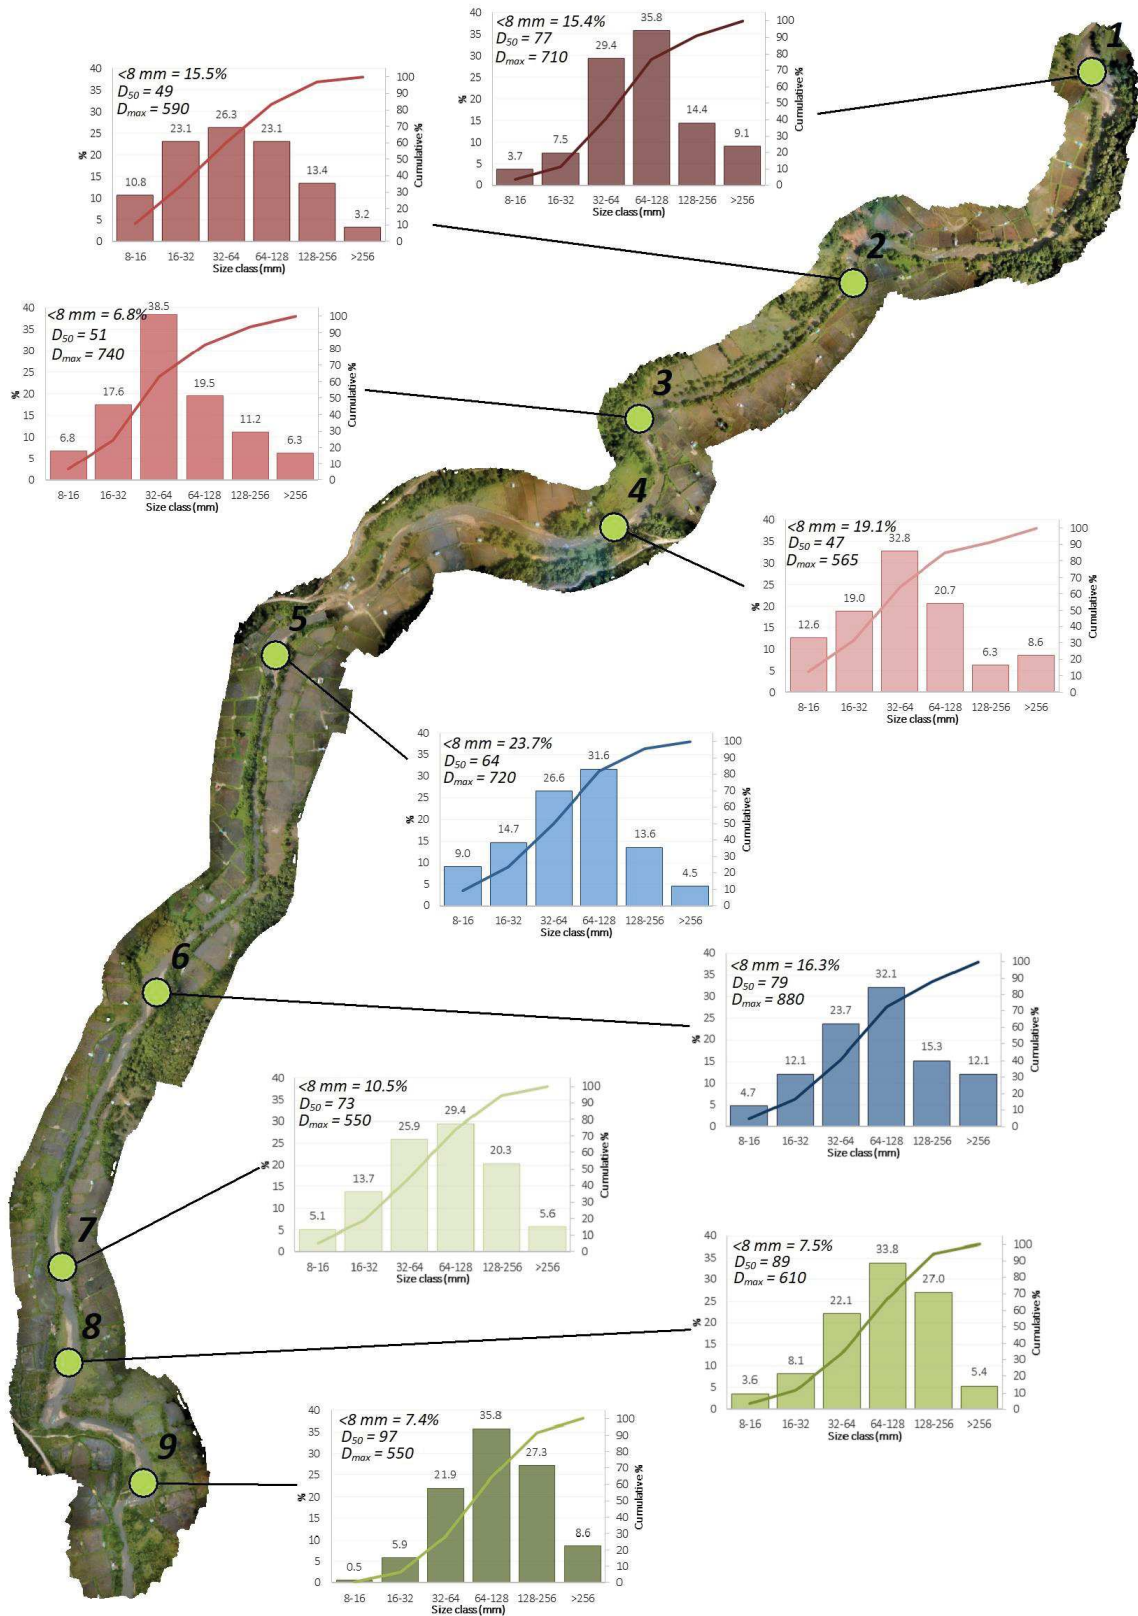
Figure 21. GSDs of the different gravel bars samples along the upper Trusan; with the largest particle measured ( $D_{max}$ ) and percentage of particles smaller than 8 mm.

Grain Size Distributions (GSDs) measured at the bar scale revealed that the upper half of the study section was dominated by the 32-64 mm size class (large gravels) while the lower part was dominated by the 64-128 mm size class (small cobbles). This difference, however, is not reflected in the size of the large clast found ( $D_{max}$ ), which was smaller in the lower part of the section and larger (880 mm) in the middle (bar 4, Figure 21). The lowest fractions of sediment <8 mm were found where the bars showed few small gravels (class 8-16 mm). Bars 5, 6 and 8 contained large proportions of sediments <8 mm (between 15.5 and 23.7%); these bars are located just downstream from large disturbances, such as landslides (bar 6 and 8) and channel stabilisation, undertaken to protect a road bridge (bar 5). The presence of large volumes of fine sediments on these bars does not seem to influence the grain size distribution of the larger particles; these are thus a direct response to human disturbances.

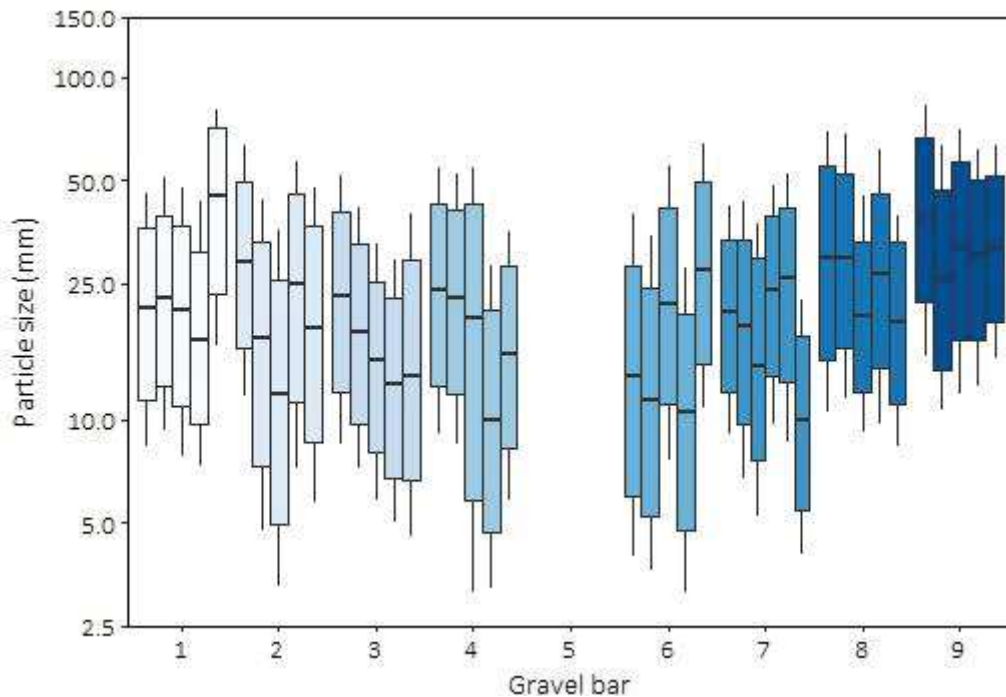
Analysis using the digital gravelometric software focussed at the patch scale and incorporated finer sediments in the analysis (i.e. unlike pebble counts, the GSDs produced by the software incorporate material < 8 mm). Results of photosieving (Figure 22) suggest that while the upper and lowermost bars surveyed have different GSDs, there are no clear leaner up to downstream change in sizes; in general there as much variation in GSD across each bar as there is between bars.

Results from the boxplots (Figure 22) show similar trends to the Wolman pebble counts (Figure 21), with more details about fine sediments. Bars located at the very top (1) and bottom (8 and 9) of the study reach are made of coarse material, with no fine sediments ( $D_{16} > 7$  mm). Inversely, gravel bars found towards the middle of the section show very low  $D_{16}$ , illustrating the high proportion of sand and silt, with the  $D_{50}$  as low as 10 mm in places. While interesting, the main value of these GSD data is for hydraulic modelling (e.g. for roughness estimates) and a baseline against which future changes can be assessed.

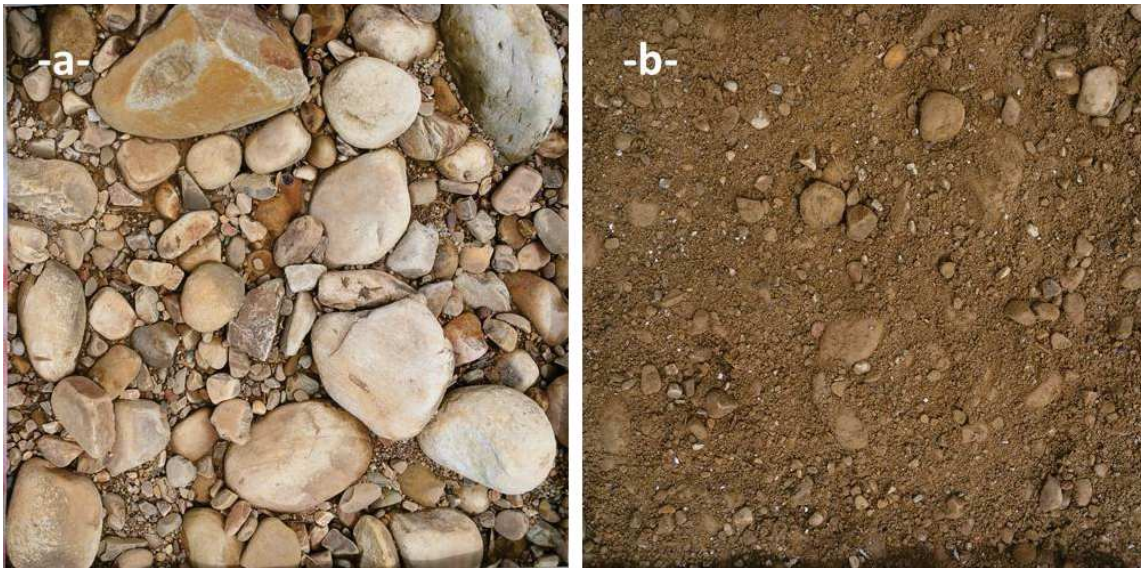
Figure 24. Example of the surface (-a-) and subsurface (-b-) particle size from the same patch.

It appears that the armouring ratio of gravel bars decreases downstream (Table 4). Using the traditional method, an armouring ratio of 3.6 would represent a very high armouring. Armouring occurs naturally in rivers, but can be exacerbated by human activities. In particular, it tends to increase when coarse sediment supply from the catchment is reduced, and/or when large volumes of fine sediment deposit within the gravel matrix. The higher armouring ratios of gravel bars upstream reflect the higher human interferences (bank stabilisation, landslides, cattle access to the river, etc.). Although bank erosion is very pronounced in the downstream part of the river, it seems that this geomorphic activity allows the river to rework its bars, thus limiting armouring.

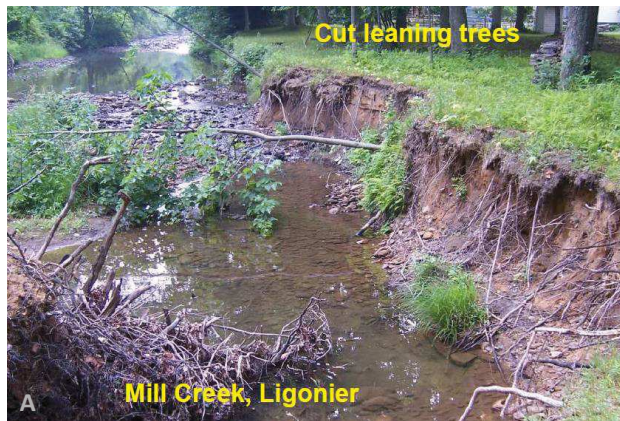
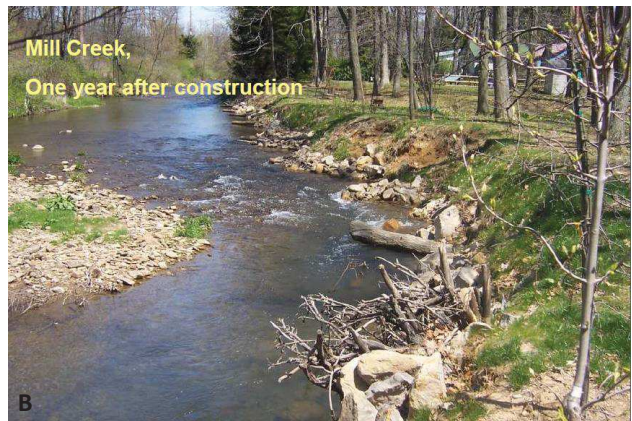
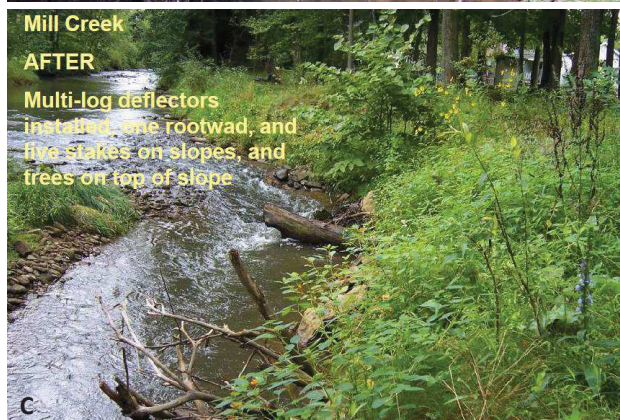
Figure 31. Photos of a fast-flowing river bend where a combination of root wads, log deflectors and live stakes were used for bank stabilisation. (Source: Rob Cronauer, Westmoreland Conservation District, 2016).

3. At the downstream end of the study section, there are two areas of severe bank erosion (G and H in Figure 29; see Plate 5 Plate 6). Bank heights here are approximately 2-3 m. There are several options. One would be to insert root wads, using trees whose roots extend to bank

tops once inserted (Figure 31Figure 32). Alternatively, a fence made from the woody stems of a local plant (e.g. bamboo) could be built at the base of the slopes, providing short term protection. The area behind this can be filled with soil and bankside material (Figure 32), and seeded with local grasses or Vetiver, and planted with saplings for longer term stability. In parallel with whichever of these is adopted, cattle fences should be erected well back from the bank top and the riparian zone left to be colonised by trees and shrubs. Ideally to help this process, some planting of the riparian zone could be encouraged.
