# Hydrological & geomorphological analysis of the Upper Trusan River to assess remediation for riverbank integrity. WWF-Malaysia Project Report

Baptiste Marteau, Chris Gibbins, Ramon J. Batalla, Damià Vericat

Report Produced Under Project SW010603-831-CORP SCP-CIMB

Long Semadoh Riverbank Instability and Erosion Project

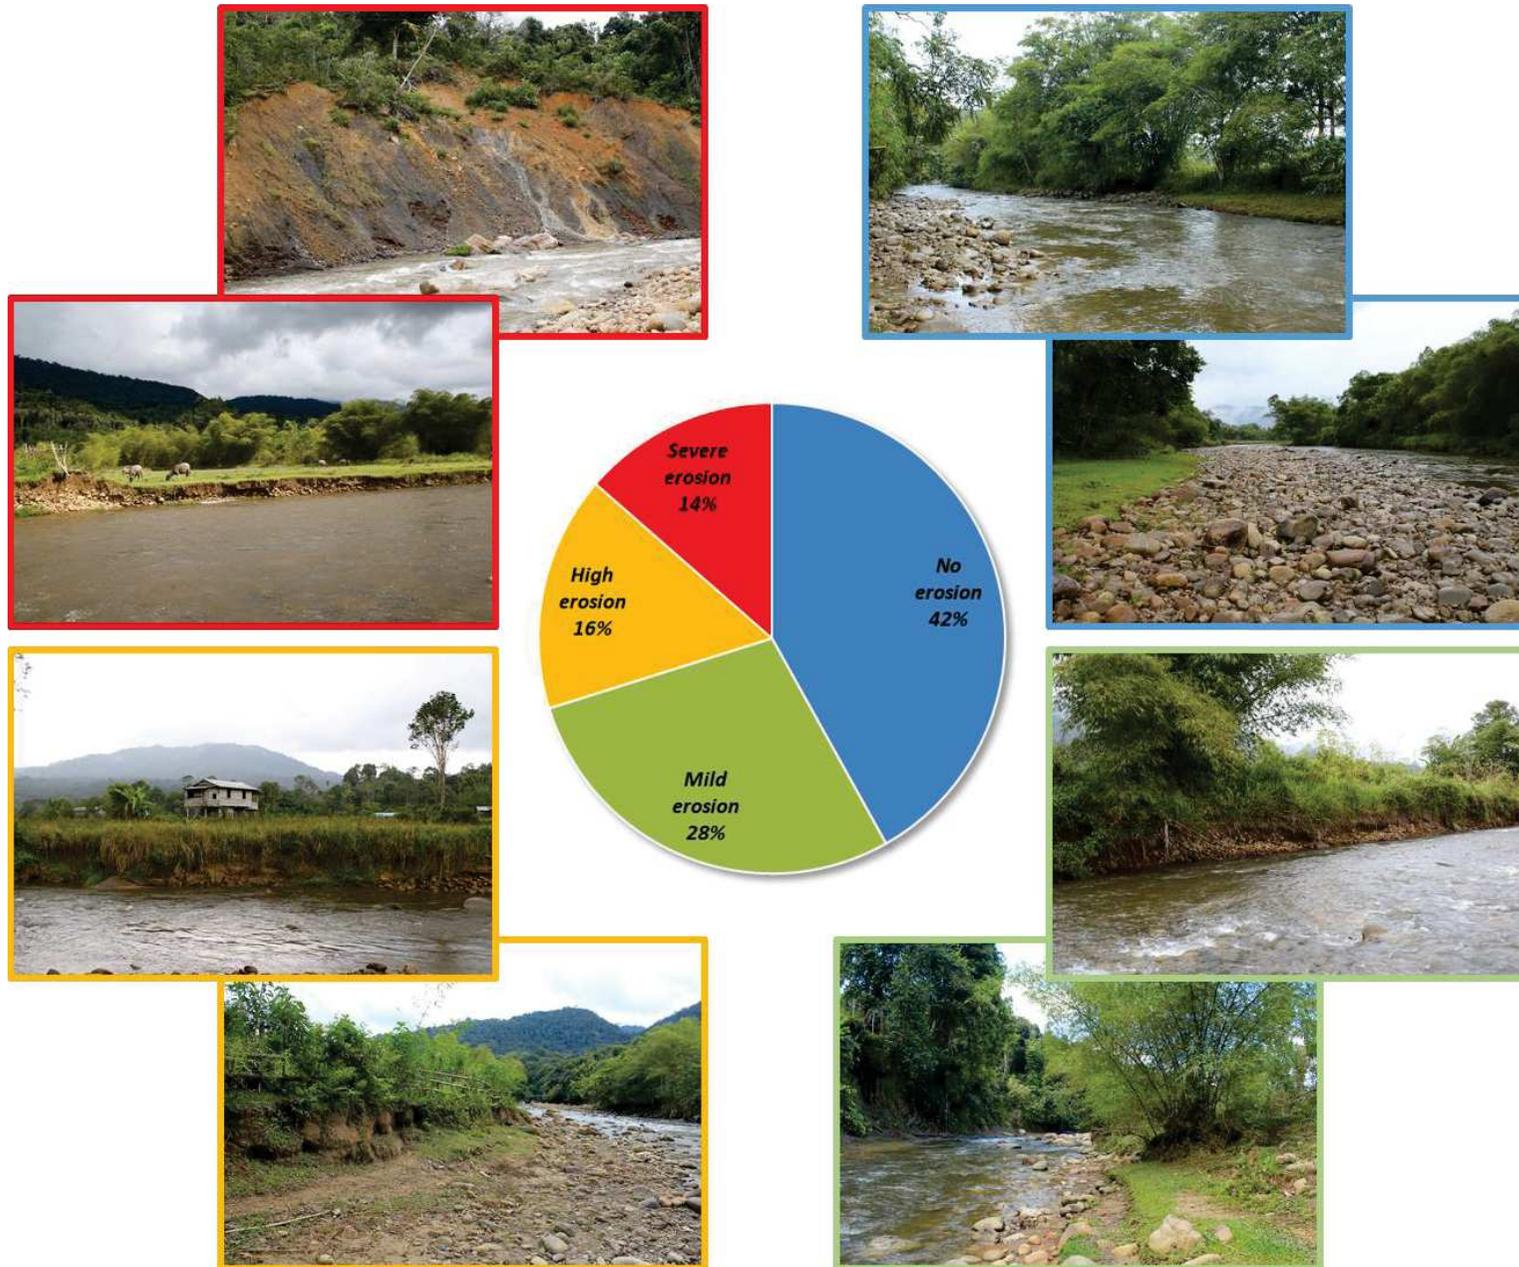
Figure 16. Proportion of the different categories of bank erosion observed in the upper Trusan (see also Figure 17).

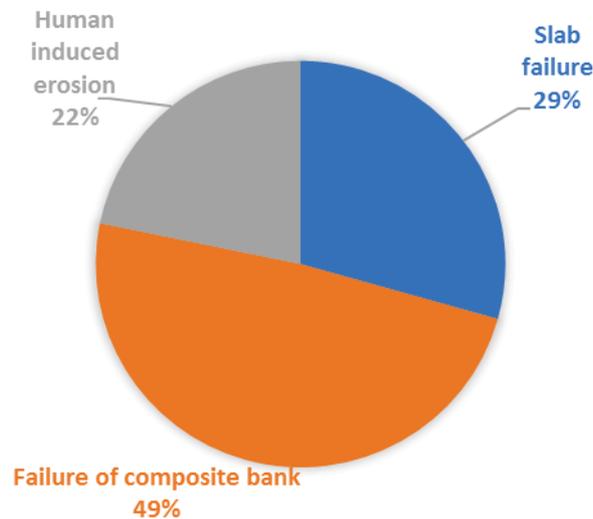
Figure 19. Categories of erosion observed in areas suffering from high or severe erosion. Human induced erosion involves the direct damage caused by diggers or trampling by buffalo. Results indicate that the majority of erosion is caused by the failure of composite banks. This category is often associated with fluvial processes - flow fluctuations, flow competence and bed scouring.

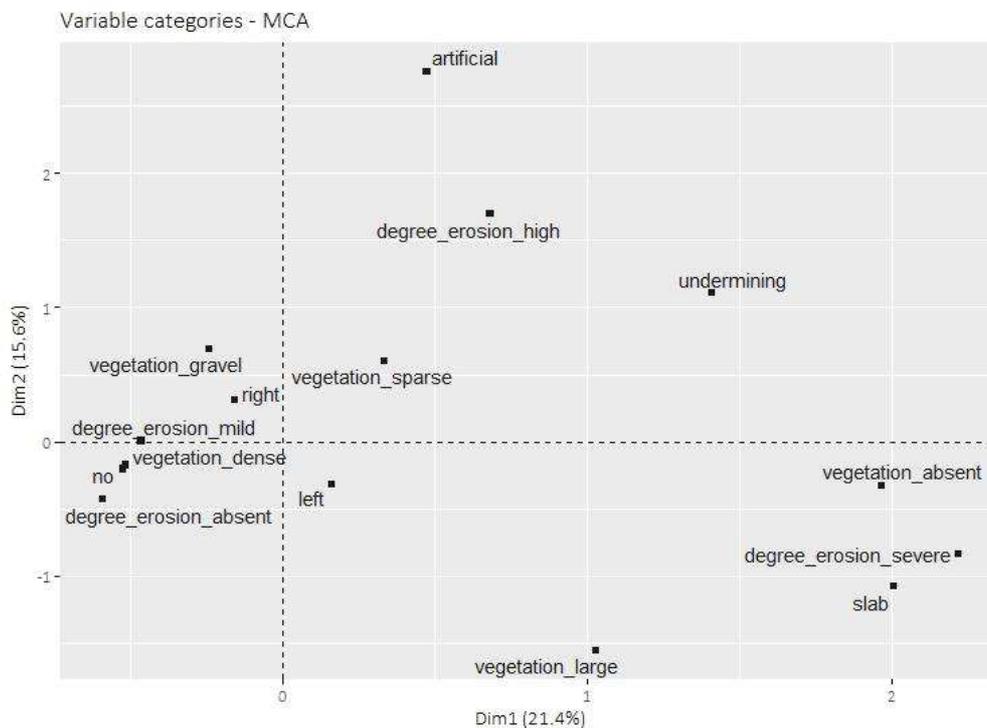
Results from the MCA show that severe erosion is strongly correlated with the absence of vegetation (dots for these two parameters are located close to each other on the graph (Figure 20). Similarly, modification of banks (i.e. alteration by access with diggers or cattle) is statistically associated with high erosion. Conversely, locations with mild and no erosion have their banks protected by gravel bars or dense vegetation. Interestingly, erosion (either its absence or presence) is not strongly correlated with the presence of bands of large trees (i.e. forest-like density); thus, while locations with a high density of vegetation experience limited erosion, having large mature trees does not further prevent bank erosion. To assess whether erosion was generally more prevalent on one bank or the other, 'left' and 'right' were used in the analysis. The fact that dots for these dummy variables plot close to zero-zero (the origin) indicates that when considered along the whole of the 5.2 km section, the degree of erosion is not influenced by which side of the channel a location happens to be on.

Figure 20. Results of the Multiple Component Analysis of bank erosion data.

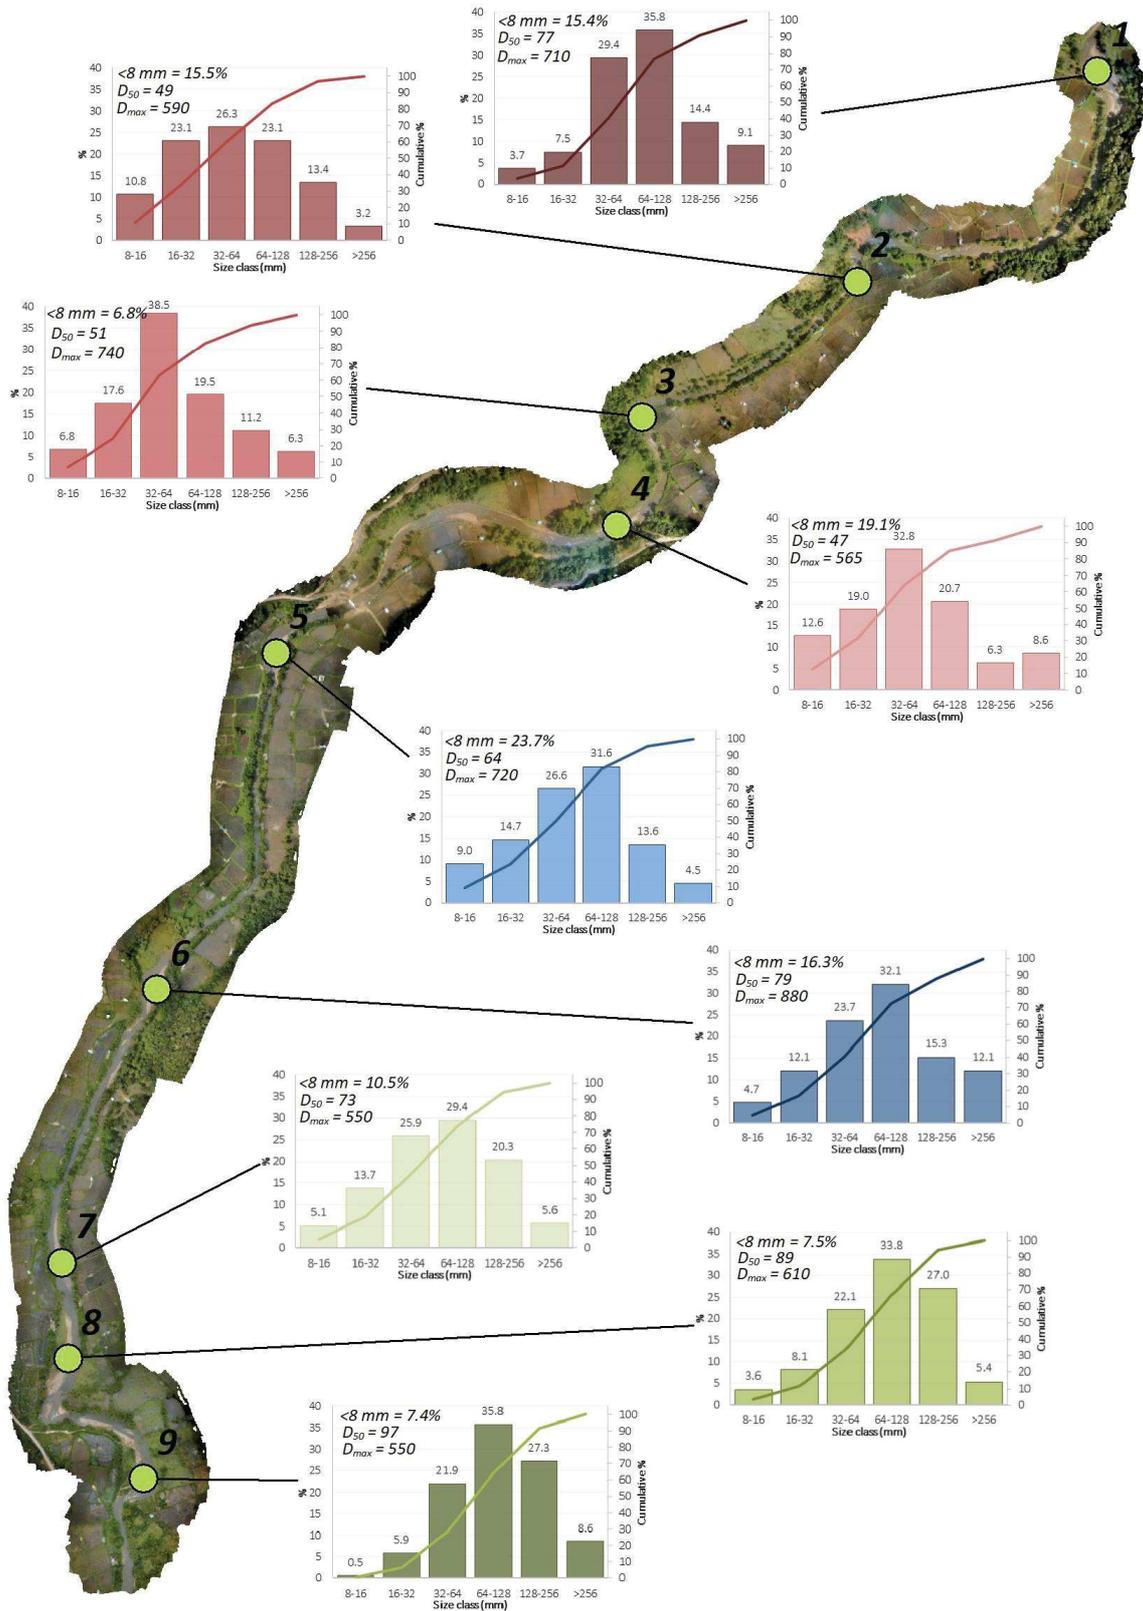
Grain Size Distributions (GSDs) measured at the bar scale revealed that the upper half of the study section was dominated by the 32-64 mm size class (large gravels) while the lower part was dominated by the 64-128 mm size class (small cobbles). This difference, however, is not reflected in the size of the large clast found ( $D_{max}$ ), which was smaller in the lower part of the section and larger (880 mm) in the middle (bar 4, Figure 21). The lowest fractions of sediment <8 mm were found where the bars showed few small gravels (class 8-16 mm). Bars 5, 6 and 8 contained large proportions of sediments <8 mm (between 15.5 and 23.7%); these bars are located just downstream from large disturbances, such as landslides (bar 6 and 8) and channel stabilisation, undertaken to protect a road bridge (bar 5). The presence of large volumes of fine sediments on these bars does not seem to influence the grain size distribution of the larger particles; these are thus a direct response to human disturbances.

Figure 21. GSDs of the different gravel bars samples along the upper Trusan; with the largest particle measured ( $D_{max}$ ) and percentage of particles smaller than 8 mm.

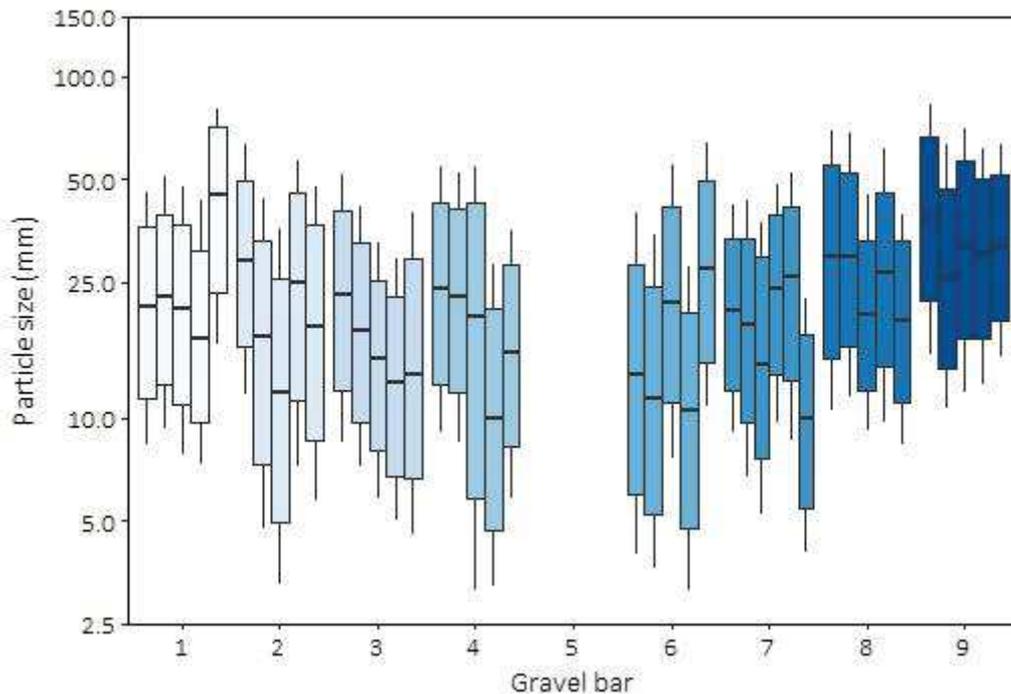
Figure 22. Boxplot representing the results from photosieving; tips of boxplots =  $D_{16}$  and  $D_{84}$ ; edges of boxplots =  $D_{25}$  and  $D_{75}$ ; centre =  $D_{50}$ . Each box represents a different patch photographed, with 5 photographs taken on each bar. See Figure 7. Schematic to show the spatial distribution of gravel bars (numbered 1 to 9) and data collected at each one to help characterise riverbed conditions. Figure 7 and Figure 21 for bar numbering.

Results from the boxplots (Figure 22) show similar trends to the Wolman pebble counts (Figure 21), with more details about fine sediments. Bars located at the very top (1) and bottom (8 and 9) of the study reach are made of coarse material, with no fine sediments ( $D_{16} > 7$  mm). Inversely, gravel bars found towards the middle of the section show very low  $D_{16}$ , illustrating the high proportion of sand and silt, with the  $D_{50}$  as low as 10 mm in places. While interesting, the main value of these GSD data is for hydraulic modelling (e.g. for roughness estimates) and a baseline against which future changes can be assessed.

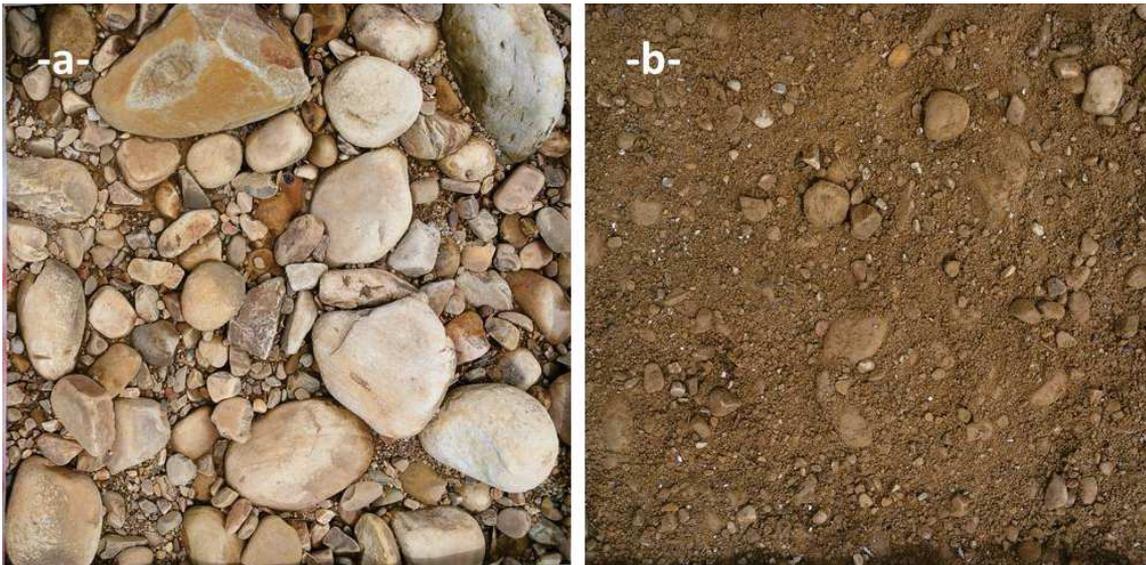
Figure 24. Example of the surface (-a-) and subsurface (-b-) particle size from the same patch.

It appears that the armouring ratio of gravel bars decreases downstream (Table 4). Using the traditional method, an armouring ratio of 3.6 would represent a very high armouring. Armouring occurs naturally in rivers, but can be exacerbated by human activities. In particular, it tends to increase when coarse sediment supply from the catchment is reduced, and/or when large volumes of fine sediment deposit within the gravel matrix. The higher armouring ratios of gravel bars upstream reflect the higher human interferences (bank stabilisation, landslides, cattle access to the river, etc.). Although bank erosion is very pronounced in the downstream part of the river, it seems that this geomorphic activity allows the river to rework its bars, thus limiting armouring.

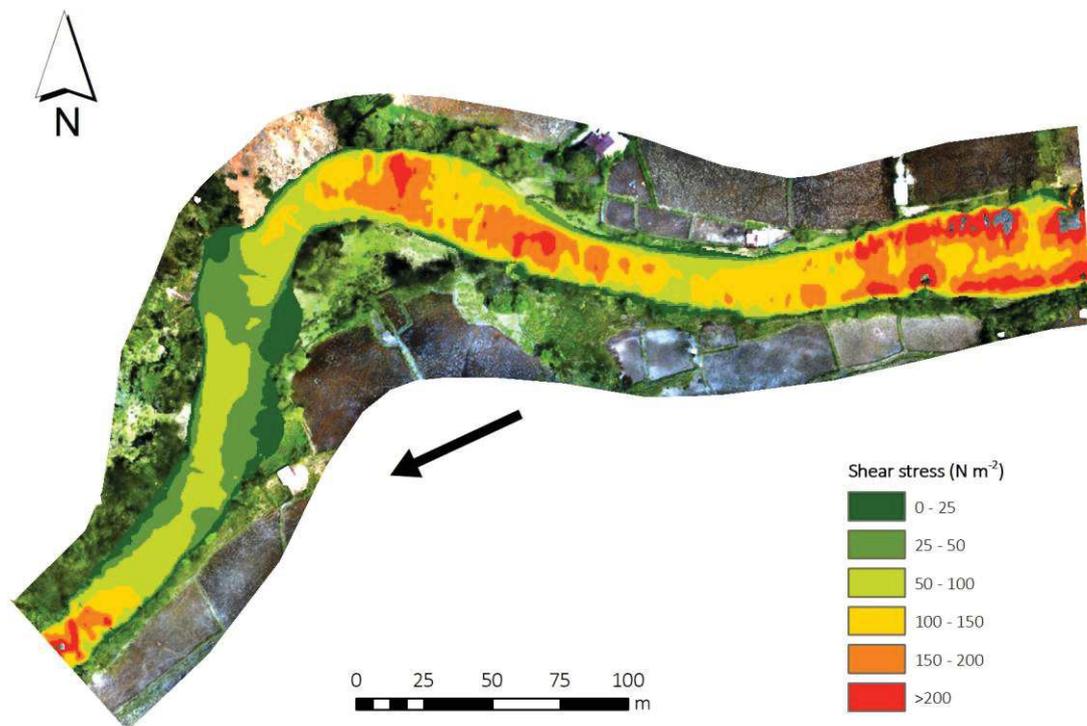
The upper reach (Figure 25; Reach 1 in Figure 3) shows high shear stresses in places where depth is low to moderate as flows are turbulent. The entrance of the bend, where the right bank is clearly exposed (i.e. land cleared and high sediment delivery into the channel), shear stresses are also very high and so water hits the banks at high velocity and force. The energy is then rather well dissipated, with the section directly downstream from the bend being very deep and having low shear stresses (i.e. low velocities) and easily subject to deposition of finer particles (such as the ones eroded from the exposed bank upstream). This is supported by field observations of fine material accumulating on the surface of the bar in this area.

Figure 25. Shear stresses estimates from the 2D model at bankfull discharge ( $Q = 75 \text{ m}^3 \text{ s}^{-1}$ ) for the upper reach (Reach 1 in Figure 3).

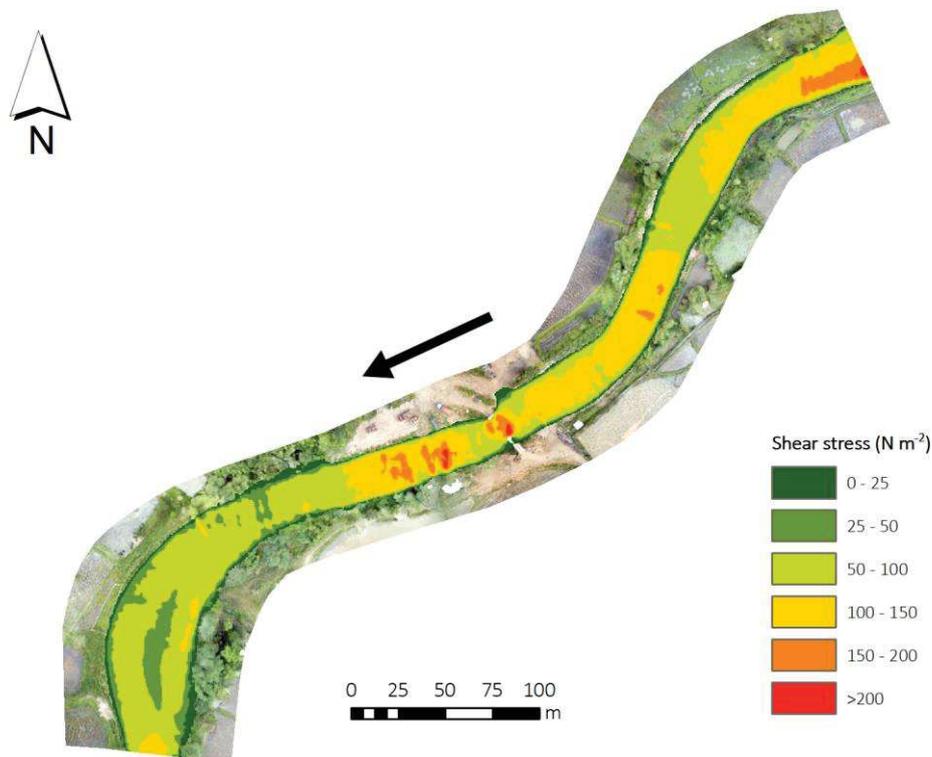
The model output for the middle reach (Reach 4 in Figure 3) is shown in Figure 26. This reach was fully channelized upstream from the road bridge (located approximately in the middle of Figure 26, adjacent to the flow direction arrow). At bankfull, the channelized section is clearly homogeneous with high shear stresses ( $>100 \text{ N m}^{-2}$ ) over the entire width of the channel, initiating an accelerated area of flows concentrated under the bridge that generate very high shear stresses in the vicinity of the bridge as well as further downstream. As the water moves downstream, it appears that shear stresses are not particularly high on the outside the bend. Stresses are higher on the inside; this corresponds with field observation of rather intense erosion of exposed banks in these areas, despite them being outside the wetted channel at low flows.

Figure 26. Shear stresses estimates from the 2D model at bankfull discharge ( $Q = 75 \text{ m}^3 \text{ s}^{-1}$ ) for the middle reach.

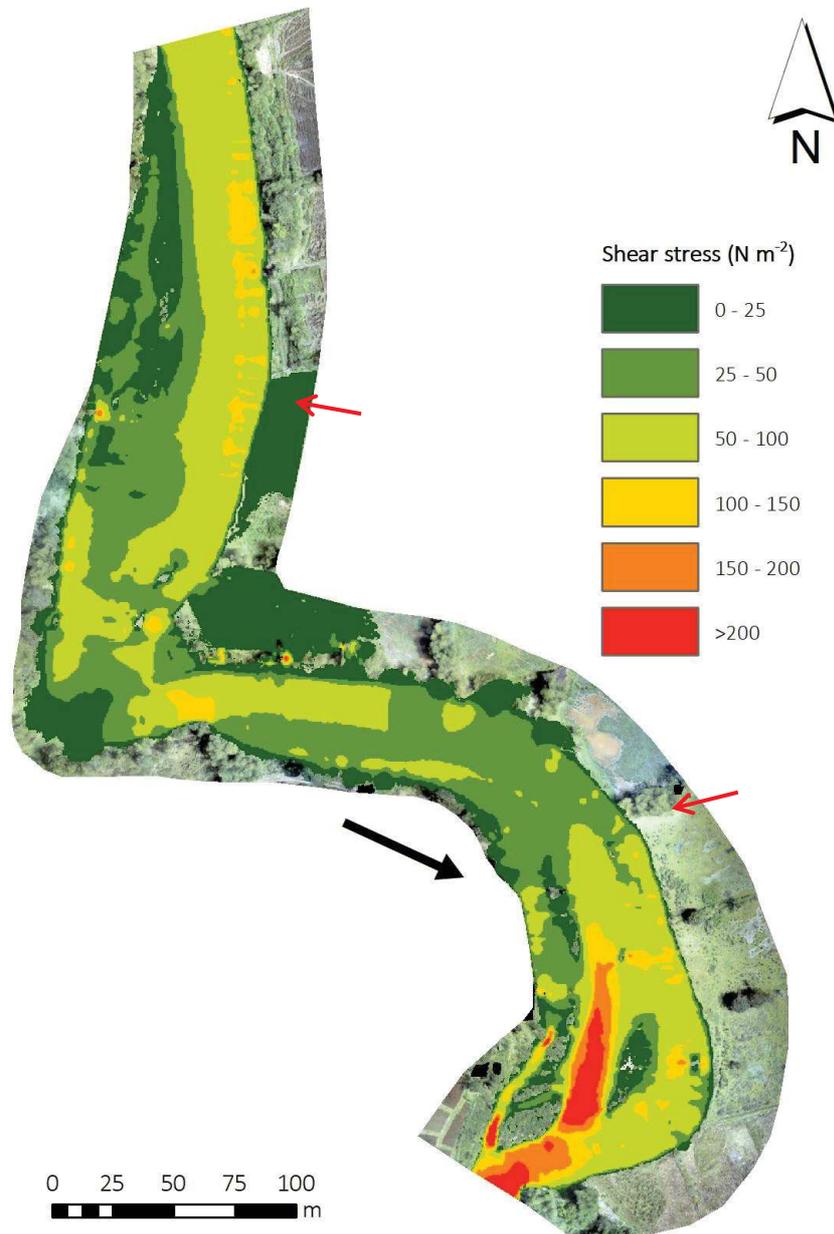
Shear stresses are predicted to be particularly high at the bottom end of this reach. Generally, shear stresses are not particularly high in the section and, most interestingly, are not very high

in locations suffering from severe erosion (see arrows). This, along with the observations made earlier about the importance of the absence of vegetation, illustrates that hydraulics is not directly responsible for the occurrence of severe erosion along these banks. A combination of bank material properties (i.e. loose fluvial material) and the lack of trees rendered these areas sensitive to erosion even for the moderate shear stresses that occur during bankfull discharges.

Figure 27. Shear stresses estimates from the 2D model at bankfull discharge ( $Q = 75 \text{ m}^3 \text{ s}^{-1}$ ) for the lower reach.

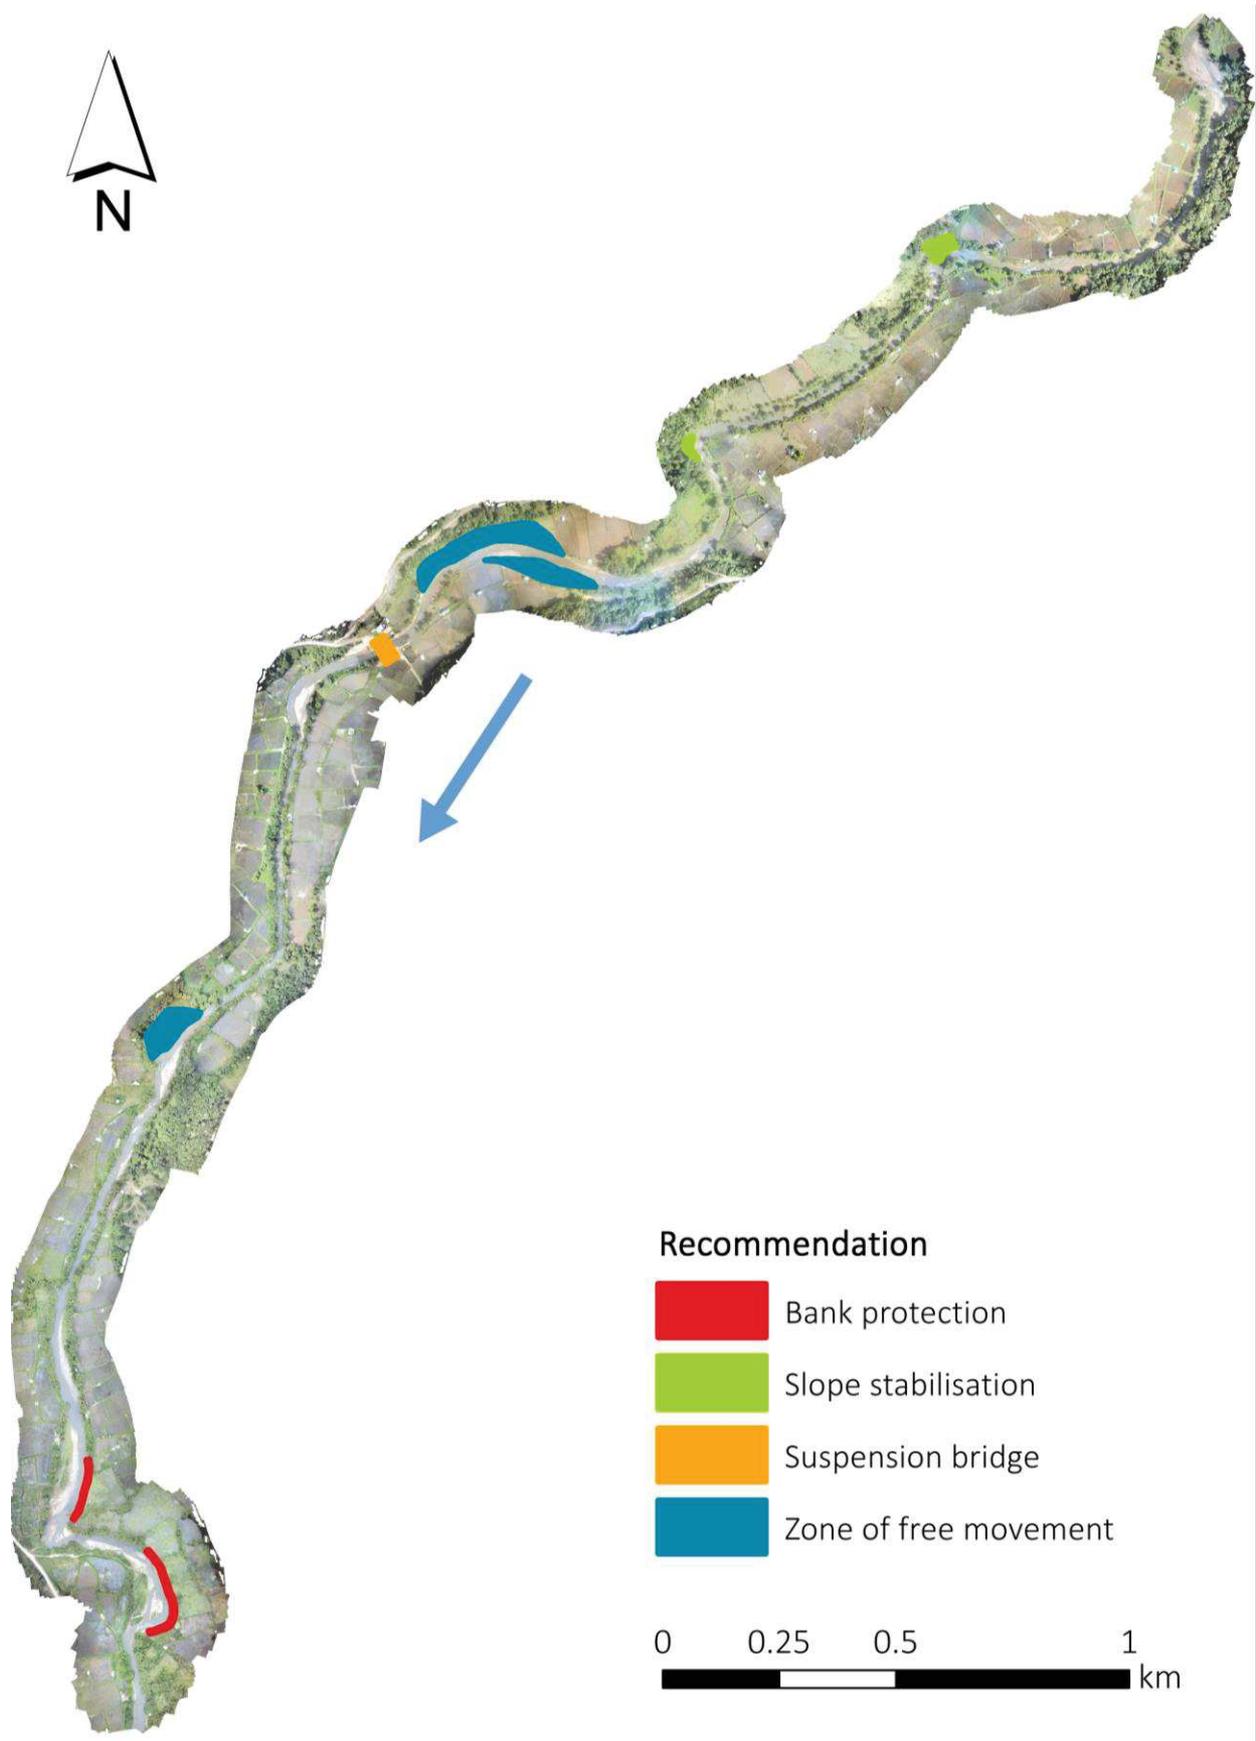
Figure 28. Map of recommendations proposed at the corridor scale for the Upper Trusan River.

First, we suggest some managed retreat from the riverbank zone in selected areas. The idea is to leave room for the river to erode and dissipate its energy in places where geomorphic activity is possible and risks are low (i.e. no population, no valuable land etc.). Three main areas are suggested to be left for the river (see Figure 28). Both the left and right banks of the river upstream from the road-bridge leading to Long Telingan can be left unprotected as this would help dissipate energy before the water reaches the bridge (i.e. natural protection from bridge undermining). The third area is located further downstream at the confluence of a small tributary. This stretch is situated between two sections with relatively high stability (strong riparian cover that protect the banks from erosion). The protection of these two sections is key as large rice paddies can be found on either side of the river. Leaving room for the river between these two critical sections can prevent any damage in the future (i.e. progressive or regressive erosion).

Fourth, and finally, we strongly recommend preventing any direct alteration of channel geometry in the vicinity of areas suffering from high and severe erosion. Bank stabilisation by moving boulders from the channel will only displace (and potentially worsen) the problem elsewhere by disturbing the natural equilibrium (although it should be seen as a 'dynamic equilibrium) of the river. There are one or two instances where boulders placed along banks have resulted in erosion behind them, such they are now sitting in the middle of the channel. If access is possible, such boulders could be removed to avoid any further erosion and displacement of high flow forces. One clear example of the unanticipated consequences of badly conceived intervention is the generation of high velocity areas under the bridge (as modelled at bankfull discharge); this may have direct and rapid consequences when it comes to stability of the bridge. Similarly, extracting gravel from the bed will have significant consequences on channel equilibrium.
