Criticality Accidents Occurred in Research Reactor Facilities in France

Fabien Duret¹, Aurélie Bardelay¹ and Tristan Adatte¹

¹Autorité de Sûreté Nucléaire et de Radioprotection (ASNR)
BP 17, 92262 Fontenay-aux-Roses Cedex, France

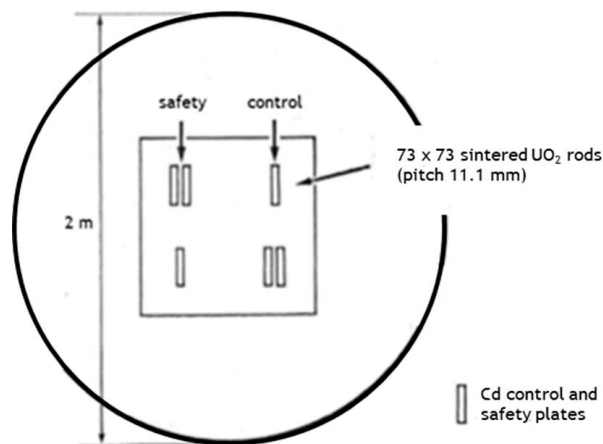
Figure 1. Horizontal sectional view of the ALIZE reactor [2]

The ALIZE reactor had been operated by CEA in Saclay since 1959. This critical assembly was a water reflected and moderated UO_2 system, enriched to 1.5% in ^{235}U . The 2.2 tons of UO_2 were immersed in a 2 meter diameter aluminum cylindrical tank. The assembly was composed of 5,257 aluminum clad sintered UO_2 rods arranged in a 73×73 units array with a 11.1 mm square pitch. Each rod had a diameter of 6.395 mm and a height of 1,080 mm. It also contained six cadmium plates, ensuring both safety and control, gathered two by two and inserted in the place of six groups of 12 fuel rods. The critical approach parameter was the water height in the tank. The reactor was installed in a 9 m deep pit, which was closed by two concrete slab doors at ground level during reactor operation, ensuring biological shielding. Figure 1 illustrates the core layout.
