# Complexity of shear localization in a Zr-based bulk metallic glass

The compressive behaviour of a Zr-based metallic glass was studied *in situ* through optical and infra-red imaging. Results show that localization bands are more complex than simple planes, and interactions between different slip systems are an essential ingredient to understand slip arrest and hence the ultimate strain such materials sustain. Roughness, which is responsible for both damage and arrest mechanism, is argued to be another key feature to enhance the ultimate macroscopic shear strain.

**Keywords:** Metallic glass; Shear bands; Compression test; Digital Image Correlation.

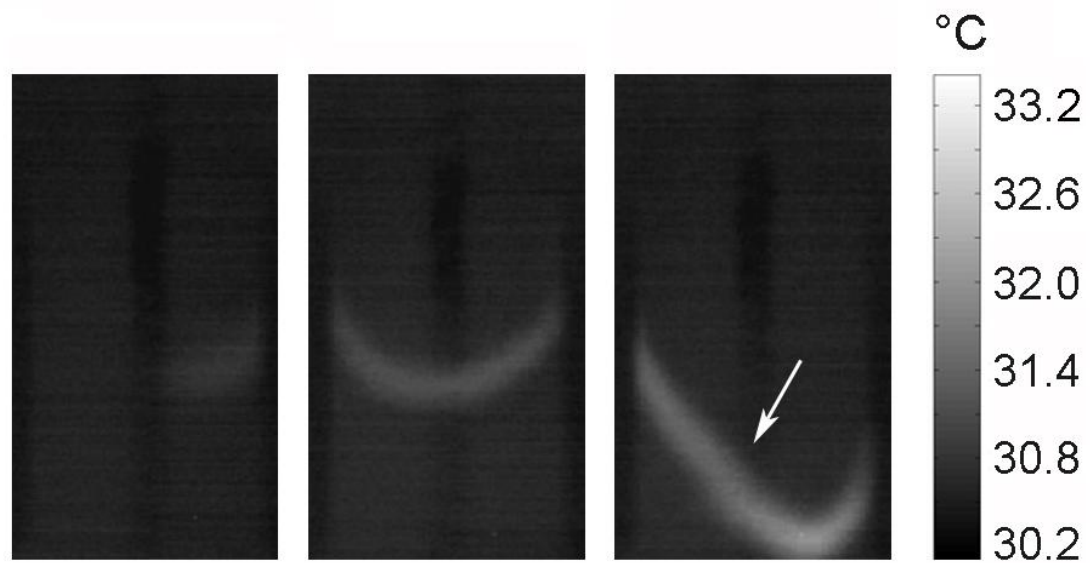
**Figure 1:**

Three infra-Red camera images after shear band slips along the experimental test. Note that the left image shows a partial slip or rotation, while the right one displays a kink (shown with an arrow) which can be interpreted as the mobilization of two slip planes.

At those instants, the temperature maps shown in Figure 1 clearly show a hot trace appearing on the surface of the sample with an approximate elliptical shape corresponding to a slip along a maximum shear plane (at  $45^\circ$  with respect to the compression axis). In spite of the short inter-frame time, the spatial extent of these bands appears broad essentially because of heat diffusion from the slip plane. Some pictures show remarkable features, namely, the temperature increment appears to be highly asymmetric signalling non uniform slip (Fig. 1 left). At some other times, a kink is observed in the trace of the slip band, suggesting that the support of slip consists of at least two such planes crossing each other (Fig. 1 right). This reveals an unexpected complexity in the geometry of these slip events.

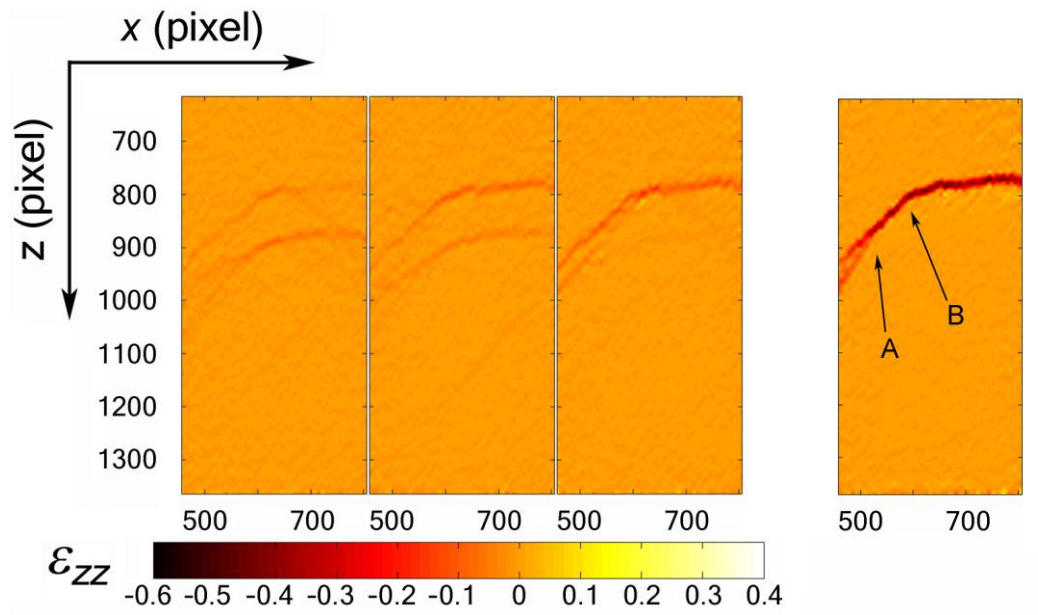
**Figure 2:**

(left) Three consecutive incremental strain maps obtained from DIC showing multiple slip systems being simultaneously active. (right) Strain map prior to failure where A shows a branching point, and B a kink produced by the intersection of two slip bands. The colorbar indicates the apparent strain level computed over 35  $\mu\text{m}$  wide elements.

Figure 2 shows incremental strain maps, where the strain refers to the component  $\varepsilon_{zz}$  along the compression axis,  $z$ . Incremental in this context means in between two consecutive images taken along the test. DIC reaches subpixel resolution from the integration of the displacement over a zone that has a finite extent. In the present case, we used a code such that the displacement is decomposed over square bi-linear finite-element shape functions [15], whose size is  $35 \times 35 \mu\text{m}^2$  for which typical displacement uncertainties are of the order of  $0.5 \mu\text{m}$ . It is observed that the strains are concentrated into very thin (one finite-element wide, or  $35 \mu\text{m}$ ) structures that are the trace of a kinematic discontinuity. A refined analysis leads to the conclusion that the support of the discontinuity is of the order of  $5\text{-}10 \mu\text{m}$  (1-2 pixels) at most. The actual size may be much smaller but it cannot be resolved with the present technique. The apparent vertical amplitude of the displacement discontinuity is of the order of  $5\text{-}10 \mu\text{m}$  depending on the studied band. The geometry of the bands is much more accurately determined than that obtained from the temperature maps because of heat diffusion. The above reported observations concerning the overall variability and persistence of the different shear bands are confirmed through this analysis, with a much better accuracy. The final slip system, for example, that appears as a smooth elliptical shape from temperature maps, is here observed to be much rougher, with kink and branching as shown in Fig. 2. This roughness is not an artefact of the DIC analysis, as will be shown hereafter.

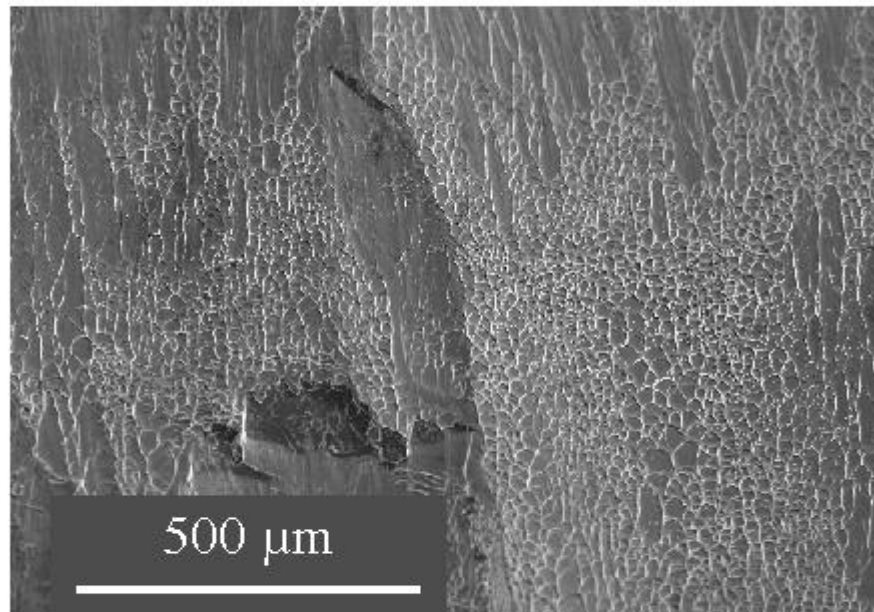
**Figure 3:**

Failure surface showing both brittle micro-cracks (top and lower part of the picture) and river patterns characteristic of the separation of the surfaces along a region where viscous flow took place.

due to surface tension driven flow that requires a very low viscosity because of the very short duration of slip. The origin of these lines is due to cavity (or bubble) nucleation and growth that drag the viscous phase at the junction between neighbouring porosities. When the patterns are isotropic, it means that it was produced under mostly normal separation of the surfaces. However, it is often seen that the “river” pattern is markedly anisotropic. This corresponds to a separation involving both normal and tangential displacement discontinuities (mixed mode cracks in the language of fracture mechanics). In Fig. 4 a more surprising feature is observed, namely some parts of the surface show different slip directions forming a large angle (presumably in different episodes) in different zones of the final failure surface. Moreover, in addition to such river patterns, more brittle-like areas develop, which reveal some micro-cracking.

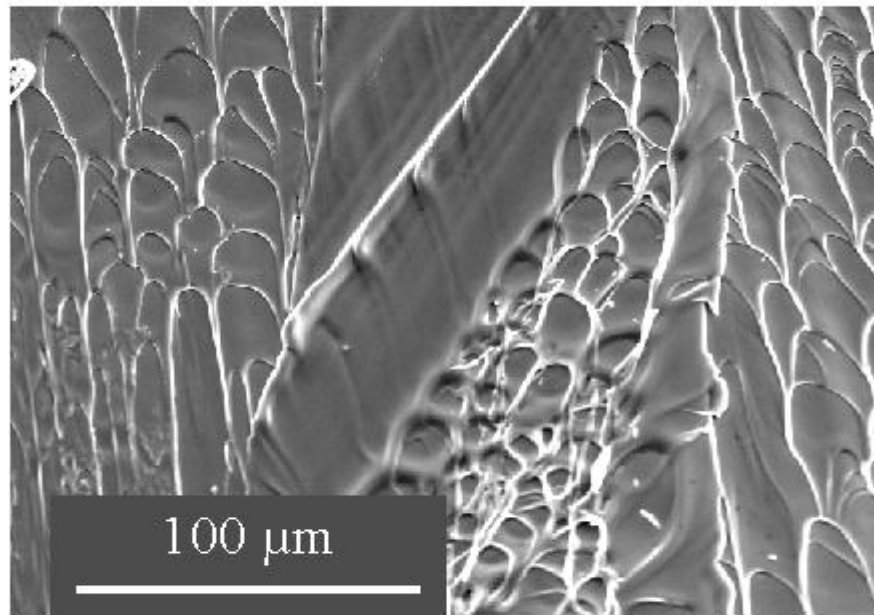
**Figure 4:**

SEM observation of the specimen free surface after failure. Different slip directions can be distinguished over the final failure surface.

The multiplicity of different and parallel shear bands has already been mentioned several times in the literature [16-18] but only from post-mortem surface observations without any information on the time sequence of these bands. SEM images of the sample after failure show on the sample side the traces of shear bands. A large number of quasi parallel shear bands do support the previous observation of scatter of the shear band location. Moreover, if the dominant geometry of these surfaces is roughly planar and forming an angle of ca.  $45^\circ$  with respect to the compression axis (maximum shear stress), other traces correspond to a significantly different angle. It is also to be observed that the sample is finally broken mostly through slip along surfaces that correspond to such shear bands, but these surfaces are connected by a step that is essentially a mode I crack as can be seen in Figure 3. From these low magnification SEM images, it is concluded that the failure surface (besides the above mentioned step) is not a perfect plane, but rather a rough surface.

The post-mortem observation of the fractured surface is also quite enlightening. On most of the surface (Fig. 4) characteristic “river” patterns appear, as often reported in the literature. They correspond to the separation of the two surfaces along an interface where the material has been brought up to the glass transition temperature where viscous flow could take place. At very small scales, the surface smoothness is
