Sensitivity of Structurally Loaded Sandwich Panels to Localized Ballistic Penetration

Jørgen A. Kepler, Peter H. Bull

This paper describes a series of tests focused on the combination of structural loading (bending, shear) and simultaneous penetrating impact on sandwich panels with thin GFRP face-sheets, with emphasis on the specific damage morphologies and developments depending on the type and magnitude of structural loading. The test specimens were sandwich panels, length 250 mm and width 150 mm, with carbon fibre prepreg face-sheets ($[0^\circ/90^\circ]$, thickness $t_f \cong 0.5$ mm) bonded to the faces of a foam core (density 80 kg/m³, thickness $H = 10$ mm). The impact velocity was approximately 420 m/s, using a spherical steel impactor, diameter 10mm, with a mass of 4.1 g. A high-speed camera was used for registration of panel response. It was demonstrated, that, at preload levels above a specific limit, the impact would cause catastrophic failure, i.e. complete or near-complete loss of structural load carrying capacity. Developments of failure morphology, consistent with the observed evidence, were derived and outlined.

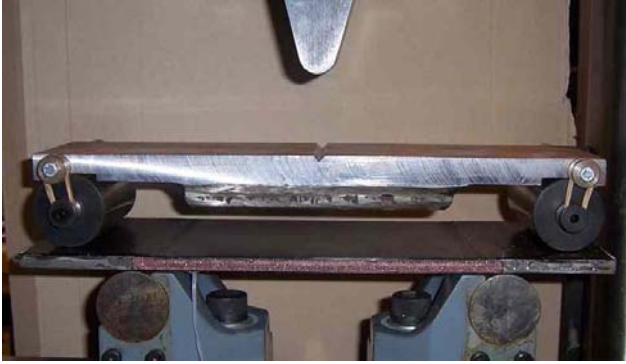
Fig. 4: Static test setup.

For determining the maximum feasible preload level, a number of specimens were tested to failure in a quasi-static test setup (without impact). The test setup, essentially a wide-specimen 4-point beam bending test, is outlined in Figure 4 (shown for symmetric bending).
