# Effect of sealed anodic film on fatigue performance of 2214-T6 aluminum alloy

Keywords:  
Fatigue  
Anodic film  
Sealing  
SEM  
Micro-cracks

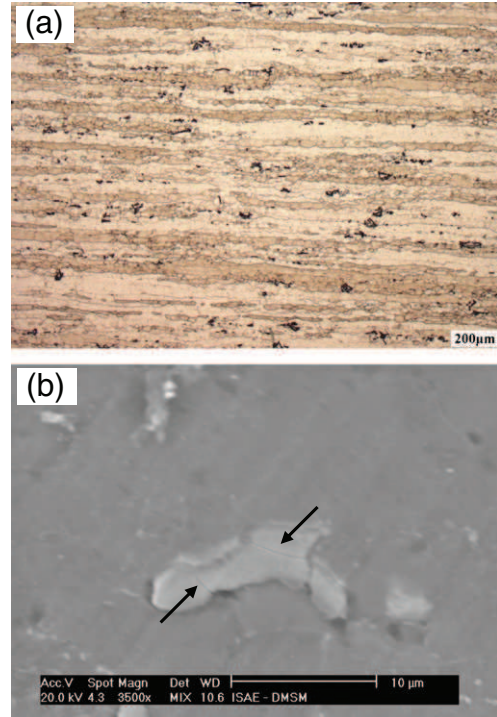
**Fig. 1.** (a) Optical micrograph of 2214-T6 aluminum alloy microstructure and (b) Cracked particle observed prior to fatigue loading.

Metallographic analysis of the microstructure by optical microscope revealed that it is composed of unrecrystallized and recrystallized grains and latter are elongated in the rolling direction as shown in Fig. 1. Two types of constituent particles were found in this material:  $Al_2Cu$  and  $AlSiMnFeCu$  and their average size varied between 8 and 12  $\mu m$ . These types of particles have also been reported earlier [12] for the given alloy. Microstructure was also analyzed by SEM and it was observed that some of the constituent particles of second type ( $AlSiMnFeCu$ ) had cracks prior to any fatigue loading.

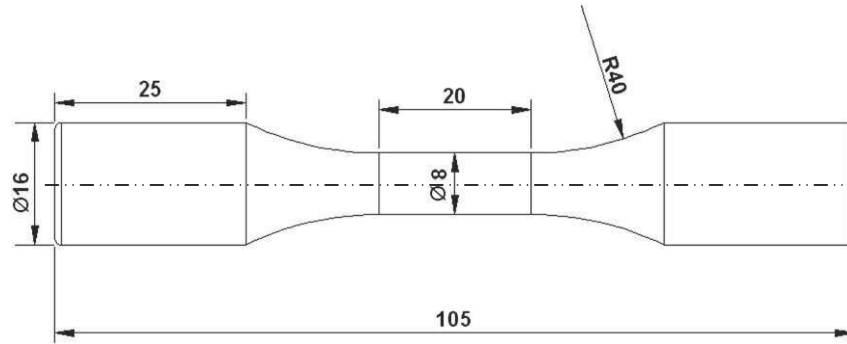
Fig. 2. Fatigue specimen geometry (dimensions in mm).

Fatigue test specimens have been designed according to the useful fastening system of the fatigue testing machine and to prevent buckling of the shaft of the specimen during fatigue tests under stress ratio of  $-1$ . Connection profiles have been sized in order to reach a stress concentration factor ' $K_t$ ' of 1.04 [13]. Geometry of specimens is shown in Fig. 2. Surface of specimens has been machined with initial surface roughness  $R_a = 0.7 \pm 0.1 \mu m$  by lathe turning with the rolling axis parallel to loading axis without using lubricant. The initial roughness of 0.7  $\mu m$  is deliberately produced to mimic the surface roughness generated for components used by industrial partner.

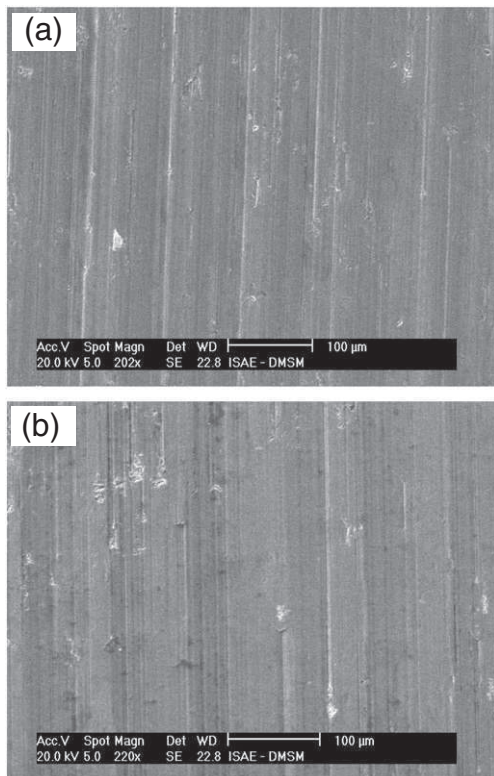
Fig. 3. (a) SEM micrograph of the surface of machined specimen and (b) SEM micrograph of the surface of pickled specimen.

The long pickling time prior to anodization could result in the formation of pits with significant fatigue life implications [15]. Also in the previous work for 7010-T7451 aluminum alloy, Shahzad et al. [16] have shown that pickling process reduced the fatigue life considerably. In fact, in that previous case, pickling process used in [16] was found to attack constituent particles resulting in pits at surface which in turn acted as stress concentration facilitating crack initiation and subsequent crack growth. Therefore, microscopic examination was made after pickling process to verify that if this changes the surface topography of the specimen. Concerning present 2214-T6 aluminum alloy, comparison of micrographs (Fig. 3a and b) before and after pickling process, allows us to say that pickling process did not change

the surface topography of the specimens. Moreover, EDS analysis showed that constituent particles  $Al_2Cu$  and  $AlSiMnFeCu$  were always present for the pickled specimens.

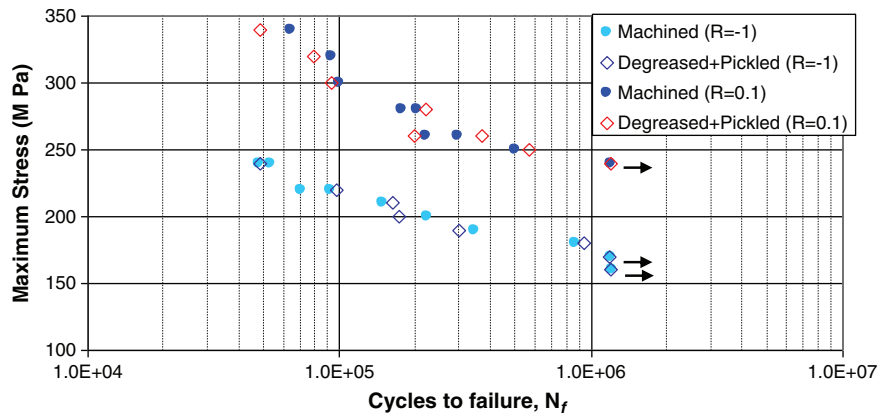
Fig. 5. Fatigue test results for as machined and as degreased + pickled specimens showing no change in fatigue life.

To further validate the fact that pickling has no effect on fatigue behavior of this alloy, some specimens were tested in pickled conditions and results presented in Fig. 5 showed no change in fatigue life as compared to machined specimens.

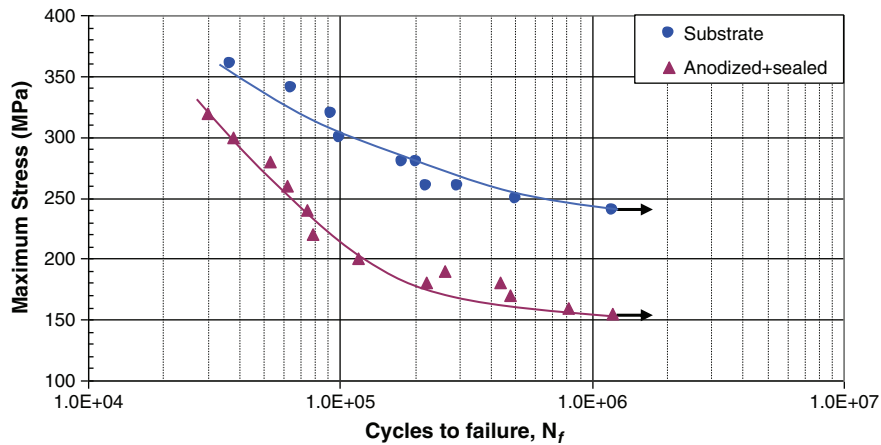
Fig. 6. S-N curves for bare and anodized specimens at stress ratio,  $R = 0.1$ .

Fatigue test results for bare and coated specimens are given in Figs. 6 and 7 for  $R=0.1$  and  $-1$  respectively. It can be clearly seen that tendency of sealed anodic film is to degrade the fatigue performance for the given alloy at all stress levels as compare to bare specimens. For fatigue life of  $10^6$  cycles, there is a decrease of 35% for  $R=0.1$  and 41% for  $R=-1$ . It can be noted that the fatigue strength of anodized coated specimens showed a dependency on the applied stress ratio. However, the presence of anodic film did not modify significantly the effect of stress ratio as shown in Fig. 8 on which Haigh diagram has been established for  $10^6$  cycles for machined and anodized specimens: the slope for the two segments did not change significantly:  $-0.418$  for machined and  $-0.394$  for anodized specimens.

From Figs. 6 and 7, one can note that with the increase in the applied stress amplitude, S-N curves tend to converge thus reducing the negative effect of the anodic film. This behavior of convergence for high stress can be observed for both stress ratios. One possible explanation for this phenomenon may be the differences in relative importance of crack nucleation versus crack propagation in high and low stress regimes. Indeed, fatigue life is essentially divided into two regions: crack nucleation life (dominant for low stresses) and crack propagation life (dominant for high stresses). In addition, as the anodic film is significantly thin compared to the total section of the specimen, a pronounced effect of film on fatigue crack growth behavior and hence on fatigue crack propagation life would not be expected: this results in a slighter effect of the film for high stresses. On the other hand, crack nucleation is known to be sensitive to surface condition. Therefore, the anodic film would be expected to influence fatigue nucleation life and hence fatigue lives at low stresses more significantly.

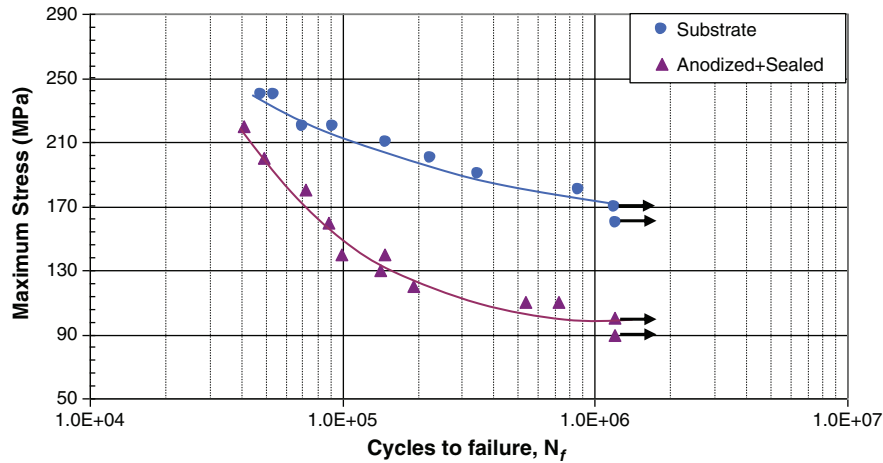
Fig. 7. S-N curves for bare and anodized specimens at stress ratio,  $R = -1$ .

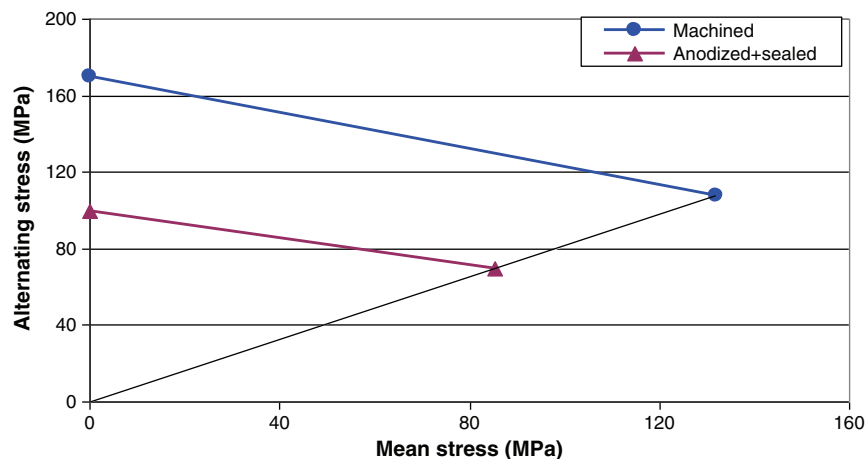
Fig. 8. Haigh diagram to evaluate the effect of mean stress at  $10^6$  cycles between machined and anodized specimens.

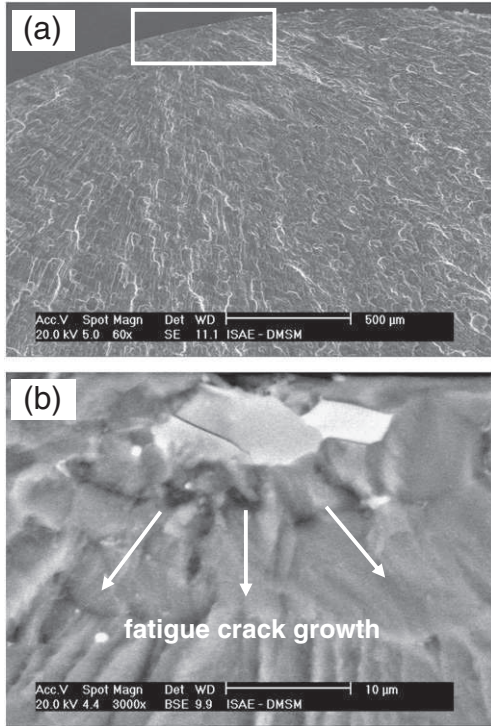
**Fig. 9.** (a) SEM image for bare specimen at low magnification showing crack initiation site and (b) higher magnification of (a) showing cracking of particle and subsequent fatigue crack growth.

Several specimens tested at different stress levels were examined after failure by SEM, using backscattered and secondary electrons, in order to understand the different fatigue damage behaviors for machined as well as anodized conditions. Fatigue test results presented above indicate that the decrease in fatigue strength of anodized specimens was related to the crack initiation stage. Therefore, it is important to identify the origin of fatigue cracks for different specimens. For aluminum alloys, constituent particles and grain boundaries are the common sites for fatigue crack initiation [19]. For the specimens tested in as machined and pickled condition, fatigue cracks have been observed to nucleate at constituent particles  $AlSiMnFeCu$ , as determined by EDS technique, and  $Al_2Cu$  particles were not effective in initiating cracks. Almost all of

the fatigue cracks were initiated by the cracking of the constituent particle ( $AlSiMnFeCu$ ) and there was no evidence of debonding at the interface of matrix/particle (Fig. 9).

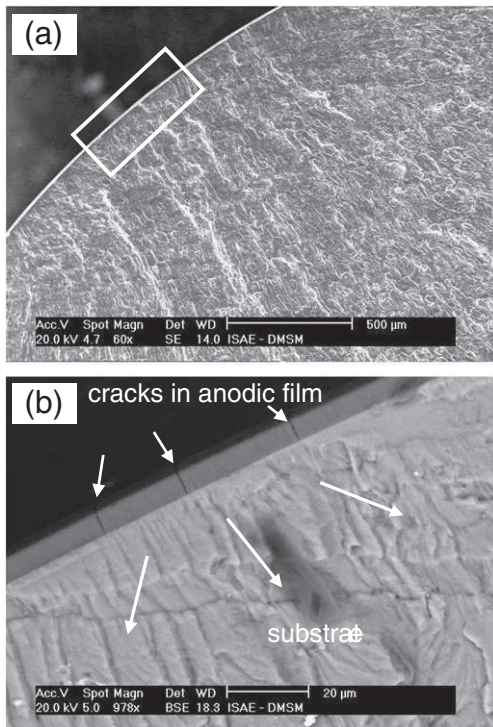
**Fig. 10.** Fracture surfaces of anodized specimen ( $R = 0.1$ ), at low and high magnification showing fatigue cracks initiated within the film and propagated towards substrate.

The sealed anodized specimens exhibited various fatigue crack initiation points, which propagated resulting in fracture. For most of the anodized specimens, cracks developed in the film and then propagated towards the substrate. Such mechanism is shown in Fig. 10, which presents the fractured surface of one of the anodized specimen tested at 180 MPa.

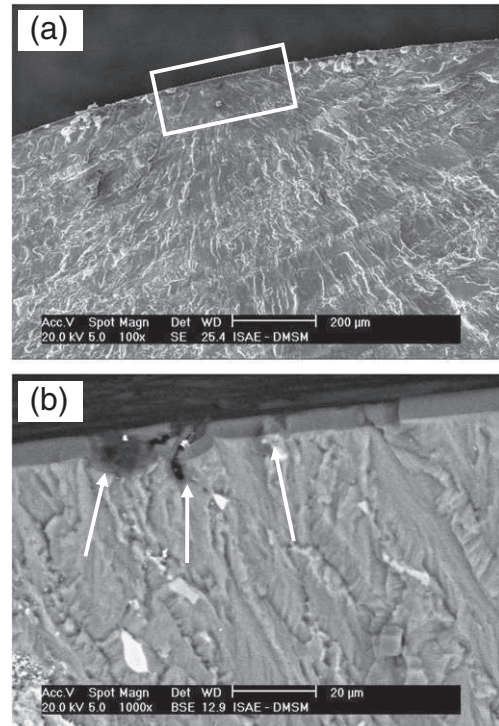
**Fig. 11.** SEM images of anodized specimen;  $R = -1$ ,  $\sigma_{max} = 200$  MPa,  $N_f = 51025$  cycles at low and high magnification showing the crack initiation from cavities in film.

Besides the cracking of anodic film, the presence of pit like defects (cavities) in the film was also found to be another source of crack initiation for substrate as can be seen in Fig. 11. These pits may cause local stress concentration and may have a provocative effect on the subsequent cracks growth in the substrate. The phenomenon of initiation from cracking of film and cavities was observed for both stress ratios. For anodized specimens, the main controlling factor for crack initiation appears to have been provided by the film. Constituent particles ( $AlSiMnFeCu$ ) played no role in fatigue crack initiation in the anodized specimens.

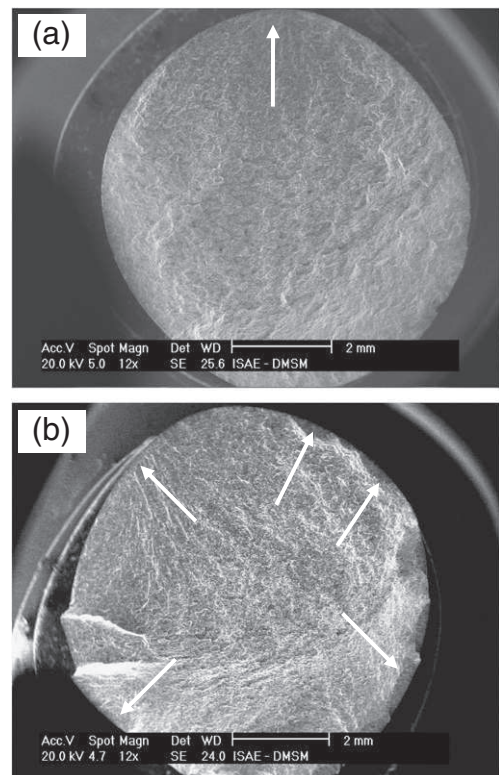
**Fig. 12.** (a) Bare specimen showing single crack initiation;  $\sigma_{max} = 260$  MPa,  $N_f = 219640$  cycles (b) anodized specimen showing multi-site initiation,  $\sigma_{max} = 260$  MPa,  $N_f = 61548$  cycles.

At the same stress level, the number of cracks formed on fractured surface of the anodized specimens was larger than that of the untreated specimens as indicated by arrows in Fig. 12. The fracture surface is not flat (Fig. 12b) which also reveals that number of fracture steps exists, indicating that fracture has occurred as a consequence of the propagation of several cracks that initiated from film. Shiozawa et al. [20] have also demonstrated this phenomenon that number of crack initiation sites increased for the anodized specimens

compared to untreated ones. For the anodized specimens, cracks at the multiple initiation sites propagated independently and coalesced with neighboring cracks. Therefore, one can also conclude that decrease in fatigue strength of anodized specimen is caused by the

increase in number of crack initiation sites and higher crack propagation rates due to coalescence of cracks.

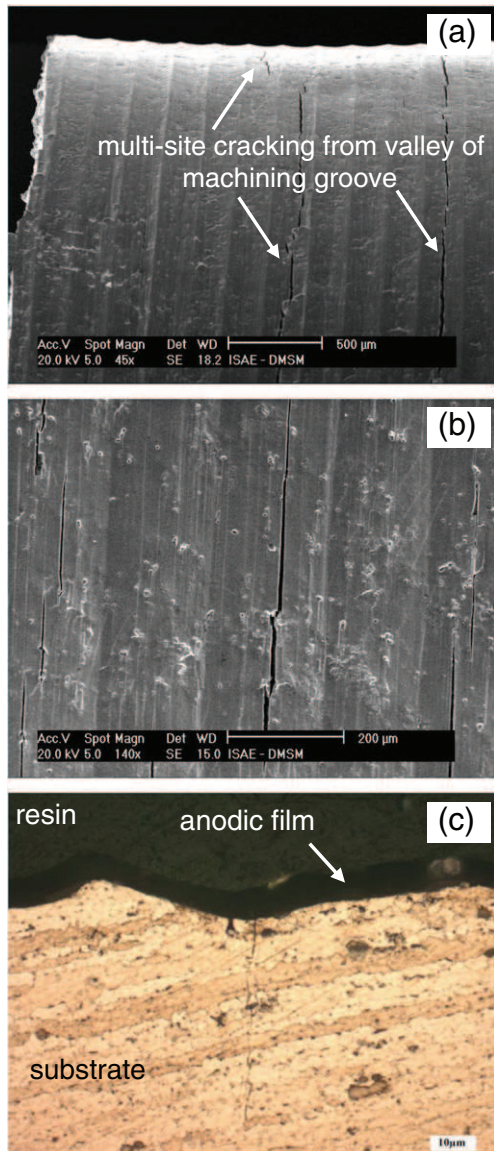
**Fig. 13.** (a) and (b) Secondary cracks on anodized specimen surface showing multi-site initiation at low and high magnification (c) transversal section image showing fatigue cracking in anodized specimen.

initiation. Fig. 13 shows that most of the secondary fatigue cracks were initiated at the valley of machined groove and started from pit like defects. To validate the fact that anodic film follows the machined surface profile, one fatigue tested specimen was cut along the long axis of the specimen. Then specimen was polished using diamond paste of 1  $\mu\text{m}$ . Optical image shows that anodic film has followed the machined surface profile.
