Interactions between propagating cracks and bioinspired self-healing vasculae embedded in glass fibre reinforced composites

C.J. Norris, R.S. Trask*, I.P. Bond

Keywords: Smart Materials (A), Fracture Toughness (B), Damage Tolerance (D), Self-healing.

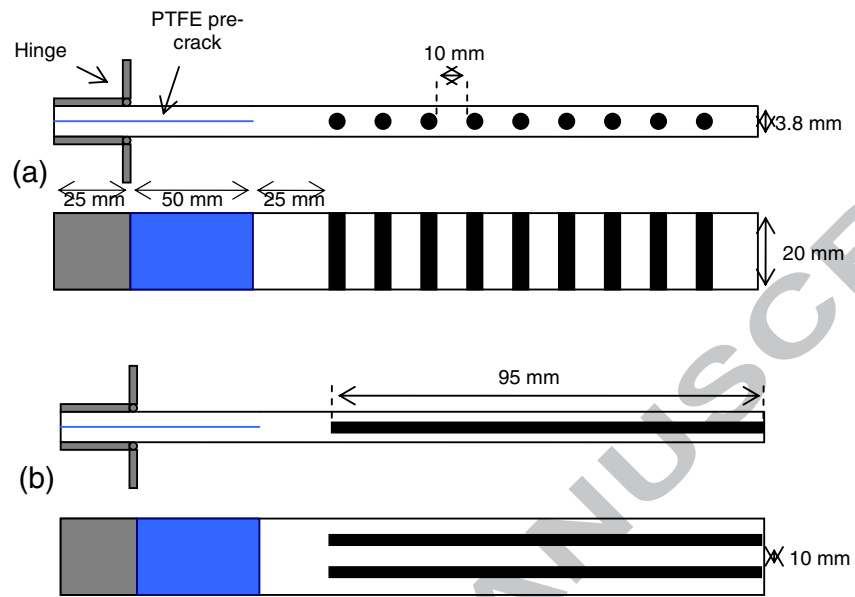
Fig. 3. Mode I DCB specimen geometry; (a) transverse vasculature and (b) aligned vasculature.

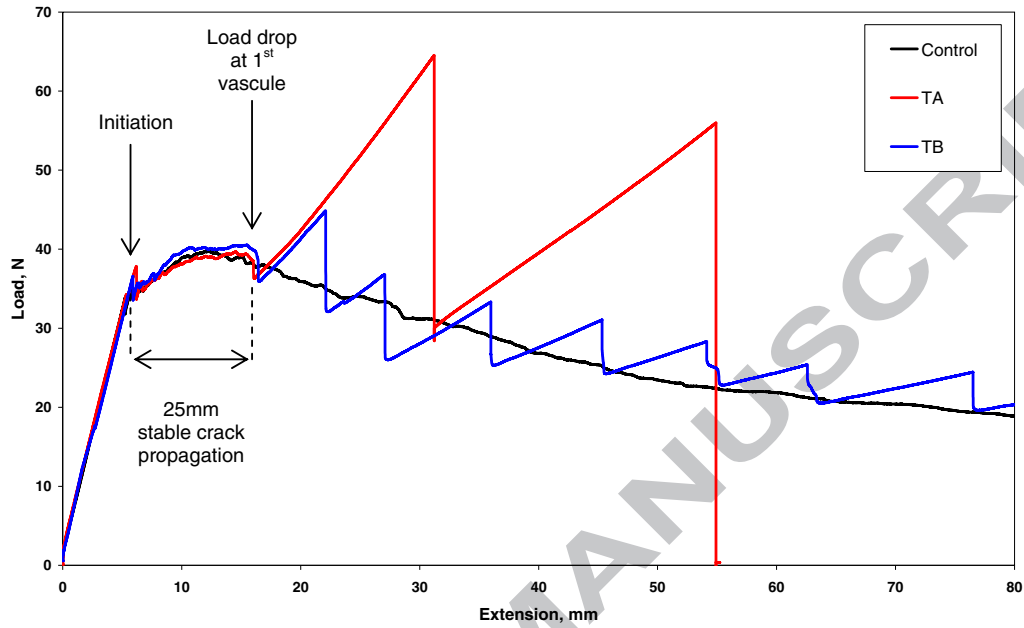
Fig. 5. Mode I load vs. displacement curves for transverse orientated vasculures (T= transverse, A = fabrication route A and B = fabrication route B).

transverse to the fibre direction, along with a control sample, are provided in **Fig. 5**. The crack propagation in the specimens containing vasculae proceeded as for the control until approximately 2mm from the first vascule (experimental observation). At this point, the crack jumped into the vascule, resulting in a sharp load drop. The observations were consistent for both vascule formation routes and confirmed them to be successful Mode I crack attractors. This is expected for fabrication route A, where **Fig. 1(a)** clearly shows the resin pocket to extend at least 2mm from the edge of the vascule. However, the resin pockets produced during fabrication route B do not protrude beyond the width of the vasculae (**Fig. 1(b)**), so it is expected that the termination of load bearing fibres caused the drop in load as the crack tip approached these vasculae. Vasculae formed via fabrication route A led to significant crack arrest, as seen by the sharp load increases. In the example provided, the load increased at the first vascule until it was sufficient for crack propagation; at this point the crack jumped 20mm until it arrested at the third vascule. Here, the load increased again until it was sufficient to overcome the vascule boundary and rapid ‘unzipping’ occurred, leading to total failure of the specimen. These findings are in line with those of Kousourakis, Mouritz and Bannister [19]. On propagation from a vascule, the crack plane is exposed to an instantaneous increase in displacement rate over the 2 mm/min set rate. Previous studies have shown the rate dependency of FRP laminates, with severe reductions in Mode I fracture toughness reported at high strain rates [26,27]. This type of uncontrolled rapid fracture is undesirable in the aerospace industry, however, the long periods of

For the transverse orientated vasculae, the force versus displacement curves followed very similar trends to the Mode I testing (**Fig. 5**). With fabrication route A, the crack was arrested at the first vascule followed by rapid unzipping of the remaining 20mm of the crack plane. The Mode II fracture toughness has also been reported to be rate dependent with reduced toughness recorded at high strain rates [29,30]. The crack plane immediately beyond a vascule is exposed to a rapid increase in displacement rate on crack propagation from the vascule, so uncontrolled rapid crack propagation could be expected. For fabrication route B, slight crack arrest was seen at each vascule.

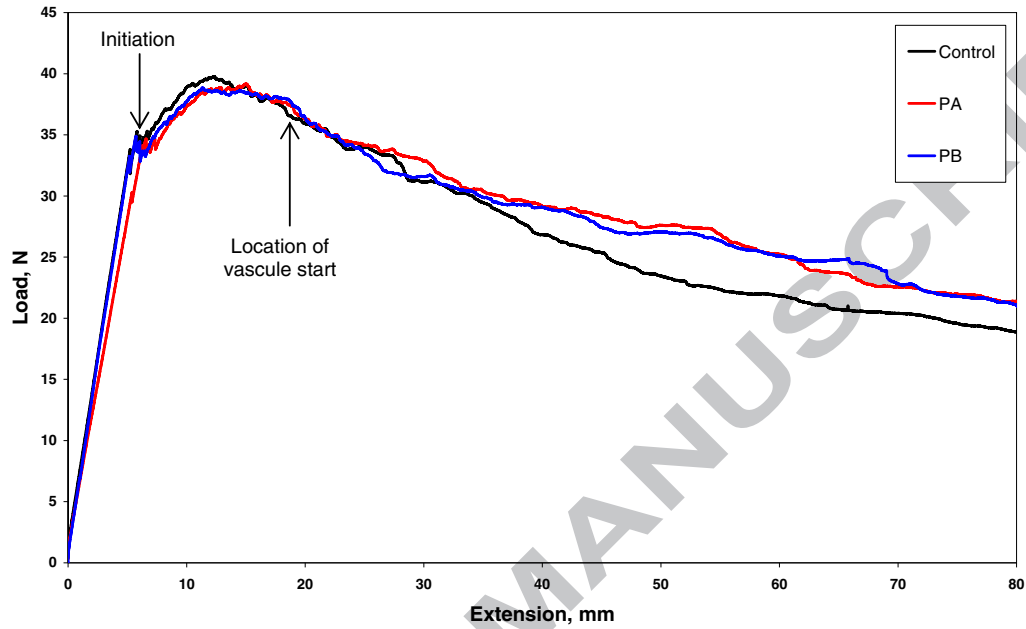
Fig. 7. Mode I load vs. displacement curves for vascules aligned parallel to the fibre direction (P = parallel, A = fabrication route A and B = fabrication route B).

Typical load-displacement curves for aligned vasculures are provided in **Fig. 7**. For both fabrication routes, the load followed that of the control sample until arrival of the crack tip at the ends of the two vasculures embedded in each specimen. The rate of load decrease is reduced from this point compared to the control. The inclusion of two 0.5mm diameter vasculures reduces the effective fracture plane width from 20 to 19mm, so a drop in load bearing ability could be
