# Impact damage evolution under fatigue loading by InfraRed Thermography on composite structures

**Abstract.** This study deals with cumulative damage and its evolution in already impact damage composite structure. In order to follow the growing damage and to compare it with cumulative model, tests are monitored with an InfraRed thermography system. A carbon-epoxy composite is first low-energy impacted and then fatigued under tension-compression loading. This study also enables a very fast analysis of predicting the damage evolution coupling InfraRed Thermography as NDT method and InfraRed thermography as a following system.

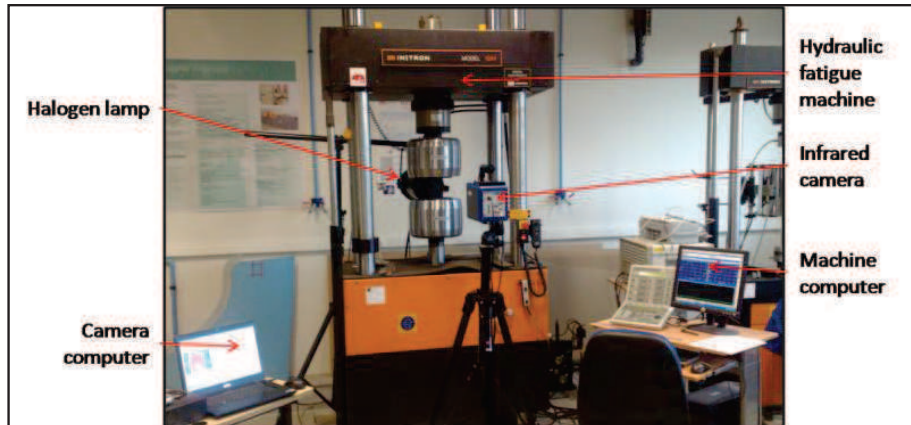
The damage and temperature evolutions were monitored during the fatigue test using an Flir Titanium infrared camera with a sensitivity of 20 mk at 30°C. The thermal movies are recorded at 149 Hz in order to catch the maximum of data as possible. The test is carried out on a controlled temperature and hygrometry room. The protocol of the test is as follow on figure 3.

Fig. 3. Fatigue protocol
