Impact damage evolution under fatigue loading by InfraRed Thermography on composite structures

Abstract. This study deals with cumulative damage and its evolution in already impact damage composite structure. In order to follow the growing damage and to compare it with cumulative model, tests are monitored with an InfraRed thermography system. A carbon-epoxy composite is first low-energy impacted and then fatigued under tension-compression loading. This study also enables a very fast analysis of predicting the damage evolution coupling InfraRed Thermography as NDT method and InfraRed thermography as a following system.

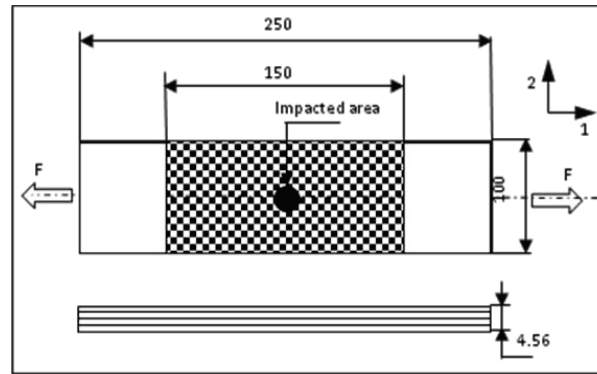
According to the standard specifications about fatigue and impact tests [18, 19], a new design of specimen was established. The useful part of the specimen allows the both tests (impact test and fatigue test).

Specimen geometry is as shown on figure 1.

Fig. 1. Specimen Geometry used for both tests

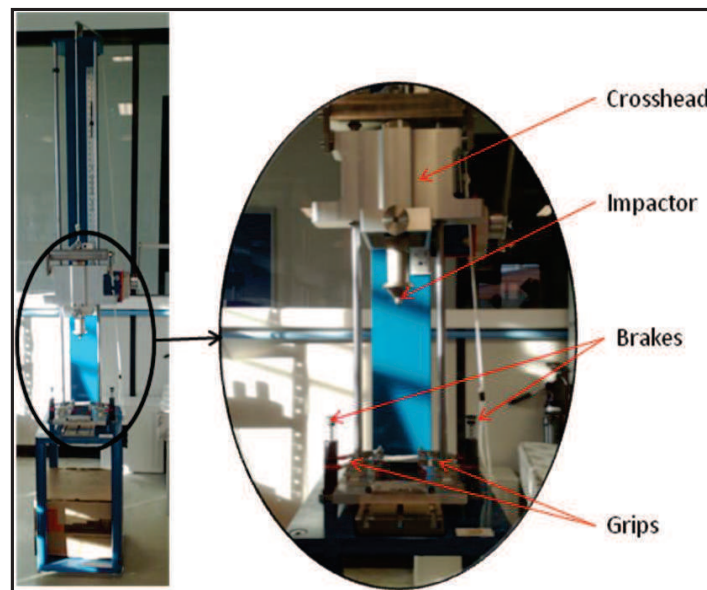
Impact tester is as shown on figure 2.

Fig. 2. Impact test machine used for this study

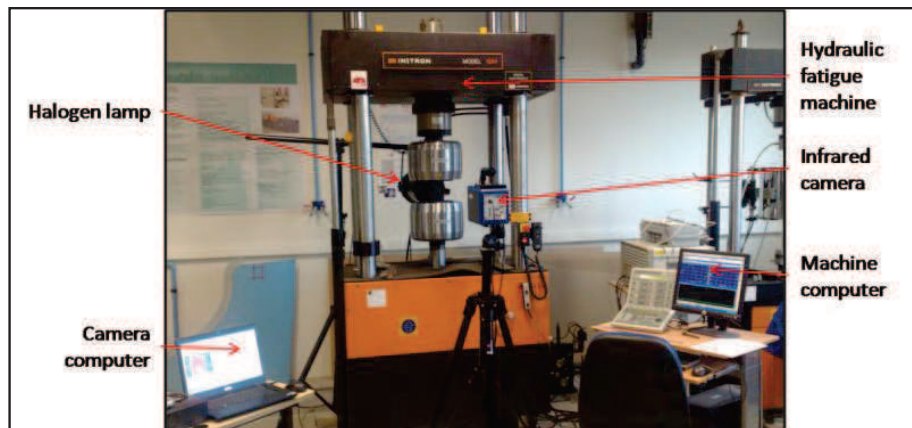
The damage and temperature evolutions were monitored during the fatigue test using an Flir Titanium infrared camera with a sensitivity of 20 mk at 30°C. The thermal movies are recorded at 149 Hz in order to catch the maximum of data as possible. The test is carried out on a controlled temperature and hygrometry room. The protocol of the test is as follow on figure 3.

Fig. 3. Fatigue protocol

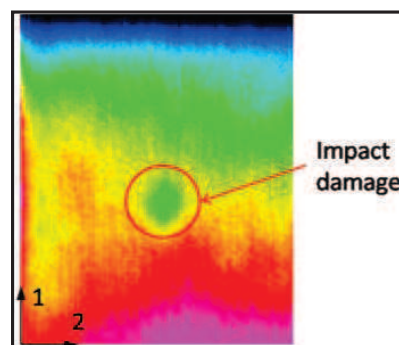
The 10J impact produced at the centre of the sample created some damages. Most common phenomena appearing during impact testing are matrix crack, delaminations, fibre breakage or fibre splitting at the back face of the specimen. In order to detect damages produced by impact, NDT method is used. For this case, Infrared thermography enables to detect the shape and the dimensions of the produced damage in a short time [14]. A thermal stress is sent to the sample by a halogen lamp. The thermal waves propagate on the material: it creates thermal gradient in it. Because of the difference of the two mediums (composite and defect) coefficient of emissivity, a thermal map is created by the IR sensor. During the heating time, the thermal movie reveals the damage, as shown on figure 4.

Fig. 4. Impact damage

The defect produced on the material is quite hemispherical, like the impactor shape and measurements are 19 mm and 17,5 mm on the direction 1 and 2 respectively.

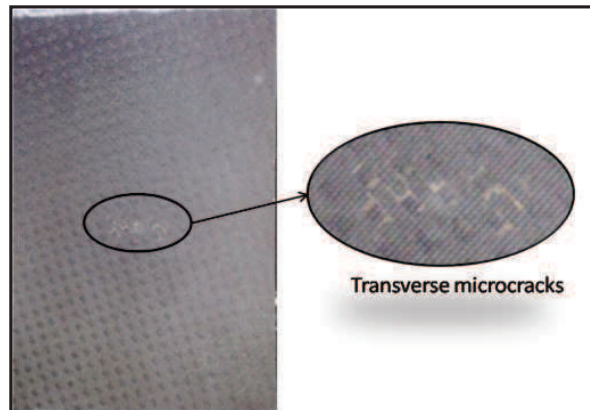
In this part, a sequence of all the visible mechanisms occurred during fatigue testing is presented. After impact, there is no visible indentation on the faces of the sample. After 100000 cycles, transverse cracks reached the front surface.

Fig. 5. Transverse microcracks on the front face

The microcracks area grows hardly after 200000cycles and just before failure, fibre breakage appears. After examining of failure, delaminations appears and are oriented on the same directions as fibre directions.

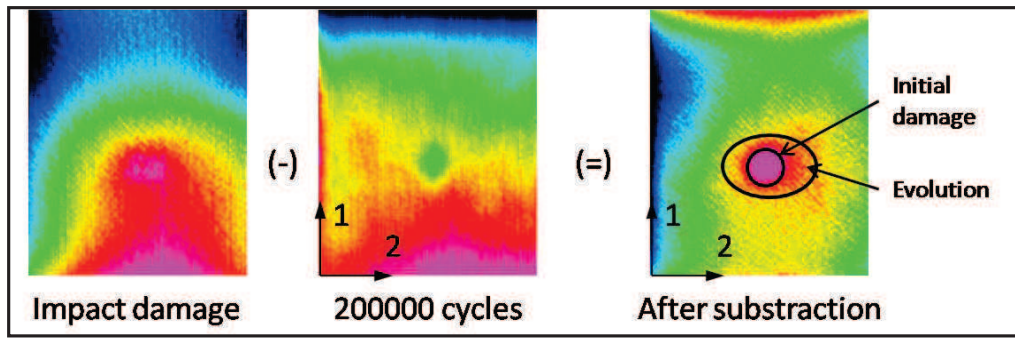
This new method consists in subtracting the initial defect image, revealed by InfraRed NDT methods, to the image caught at the required cycle, as shown in figure 6.

Fig. 6. Substracting method

A new method, consisting in coupling NDT and IR-fatigue enables to have two informations in one image: the initial defect and its evolution during fatigue. NDT methods, as shown in cf 3.1 [14], enables having a thermal map of the defect produced by impact. Following the defect during tension-compression fatigue loading by Infrared thermography outputs a thermal map of the specimen at a known number of cycles.

The substraction of the impact damage to all the IR movie gives 2 informations in the same time:

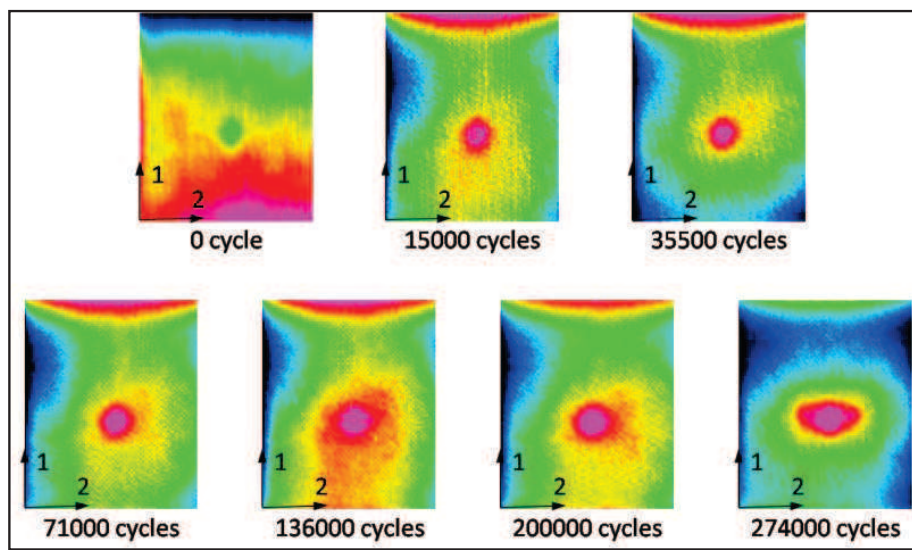
The damage evolution is followed by IR thermography. With the substracting method, impact damage evolution is performed as shown on figure 7.

Fig. 6. Evolution of the impact damage under fatigue loading by IR thermography

As shown in the figure 7, the damage mainly grows on the direction 2. In order to correlate with some other works [13], a plot of the size of the damage, for the two directions, is performed.

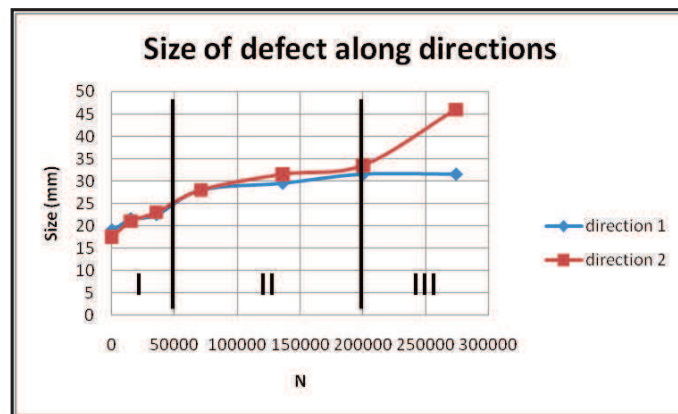
Fig. 7. Evolution of the size of the defect along directions

This trend correlates well with the cumulative damage of composite materials with 3 different stages [13].
