## Development of a laser shock adhesion test for the assessment of weak adhesive bonded CFRP structures

Bastien Ehrhart, Romain Ecault, Fabienne Touchard, Michel Boustié, Laurent Berthe, Clemens Bockenheimer, Bernd Valeske

Bastien Ehrhart, Romain Ecault, Fabienne Touchard, Michel Boustié, Laurent Berthe, et al.. Development of a laser shock adhesion test for the assessment of weak adhesive bonded CFRP structures. *International Journal of Adhesion and Adhesives*, 2014, 52, pp.57-65. 10.1016/j.ijadhadh.2014.04.002 . hal-01059299

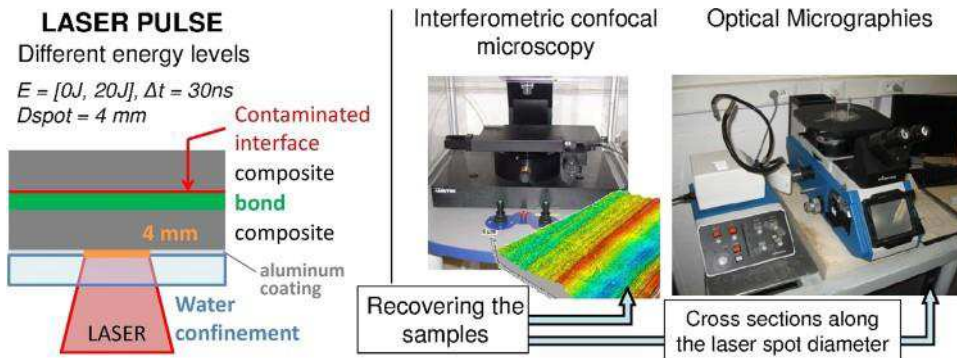
**Fig. 3.** Sketches of the laser shock experimental configuration and of the followed experimental procedure to test and analyze the bonded composites.

confinement configuration in order to increase the pressure level. A sketch of the experimental configuration is given in Fig. 3. A Nd:YAG laser (1053 nm wavelength) whose energy is tunable in the range [0–20 J] was used. Optical densities were used to change the laser energy sent on target and so, the laser intensity. The source pulse duration is about 30 ns, which leads to an induced pressure pulse about 60 ns because of the water confinement as shown by the work of R. Fabbro [34]. The laser parameters measured for each tested sample are presented in Table 3 with the associated uncertainties. After the shock, the samples are analyzed with two different setups as shown in Fig. 3. Interferometric Confocal Microscopy (ICM) on the sample back face was used to quantify the out-of-plane back face residual deformation such as height variations (topography). Optical micrographs of sample cross sections were also performed to observe the inside damage resulting from the laser shock wave propagation.

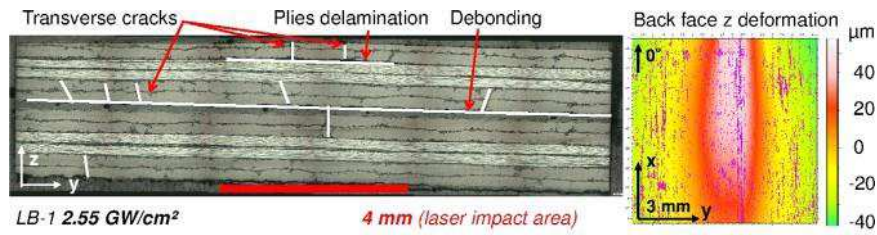
Fig. 4. Representative micrography and ICM height measurements of damage resulting from shock wave propagation inside a bonded CFRP with a low adhesion level LB-1.

A representative overview of damage resulting from laser shock on a bonded composite is given in Fig. 4. In this work, micrographies and ICM measurements are presented according the following codes (Figs. 4–7). The cross sections were performed perpendicularly to the  $0^\circ$  direction. The observed damage was enhanced using white lines. The ICM measurement gives an image of the sample out-of-plane back face residual deformation. The  $z$  deformation height is represented by the color scale, where purple is referring to non-measured points (due to roughness or out of range height). The sample presented in Fig. 4 is extracted from the LB contaminated series. Three main types of damage can be observed:

- (i) *Delamination between the plies*: they are initiated by the high tensile stresses generated by the propagation of the laser induced shock waves inside the composite. Indeed, with the used laser source, the crossing of release waves occurs close to the sample back face. Thus, the high tensile loading starts in this region, and exceeds the composite damage threshold in this case, inducing delamination. On the micrography (Fig. 4), it can be observed that the delamination took place between  $90^\circ$  and  $0^\circ$  plies. The delamination width in the  $90^\circ$  direction (cross section plan) corresponds to the focal diameter of the laser spot. Thanks to the residual back face deformation measurement by ICM, it has been evidenced that this delamination propagated in the  $0^\circ$  direction. It is characterized by the elliptical blister oriented in the  $0^\circ$  direction (see ICM in Fig. 4).

waves. Even if some fracture energy was dissipated inside the composite to initiate delamination, enough energy remained to initiate the debonding. In this case, the stresses exceeded the bond interface damage threshold. The low adherence level helped to conduct to a full debonding as shown in Fig. 4. In the case of debonding, no clue of a favorite propagation direction was found by the ICM measurement.

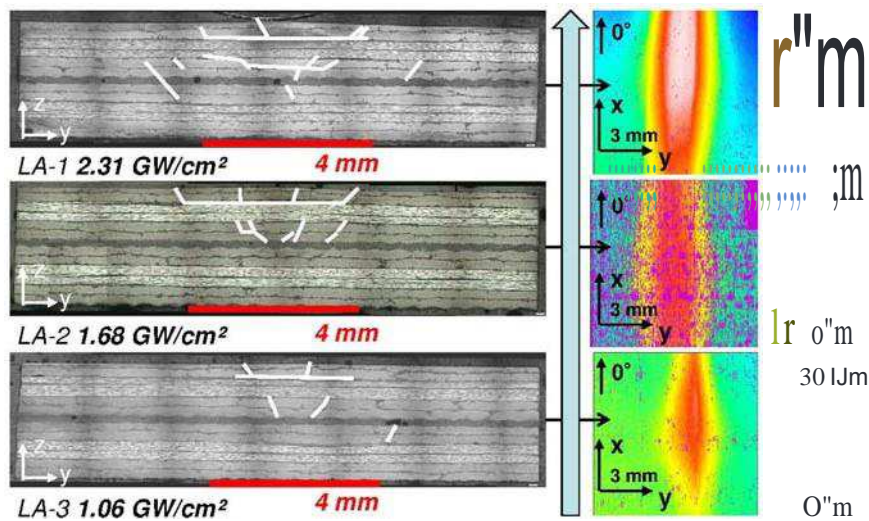
Fig. 6. Correlation between the laser intensity and the damage extent in the bonded composite material observed by micrographs and measured by ICM in case of LA series.

same tools. The characterization of the damage resulting from the laser shock wave is also carried out. Results are presented in Fig. 6. The main difference with both *LE* and *LB* series is the absence of debonding for none of the generated shocks, even the highest

intensity one. For this uncontaminated sample, the tensile stresses generated by the laser shock wave propagation were not high enough compared to the debonding threshold of the uncontaminated bond interface. Nevertheless, the transverse cracks and the

induced delamination in the composite part of the assembly are still present. The correlation between the laser intensity and the damage extent is also shown in this case, by the cross section micrographs as well as by the ICM measurements. The composite damage threshold is also close to the ones evaluated on the previous contaminated series which is logical since the contamination does not influence the composite quality.
