Study of secondary arcing occurrence on solar panel backside wires with cracks

J.M. Siguier, V. Inguibert, Gaétan Murat, D. Payan, N. Balcon

J.M. Siguier, V. Inguibert, Gaétan Murat, D. Payan, N. Balcon. Study of secondary arcing occurrence on solar panel backside wires with cracks. Spacecraft Charging Technology Conference 2014 (13th SCTC), Jun 2014, PASADENA, United States. hal-01081189

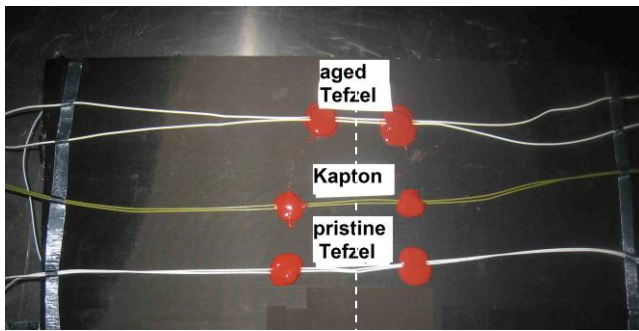
Fig. 4: cable set on CFRP board (the white dashed line shows the potential probe trajectory)

Cracks were made with a cutter blade on pristine cables. For Tefzel® we have also tested aged cables with space environment conditions simulation (collected on an aged coupon provided by Kitakyushu Institute of Technology) [5]. The 3 pairs of cables are fixed on a CFRP board with RTV-S-691 glue (Fig. 4).

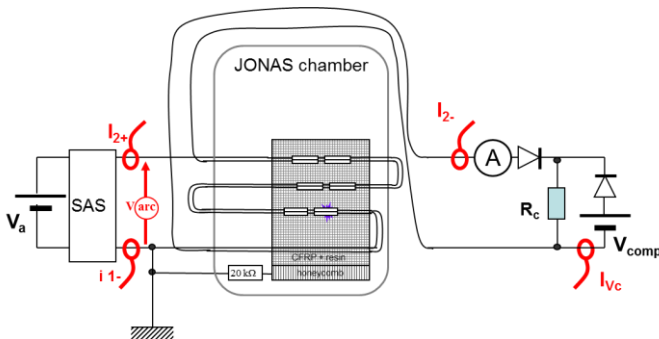
Fig. 5: electrical setup for direct charging configuration

The electrical setup is based on arcing test of solar cell coupons (Fig. 5). The 3 pairs of cables are connected in series to maximize the probability to get a secondary arc because an ESD can occur on any pair of cables.

The honeycomb + CFRP substrate is grounded and electron flux arrives perpendicularly to it.

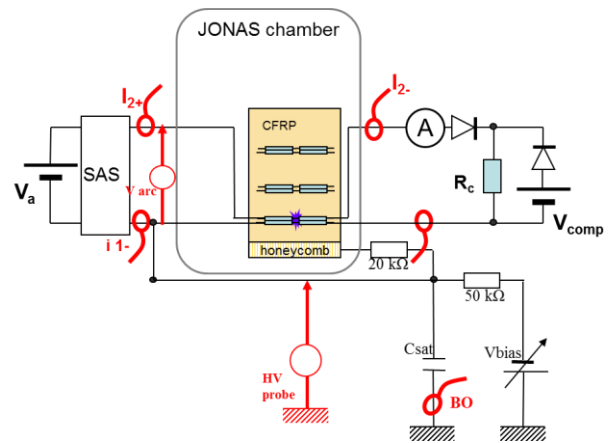
Fig. 6: electrical setup for IPG charging configuration

The electrical setup is also based on arcing test of solar cell coupons (Fig. 6). The 3 pairs of cables are tested successively. Those unconnected to the SAS are connected to the honeycomb + CFRP. In order to reach IPG situation, the sample is biased to HV (V_{bias}). $C_{\text{sat}} = 300\text{pF}$ and simulates the satellite capacitance.

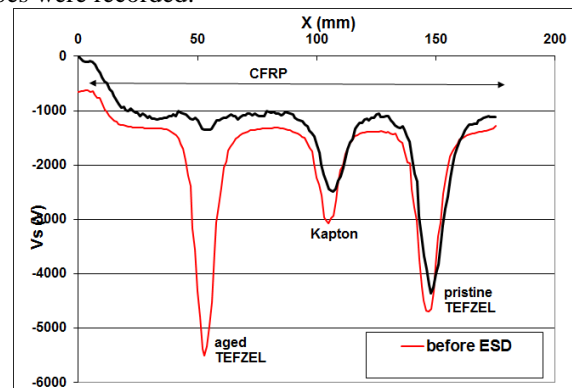
Fig. 7: Example of potential profile before and after ESD in direct charging configuration (trajectory of the probe is visible on Fig. 4)

We have recorded about 50 discharges on different cables: about 75% are on aged Tefzel, 25% are on pristine Tefzel and none on Kapton. Fig. 7 shows an example of potential profile before and after a discharge occurring on aged Tefzel. We can notice that CFRP surface is not zero due to epoxy dielectric properties.

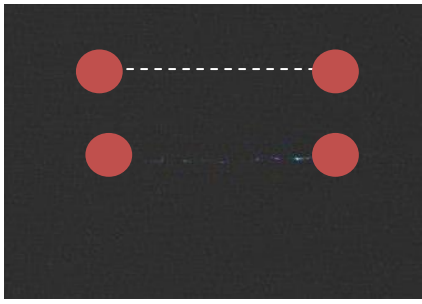
Fig. 8: Example of lightning phenomenon associated to the flashover on Tefzel cable. Approximate positions of Kapton cables (dashed line) and of RTV plots are drawn on the photograph)

Because of the very small capacitance of cables, estimated to few nC, the lightning phenomenon associated to the flashover is very weak (Fig. 8) but it proves that the flashover plasma propagates as well over the cracks.

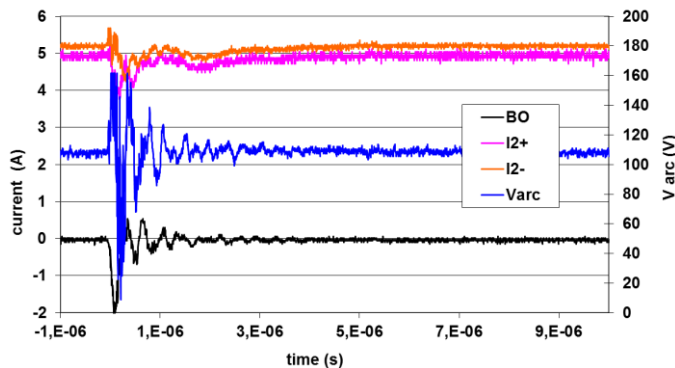
Fig. 9: Example of transient current and voltage recorded on Tefzel cable during an ESD

Fig. 9 shows currents and arc voltage measured on Tefzel cable when flashover passes over the crack (V_{arc} is disturbed). Nevertheless the flashover plasma is not enough dense to provoke a secondary arc when it passes over the cracks. In direct charging, there is no cathodic spot able to create this dense plasma. These results are very similar to those obtained by [4] where no secondary arc was triggered and same current shapes were recorded.

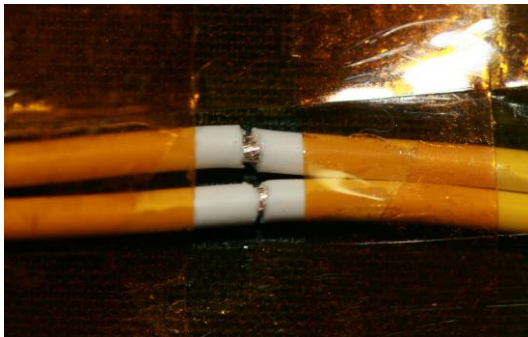
Fig. 10: Kapton film protection of substrate for IPG configuration

From $V_{bias} = -80V$, many discharges (more than 10/s) occurs on the CFRP, all over the surface, because this composite presents a multitude of triple points which are the condition of IPG discharge triggering: carbon fibers are conductive and epoxy resin is dielectric in an electrostatic point of view. In the aim of limiting ESD occurrence in an area as close as possible to the cable cracks, we have covered all the CFRP surface with a Kapton film and leaved uncovered about $1cm^2$ around the cable with cracks (Fig. 10).

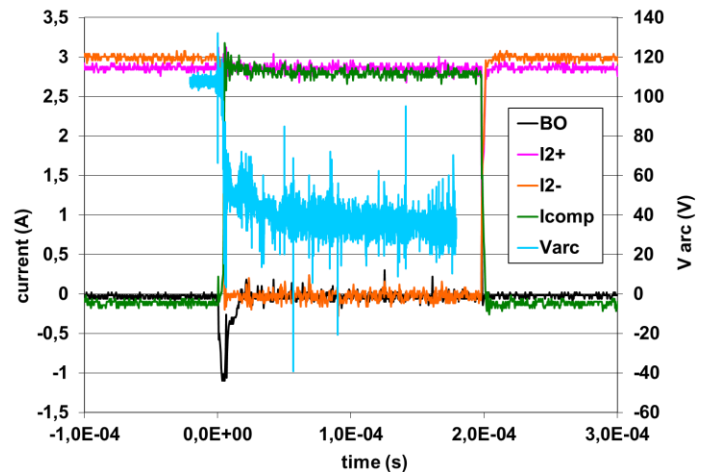
Fig. 11: example of currents and arc voltage values during a TSA on an aged Tefzel cable

Fig. 11 is an example of currents and arc voltage measured during a TSA. Blow-off duration is always about $20\mu s$ and secondary voltage is quite stable after $50\mu s$.

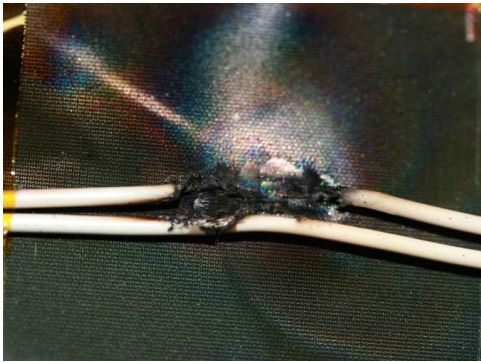
Fig. 12: pristine Tefzel cable after PSA

Fig. 12, Fig. 13 and Fig. 14 are pictures of the cables after PSA. As we can see, the dielectric is burnt around the secondary arc location but there is no propagation of the arc, known as “arc tracking”, during the few seconds of arc duration.

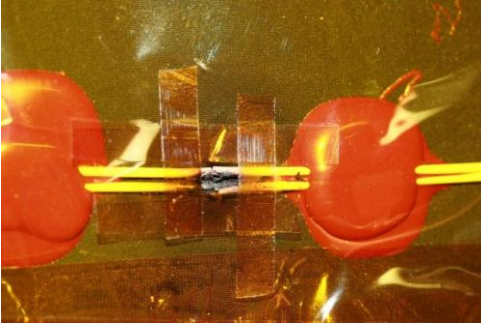
Fig. 13: aged Tefzel cable after PSA

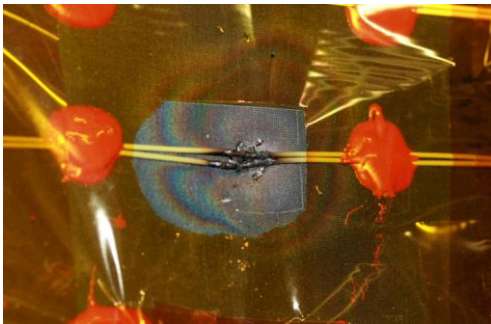
Fig. 14: Kapton cable after PSA

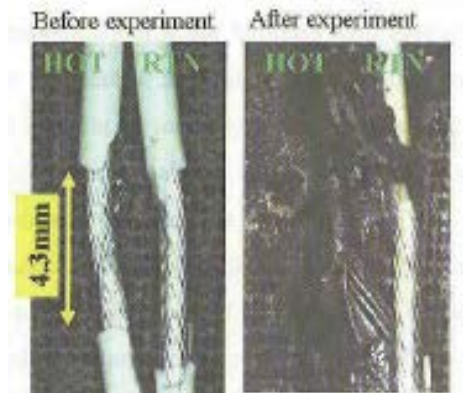
Figure 12: Photographs of before and after sustained arc

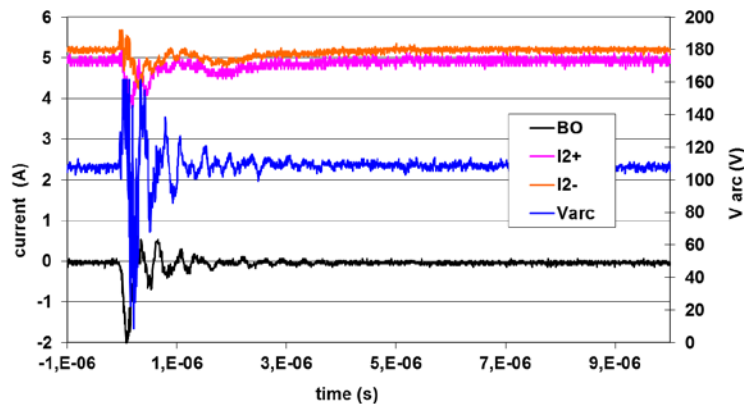
The flashover plasma is not enough dense to provoke a secondary arc when it passes over the cracks

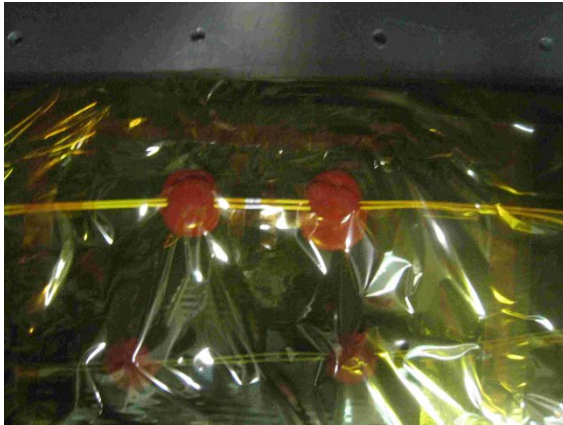
CFRP covered with Kapton film

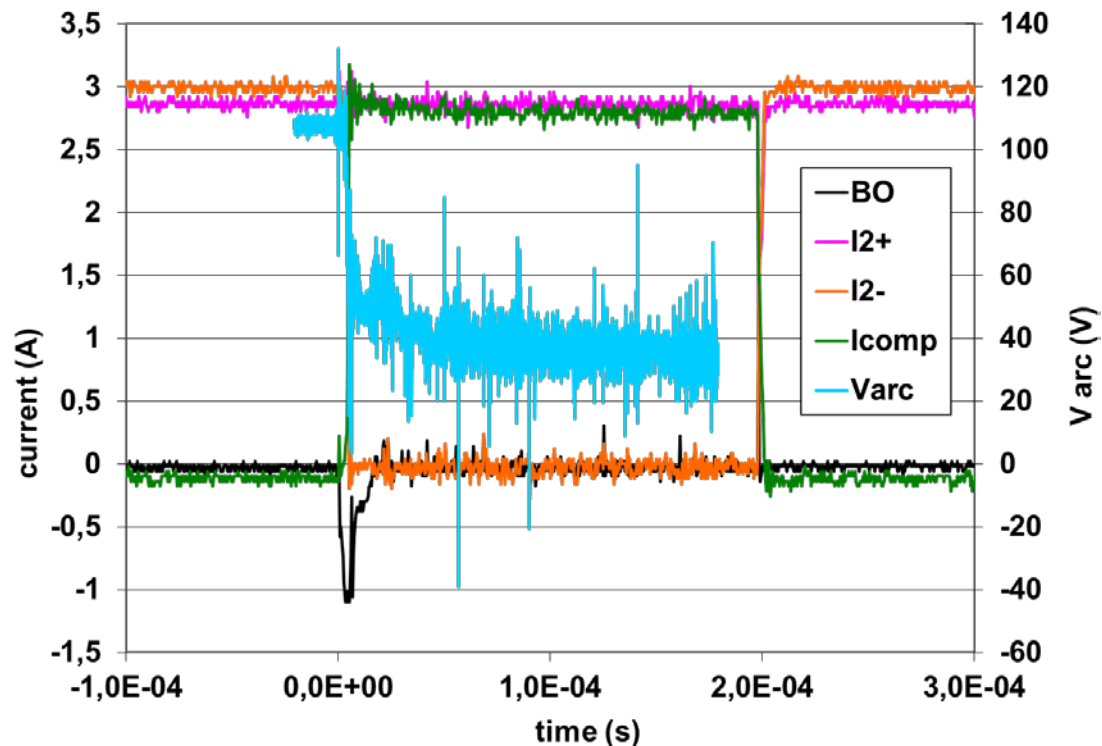
Example of current and arc voltage values during a TSA:

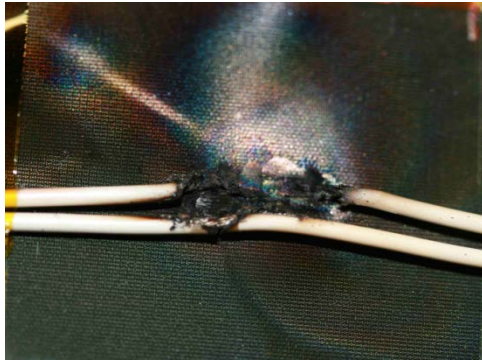
pristine Tefzel

Picture of cables after PSA:
