Investigation of damage mechanisms in 3D interlock textile composites under low velocity soft impact loading

INVESTIGATION OF DAMAGE MECHANISMS IN 3D INTERLOCK TEXTILE COMPOSITES UNDER LOW VELOCITY SOFT IMPACT LOADING

F. Dau^{1*}, M.-L. Dano², Y. Duplessis-Kergomard¹

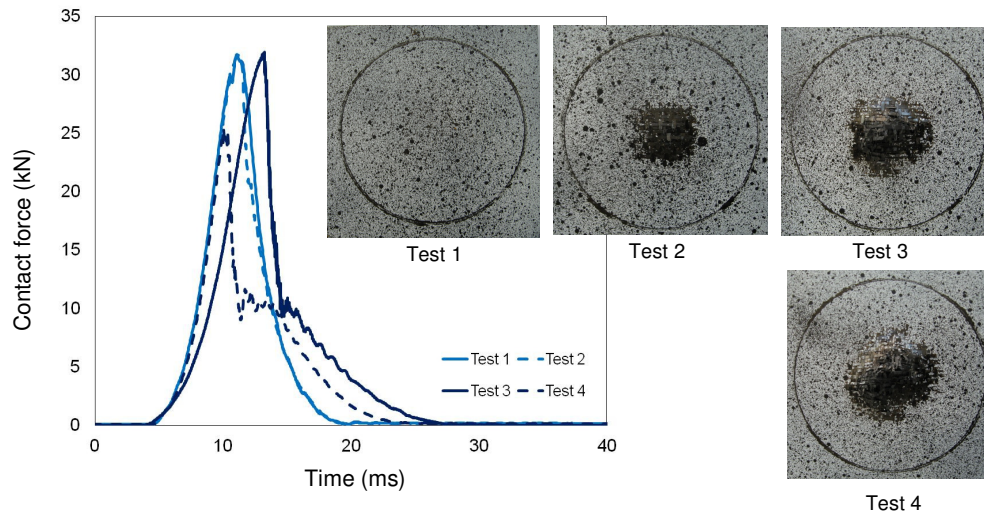
Figure 6. Contact force versus time at 272 J (Interlock 3X 55% woven composite)

The force-time curves obtained for the four tests are presented in Figure 6. The curves for tests 1 and 2 have a rather smooth bell shape which indicates that a low level of damage occurred. The first part of the curves for tests 3 and 4 are smooth but after the peak oscillations reveal that severe damage has occurred. Note that the slopes of the curves are identical before the peak for tests 1, 2 and 4. The different slope observed for test 3 is not yet explained. Pictures of the back side of the plates are shown in the figure. Plate of test 1 has no external visible damage whereas plate of test 2 is clearly damaged on the back side. However, the force-time curves are identical for the two plates. Plates of tests 3 and 4 have been so severely damaged that they have perforated.

from the experimental data. This value is the same as the theoretical one. However, for test 3, the slope is much lower and corresponds to a speed equal to 3.98 m/s at point A. Reason for this deviation is unknown. It explains that the force-time curve for test 3 does not follow the same trend as for the other tests. Results for this test are therefore not considered for further discussion. Looking at the carriage displacement curve for the three other tests, one can note that the carriage rebounds from the specimen at different speeds. The more the plate is damaged, the lower the speed of the carriage is and the longer the contact time between the impactor and the plate is. In addition, note that the maximum carriage displacement is nearly the same for every test.
