FATIGUE DAMAGE INVESTIGATION OF PA66/GF30 BY X-RAY MICROTOMOGRAPHY

M.F. Arif^a, F. Meraghni^{a*}, N. Saintier^b, Y. Chemisky^a, J. Fitoussi^c, G. Robert^d

Keywords: Micro-computed tomography, damage mechanisms, fatigue, injection molding.

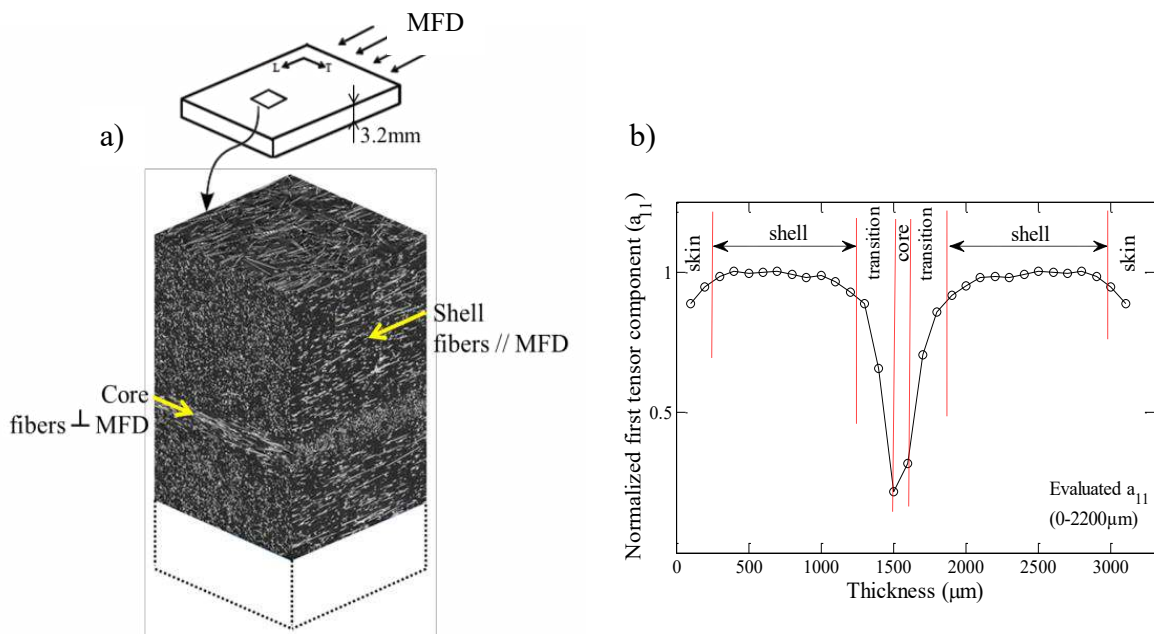
Figure 1. Microstructure formation of PA66/GF30; a) fiber orientation description by μCT , and b) normalized fiber orientation tensor. (MFD = mold flow direction)

Due to the injection process, PA66/GF30 has a skin-shell-transition-core microstructure as shown in Fig. 1. It can be seen that the shell layers, with preferential fiber orientation parallel to the mold flow direction (MFD), are the most dominant ones. Thin core layer is developed and mostly fibers in this layer are oriented transversely to the MFD. Additionally, thin skin layers at the upper and lower specimen surfaces, and the shell-core transition layers are also developed. For further description of PA66/GF30 microstructure, readers can refer to [4,5].

Specimens for fatigue damage characterization were machined in longitudinal direction with respect to the MFD from the rectangular plate produced by injection molding. This extraction condition results in the average fiber orientation in the shell (and *core*) layer that is parallel (and *perpendicular*) to the applied fatigue loading direction.

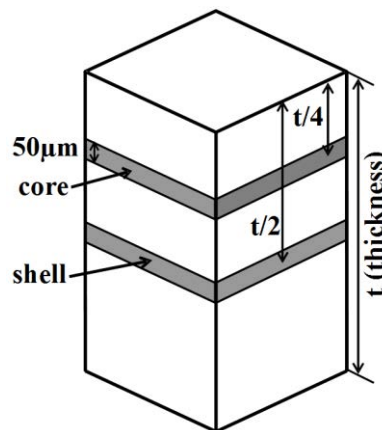
Figure 2. Description of the analyzed μ CT volumes in the shell and core layer of the composite.

In this work, the void features; the aspect ratio, volume and Euler orientation angle are analyzed. To reduce the number of analyzed voids and to establish a consistent comparison between the void features in the shell and core layer, the evaluation of void characteristics has been performed in a 50 μ m volume slice of the shell and core layer of the μ CT volume, as described in Fig. 2.

The evolution of the void volume and void aspect ratio with respect to the void orientation angle and number of cycles in the representative μ CT volume of the shell and core layer, as described in Fig. 2, are then analyzed. Examining together the void volume and void aspect ratio is important to comprehend both the size and the anisotropic behavior of the voids in relation to their orientation angle and number of cycles. It should be noted that our segmentation technique may lead to a connection of adjacent voids to be detected as a single object. This could result in an improper analysis of the void orientation angle. To avoid this, a separation algorithm was implemented so that the connected voids can be separated into many individual objects. However, while this technique leads to a reliable analysis of void orientation angle, the separation algorithm also generates small voids to be detected as independent objects, notably the ones with small void volumes and void aspect ratio.

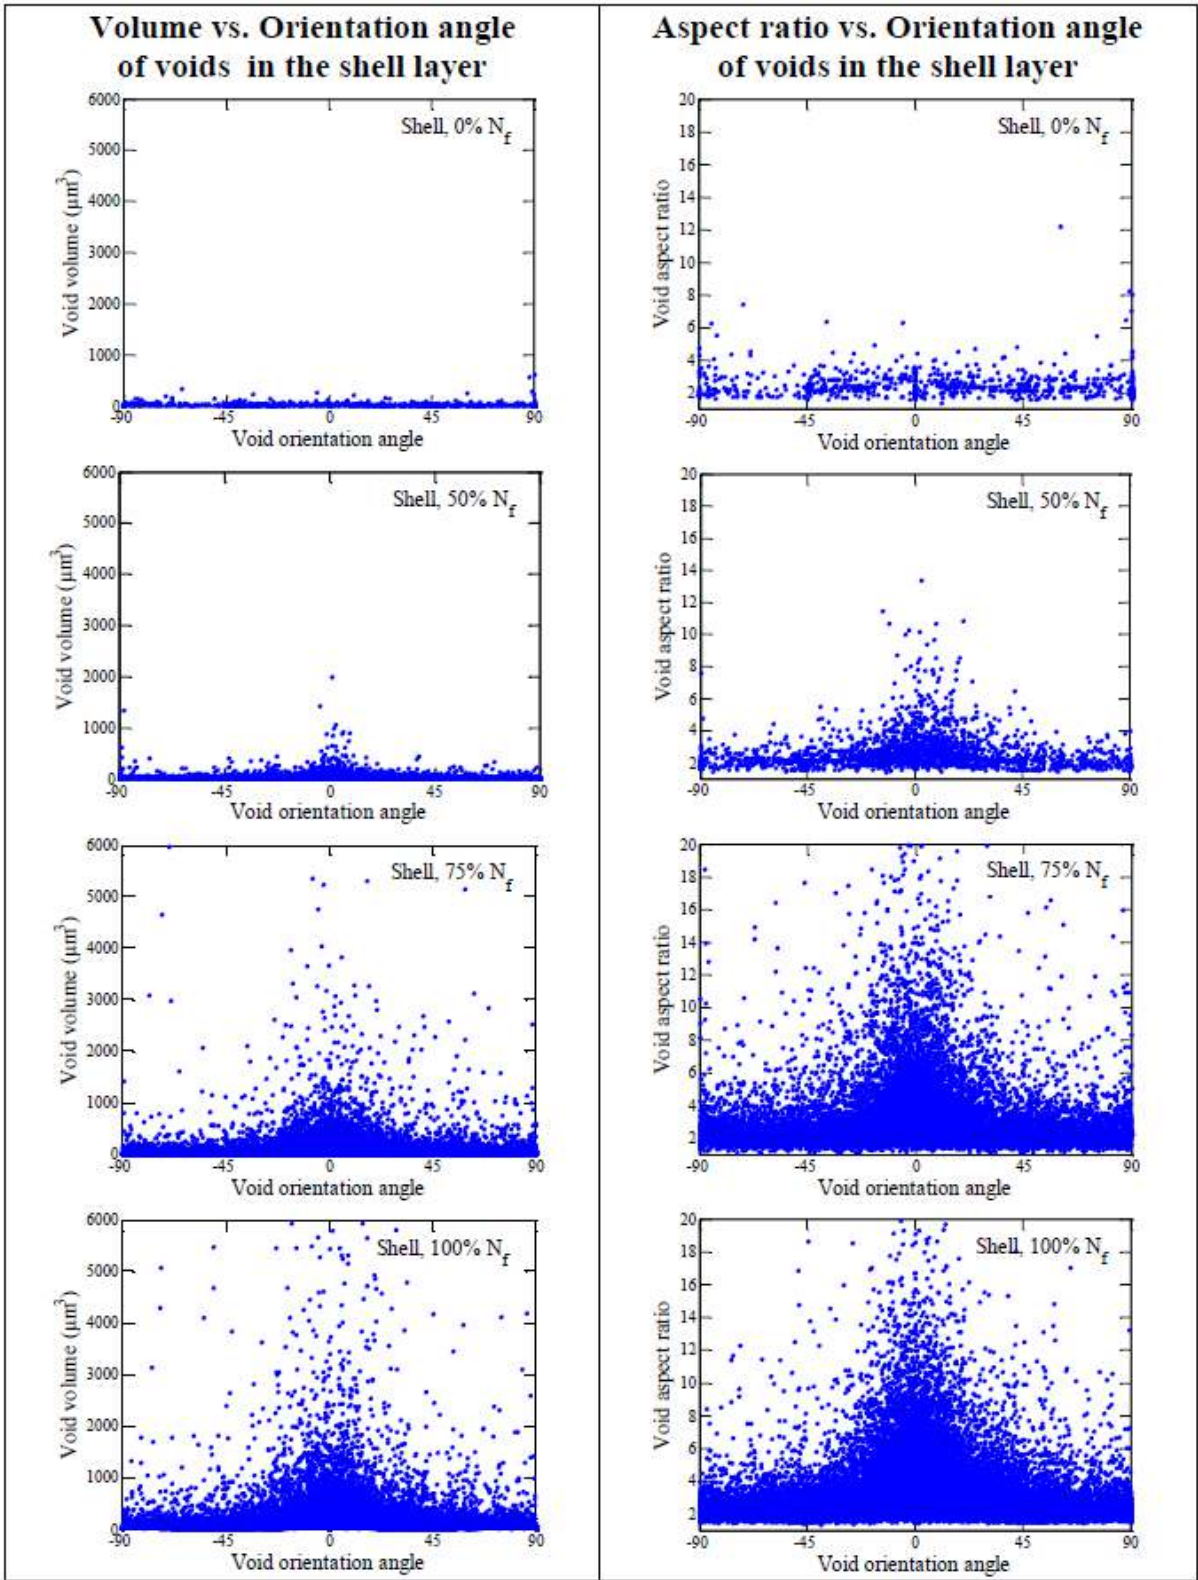
Figure 4. Graphs of void volume vs. void orientation angle (*left*) and void aspect ratio vs. void orientation angle (*right*) of the representative μCT volume of **the shell layer** of the specimens fatigue loaded up to different percentage of fatigue life (N_f). The 0° void orientation angle represents the orientation parallel to the MFD and the applied fatigue loading.

Fig. 4 illustrates the evolution of void volume and void aspect ratio with respect to the void orientation angle and number of cycles at the shell layer of specimens fatigue loaded up to different percentages of fatigue life. The figure clearly demonstrates that the void volume increases as the percentage of fatigue life increases. It is worth noticing that voids with low volumes are also observed in the virgin sample, which could be due to the real initial damage

or due to the image artifact. As the percentage of fatigue life increases, the voids with high volume are oriented mainly at around 0° , longitudinal to the fiber orientation as well as to the applied fatigue load direction. The largest void volume evolution is situated at this orientation angle. By visual verification in the rendered μ CT volume, as shown in Fig. 3, it was shown that these high void volumes are all situated along the fiber matrix interface. It can be concluded that the damage is mainly in the form of fiber/matrix interfacial debonding.

Moreover, one can see that the voids with low volumes at orientation angle around $\pm 45^\circ - 90^\circ$ are also slightly increases as the percentage of fatigue life increases. In fact, these voids are also mainly situated along fiber matrix interface. However, these small voids do not follow the fiber orientation angle due to the separation algorithm applied during image processing, as discussed above. Many small void volumes are also situated at fiber ends and in the matrix, which could be due to the image artifacts, or due to the real damage in the form of fiber/matrix interfacial debonding at fiber ends and matrix microcracks.

The evolution of void aspect ratio at the shell layer has also been analyzed (Fig. 4). The void aspect ratio can be used to study the anisotropy degree of the voids, as well as to strengthen the analysis on void volume evolution. One can see from Fig. 4 that the void aspect ratio of voids oriented at around 0° increases as the percentage of fatigue life increases. This evolution is the same as the trend of the void volume which means that the voids enlarges and elongates mainly along fiber interface as the percentage of fatigue life increases.

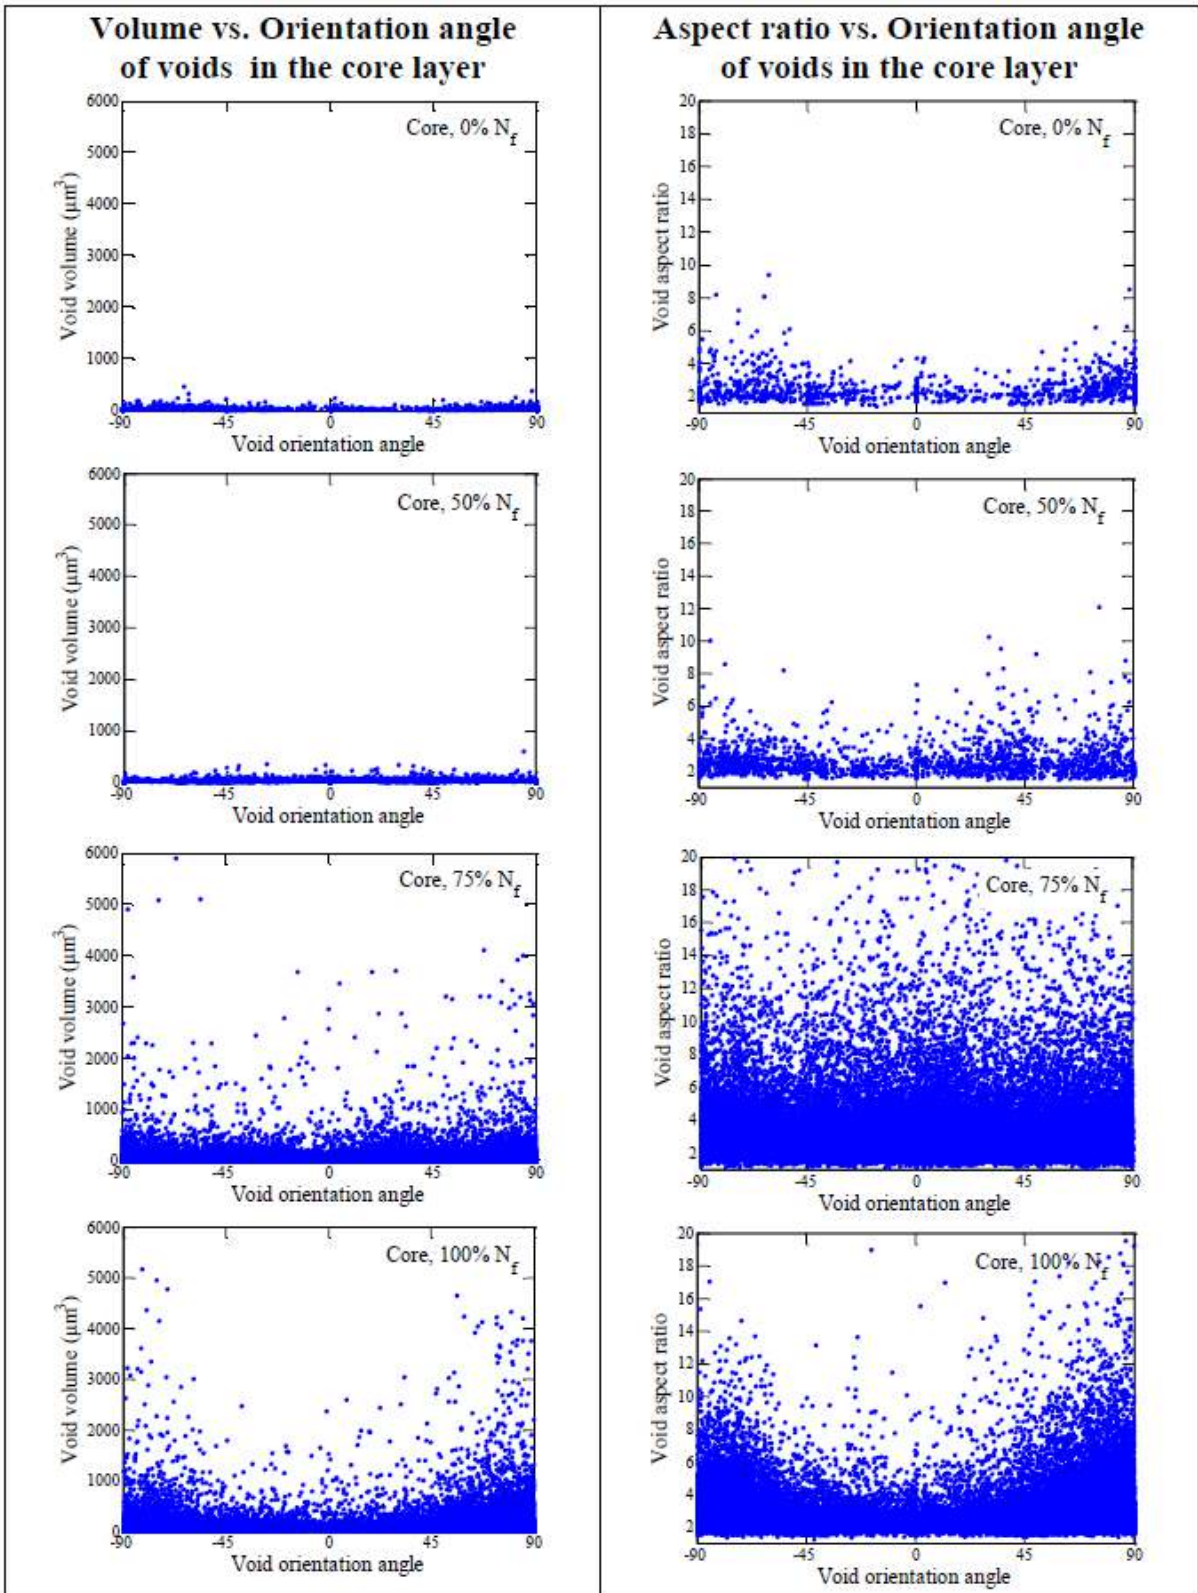
Figure 5. Graphs of void volume vs. void orientation angle (*left*) and void aspect ratio vs. void orientation angle (*right*) of the representative μCT volume of **the core layer** of the specimens fatigue loaded up to different percentage of fatigue life (N_f). The 0° void orientation angle represents the orientation parallel to the MFD and the applied fatigue loading.

The evolution of void volume and void aspect ratio with respect to the void orientation angle and number of cycles at the core layer is then analyzed. As seen in Fig. 5, obvious increase of void volume is only remarked at 75% and 100% of fatigue life. It should be noted that the thin core layer for the specimens used in the current study doesn't impart an active role on the load transfer due to its perpendicular configuration with respect to the applied fatigue loading direction. Due to this reason, the voids are only significant at 75% and 100% of fatigue life. At 75% of fatigue life, voids are mainly situated along the fiber interface. However, these voids have no tendency to be oriented into a certain orientation angle. This is affirmed by the trend of void aspect ratio which shows a highly varying aspect ratio without any preferential void orientation. As the number of cycles increases, the void volume increases and elongates along the fiber interface. Therefore, at 100% of fatigue life, voids with high volume and aspect ratio are oriented at around 90° , parallel to the principal fiber orientation of the core layer but perpendicular to the applied fatigue loading direction.
