FATIGUE DAMAGE INVESTIGATION OF PA66/GF30 BY X-RAY MICROTOMOGRAPHY

M.F. Arif^a, F. Meraghni^{a*}, N. Saintier^b, Y. Chemisky^a, J. Fitoussi^c, G. Robert^d

Keywords: Micro-computed tomography, damage mechanisms, fatigue, injection molding.

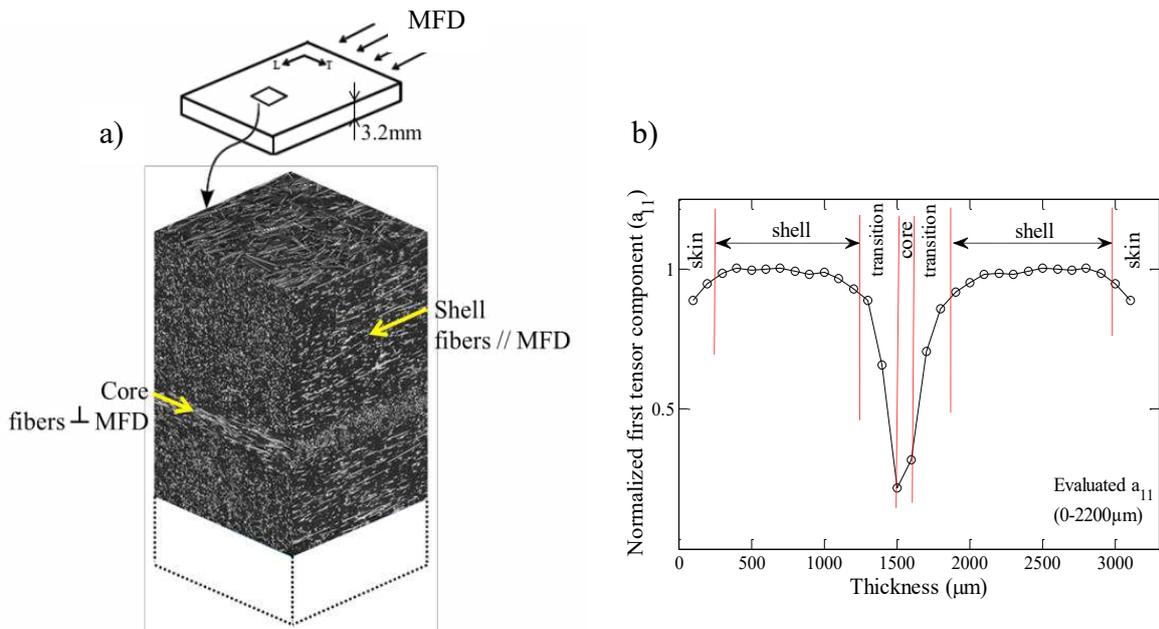
Figure 1. Microstructure formation of PA66/GF30; a) fiber orientation description by μCT , and b) normalized fiber orientation tensor. (MFD = mold flow direction)

Due to the injection process, PA66/GF30 has a skin-shell-transition-core microstructure as shown in Fig. 1. It can be seen that the shell layers, with preferential fiber orientation parallel to the mold flow direction (MFD), are the most dominant ones. Thin core layer is developed and mostly fibers in this layer are oriented transversely to the MFD. Additionally, thin skin layers at the upper and lower specimen surfaces, and the shell-core transition layers are also developed. For further description of PA66/GF30 microstructure, readers can refer to [4,5].

Specimens for fatigue damage characterization were machined in longitudinal direction with respect to the MFD from the rectangular plate produced by injection molding. This extraction condition results in the average fiber orientation in the shell (and *core*) layer that is parallel (and *perpendicular*) to the applied fatigue loading direction.

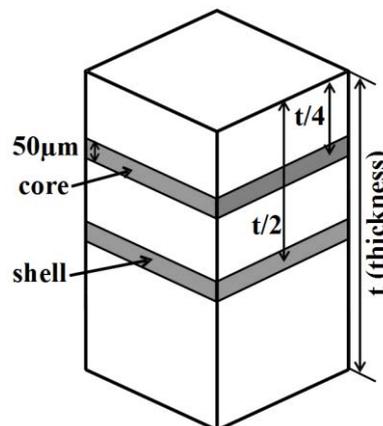
Figure 2. Description of the analyzed μ CT volumes in the shell and core layer of the composite.

In this work, the void features; the aspect ratio, volume and Euler orientation angle are analyzed. To reduce the number of analyzed voids and to establish a consistent comparison between the void features in the shell and core layer, the evaluation of void characteristics has been performed in a 50 μ m volume slice of the shell and core layer of the μ CT volume, as described in Fig. 2.

The evolution of the void volume and void aspect ratio with respect to the void orientation angle and number of cycles in the representative μ CT volume of the shell and core layer, as described in Fig. 2, are then analyzed. Examining together the void volume and void aspect ratio is important to comprehend both the size and the anisotropic behavior of the voids in relation to their orientation angle and number of cycles. It should be noted that our segmentation technique may lead to a connection of adjacent voids to be detected as a single object. This could result in an improper analysis of the void orientation angle. To avoid this, a separation algorithm was implemented so that the connected voids can be separated into many individual objects. However, while this technique leads to a reliable analysis of void orientation angle, the separation algorithm also generates small voids to be detected as independent objects, notably the ones with small void volumes and void aspect ratio.

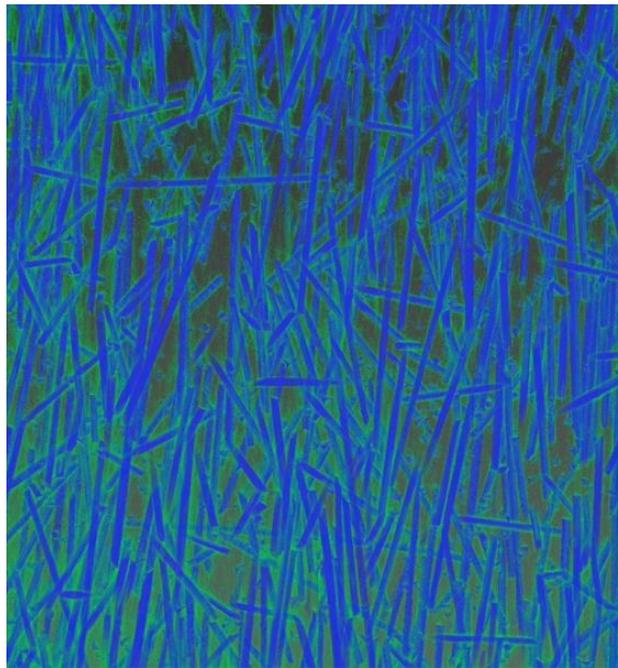
Figure 3. Rendered μ CT image of fatigue loaded specimen which shows damage in the form of fiber/matrix interfacial debonding. The blue (and *green*) color represents the fiber (and *damage*).

To build a more consistent analysis on damage mechanisms of PA66/GF30, segmentation process which involves separation of the composites' phases (fiber, matrix and damage) has been carried out. Fig. 3 shows the rendered μ CT image representing the damage and fibers. One can see that the fiber/matrix interfacial debonding is frequently observed in the fatigue loaded composites. Therefore, this interfacial debonding can be considered as the main fatigue damage mechanisms in dry PA66/GF30.

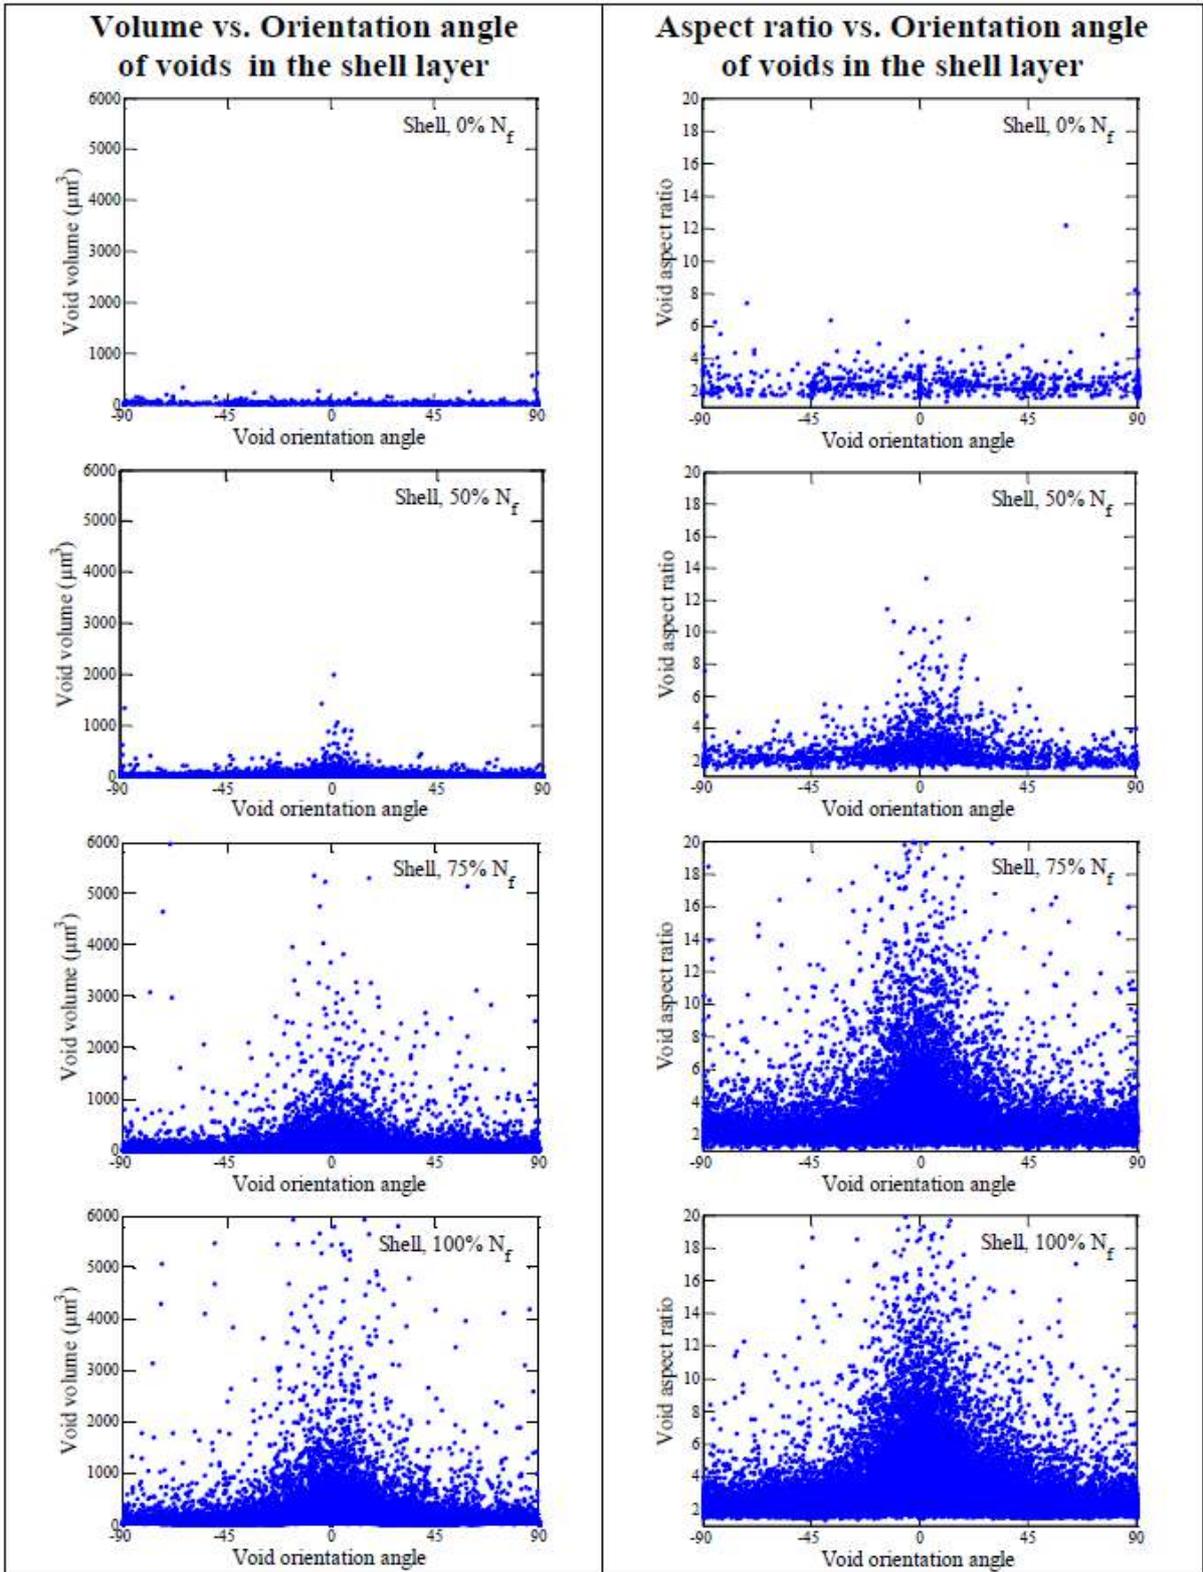
Figure 4. Graphs of void volume vs. void orientation angle (*left*) and void aspect ratio vs. void orientation angle (*right*) of the representative μCT volume of **the shell layer** of the specimens fatigue loaded up to different percentage of fatigue life (N_f). The 0° void orientation angle represents the orientation parallel to the MFD and the applied fatigue loading.

Fig. 4 illustrates the evolution of void volume and void aspect ratio with respect to the void orientation angle and number of cycles at the shell layer of specimens fatigue loaded up to different percentages of fatigue life. The figure clearly demonstrates that the void volume increases as the percentage of fatigue life increases. It is worth noticing that voids with low volumes are also observed in the virgin sample, which could be due to the real initial damage

or due to the image artifact. As the percentage of fatigue life increases, the voids with high volume are oriented mainly at around 0° , longitudinal to the fiber orientation as well as to the applied fatigue load direction. The largest void volume evolution is situated at this orientation angle. By visual verification in the rendered μ CT volume, as shown in Fig. 3, it was shown that these high void volumes are all situated along the fiber matrix interface. It can be concluded that the damage is mainly in the form of fiber/matrix interfacial debonding.

Moreover, one can see that the voids with low volumes at orientation angle around $\pm 45^\circ - 90^\circ$ are also slightly increases as the percentage of fatigue life increases. In fact, these voids are also mainly situated along fiber matrix interface. However, these small voids do not follow the fiber orientation angle due to the separation algorithm applied during image processing, as discussed above. Many small void volumes are also situated at fiber ends and in the matrix, which could be due to the image artifacts, or due to the real damage in the form of fiber/matrix interfacial debonding at fiber ends and matrix microcracks.

The evolution of void aspect ratio at the shell layer has also been analyzed (Fig. 4). The void aspect ratio can be used to study the anisotropy degree of the voids, as well as to strengthen the analysis on void volume evolution. One can see from Fig. 4 that the void aspect ratio of voids oriented at around 0° increases as the percentage of fatigue life increases. This evolution is the same as the trend of the void volume which means that the voids enlarges and elongates mainly along fiber interface as the percentage of fatigue life increases.

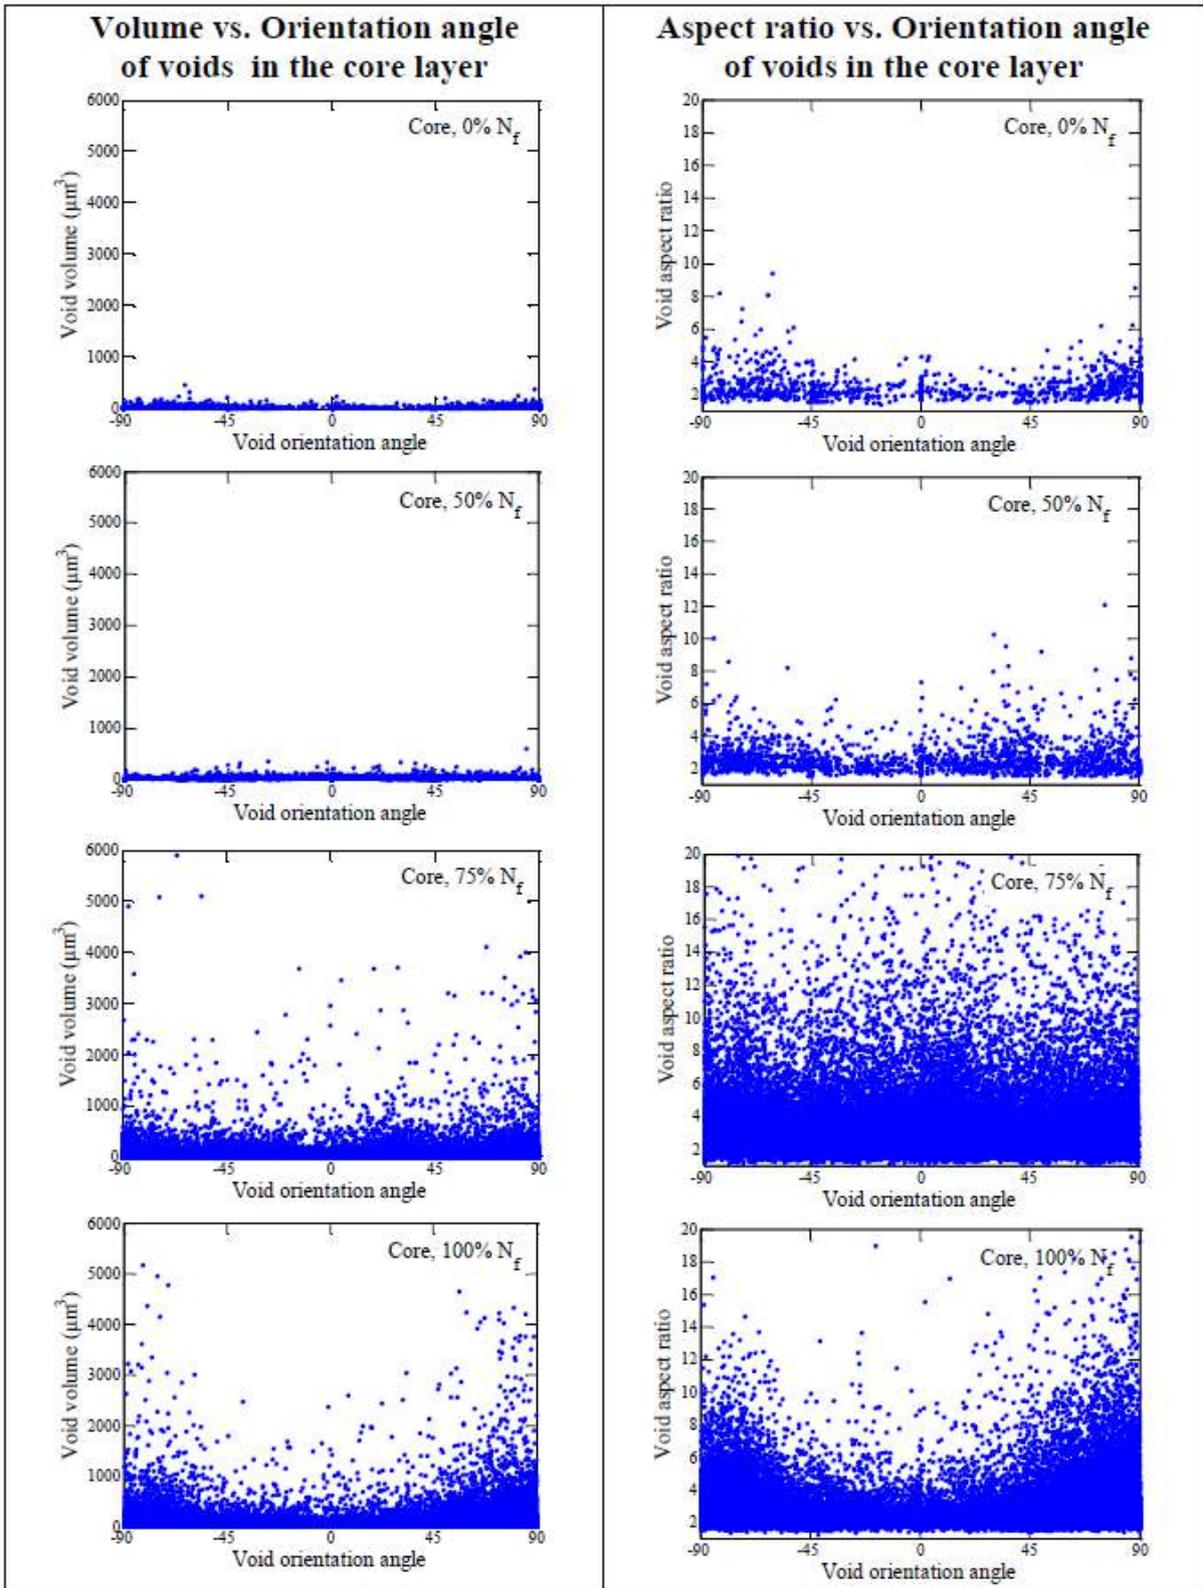
Figure 5. Graphs of void volume vs. void orientation angle (*left*) and void aspect ratio vs. void orientation angle (*right*) of the representative μCT volume of **the core layer** of the specimens fatigue loaded up to different percentage of fatigue life (N_f). The 0° void orientation angle represents the orientation parallel to the MFD and the applied fatigue loading.

The evolution of void volume and void aspect ratio with respect to the void orientation angle and number of cycles at the core layer is then analyzed. As seen in Fig. 5, obvious increase of void volume is only remarked at 75% and 100% of fatigue life. It should be noted that the thin core layer for the specimens used in the current study doesn't impart an active role on the load transfer due to its perpendicular configuration with respect to the applied fatigue loading direction. Due to this reason, the voids are only significant at 75% and 100% of fatigue life. At 75% of fatigue life, voids are mainly situated along the fiber interface. However, these voids have no tendency to be oriented into a certain orientation angle. This is affirmed by the trend of void aspect ratio which shows a highly varying aspect ratio without any preferential void orientation. As the number of cycles increases, the void volume increases and elongates along the fiber interface. Therefore, at 100% of fatigue life, voids with high volume and aspect ratio are oriented at around 90° , parallel to the principal fiber orientation of the core layer but perpendicular to the applied fatigue loading direction.
