Fatigue damage investigation of PA66/GF30 by X-Ray microtomography

FATIGUE DAMAGE INVESTIGATION OF PA66/GF30 BY X-RAY MICROTOMOGRAPHY

Keywords: Micro-computed tomography, damage mechanisms, fatigue, injection molding.

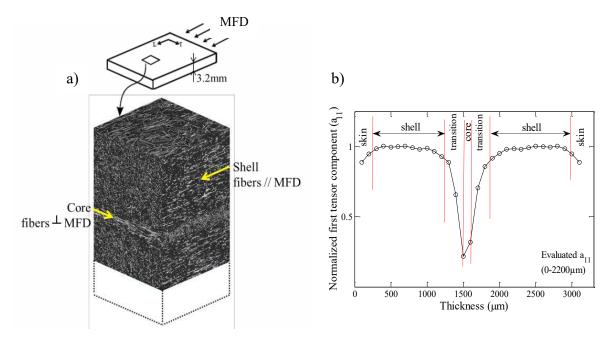
Figure 1. Microstructure formation of PA66/GF30; a) fiber orientation description by μ CT, and b) normalized fiber orientation tensor. (MFD = mold flow direction)

Due to the injection process, PA66/GF30 has a skin-shell-transition-core microstructure as shown in Fig. 1. It can be seen that the shell layers, with preferential fiber orientation parallel to the mold flow direction (MFD), are the most dominant ones. Thin core layer is developed and mostly fibers in this layer are oriented transversely to the MFD. Additionally, thin skin layers at the upper and lower specimen surfaces, and the shell-core transition layers are also developed. For further description of PA66/GF30 microstructure, readers can refer to [4,5].

Specimens for fatigue damage characterization were machined in longitudinal direction with respect to the MFD from the rectangular plate produced by injection molding. This extraction condition results in the average fiber orientation in the shell (and *core*) layer that is parallel (and *perpendicular*) to the applied fatigue loading direction.

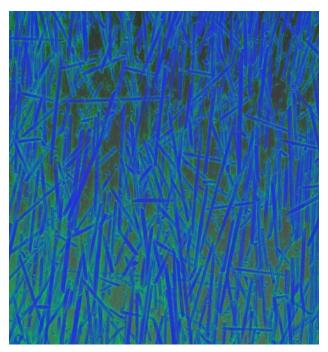
Figure 3. Rendered μ CT image of fatigue loaded specimen which shows damage in the form of fiber/matrix interfacial debonding. The blue (and *green*) color represents the fiber (and *damage*).

To build a more consistent analysis on damage mechanisms of PA66/GF30, segmentation process which involves separation of the composites' phases (fiber, matrix and damage) has been carried out. Fig. 3 shows the rendered μ CT image representing the damage and fibers. One can see that the fiber/matrix interfacial debonding is frequently observed in the fatigue loaded composites. Therefore, this interfacial debonding can be considered as the main fatigue damage mechanisms in dry PA66/GF30.

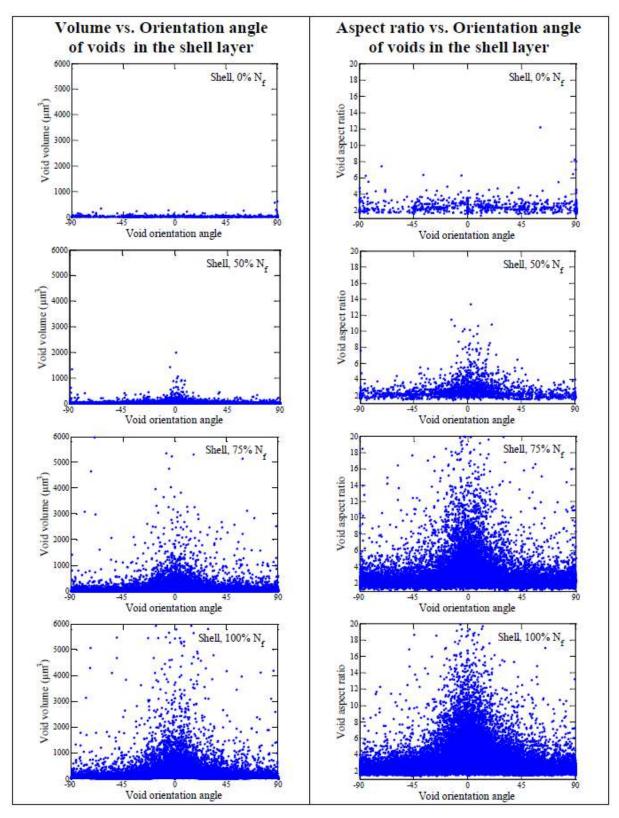
Figure 4. Graphs of void volume vs. void orientation angle *(left)* and void aspect ratio vs. void orientation angle *(right)* of the representative μ CT volume of **the shell layer** of the specimens fatigue loaded up to different percentage of fatigue life (N_f) . The 0° void orientation angle represents the orientation parallel to the MFD and the applied fatigue loading.

Fig. 4 illustrates the evolution of void volume and void aspect ratio with respect to the void orientation angle and number of cycles at the shell layer of specimens fatigue loaded up to different percentages of fatigue life. The figure clearly demonstrates that the void volume increases as the percentage of fatigue life increases. It is worth noticing that voids with low volumes are also observed in the virgin sample, which could be due to the real initial damage

or due to the image artifact. As the percentage of fatigue life increases, the voids with high volume are oriented mainly at around 0° , longitudinal to the fiber orientation as well as to the applied fatigue load direction. The largest void volume evolution is situated at this orientation angle. By visual verification in the rendered μ CT volume, as shown in Fig. 3, it was shown that these high void volumes are all situated along the fiber matrix interface. It can be concluded that the damage is mainly in the form of fiber/matrix interfacial debonding.

Moreover, one can see that the voids with low volumes at orientation angle around $\pm 45^{\circ} - 90^{\circ}$ are also slightly increases as the percentage of fatigue life increases. In fact, these voids are also mainly situated along fiber matrix interface. However, these small voids do not follow the fiber orientation angle due to the separation algorithm applied during image processing, as discussed above. Many small void volumes are also situated at fiber ends and in the matrix, which could be due to the image artifacts, or due to the real damage in the form of fiber/matrix interfacial debonding at fiber ends and matrix microcracks.

The evolution of void aspect ratio at the shell layer has also been analyzed (Fig. 4). The void aspect ratio can be used to study the anisotropy degree of the voids, as well as to strengthen the analysis on void volume evolution. One can see from Fig. 4 that the void aspect ratio of voids oriented at around 0° increases as the percentage of fatigue life increases. This evolution is the same as the trend of the void volume which means that the voids enlarges and elongates mainly along fiber interface as the percentage of fatigue life increases.

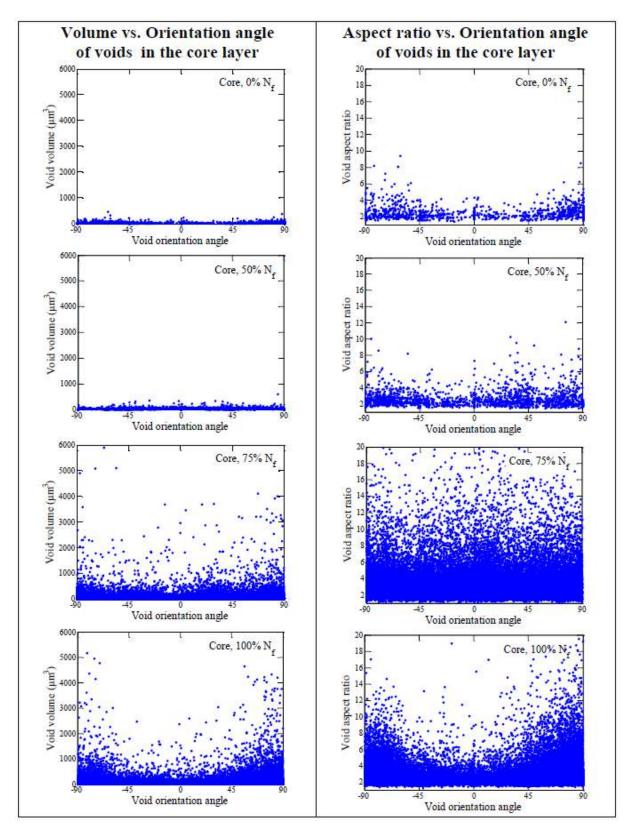
Figure 5. Graphs of void volume vs. void orientation angle *(left)* and void aspect ratio vs. void orientation angle *(right)* of the representative μ CT volume of **the core layer** of the specimens fatigue loaded up to different percentage of fatigue life (N_f). The 0° void orientation angle represents the orientation parallel to the MFD and the applied fatigue loading.

The evolution of void volume and void aspect ratio with respect to the void orientation angle and number of cycles at the core layer is then analyzed. As seen in Fig. 5, obvious increase of void volume is only remarked at 75% and 100% of fatigue life. It should be noted that the thin core layer for the specimens used in the current study doesn't impart an active role on the load transfer due to its perpendicular configuration with respect to the applied fatigue loading direction. Due to this reason, the voids are only significant at 75% and 100% of fatigue life. At 75% of fatigue life, voids are mainly situated along the fiber interface. However, these voids have no tendency to be oriented into a certain orientation angle. This is affirmed by the trend of void aspect ratio which shows a highly varying aspect ratio without any preferential void orientation. As the number of cycles increases, the void volume increases and elongates along the fiber interface. Therefore, at 100% of fatigue life, voids with high volume and aspect ratio are oriented at around 90°, parallel to the principal fiber orientation of the core layer but perpendicular to the applied fatigue loading direction.
