Failure Mechanisms of Plasterboard in Nail Pull Test Determined by X-ray Microtomography and Digital Volume Correlation

Amine Bouterf, Jérôme Adrien, Eric Maire, Xavier Brajer, François Hild, Stéphane Roux

1 **Failure mechanisms of plasterboard in nail pull**
2 **test determined by X-ray microtomography and**
3 **digital volume correlation**

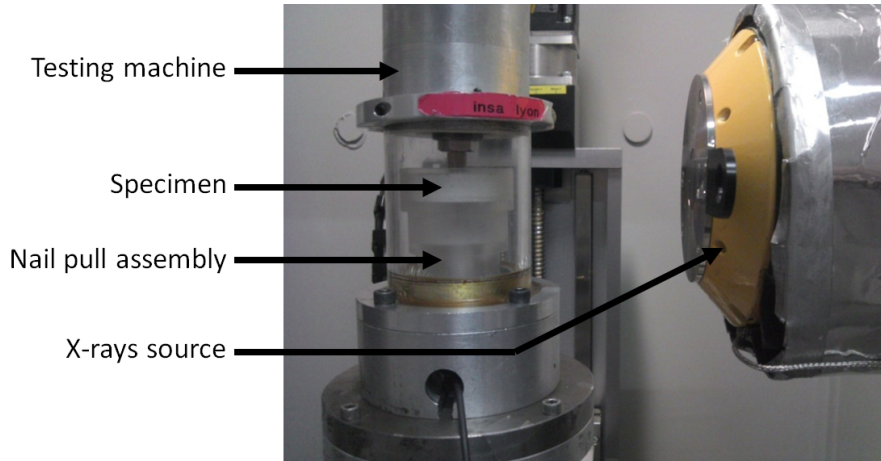
175 to be mounted on the rotary stage of the tomograph. To avoid obstruction of
 176 the X-ray beam by the testing machine during the 360° rotation, the com-
 177 pressive load applied onto the nail head is balanced by a tensile load on a
 178 cylindrical tube that encloses the test (without contact). This hollow cylin-
 179 der is made of PMMA so that the X-ray absorption is low as well as uniform,
 180 regardless of its angular position. The displacement of the upper platen is pro-
 181 vided by a stepping motor controlled by a computer. The latter also records
 182 the load.

Fig. 4. In-situ nail pull test

172 The nail pull assembly (Figure 3 (b)) is positioned in a tension/compression
173 machine inside the tomograph (Figure 4). The test is performed using the test-
174 ing device developed at MATEIS laboratory (INSA de Lyon) [23] and designed

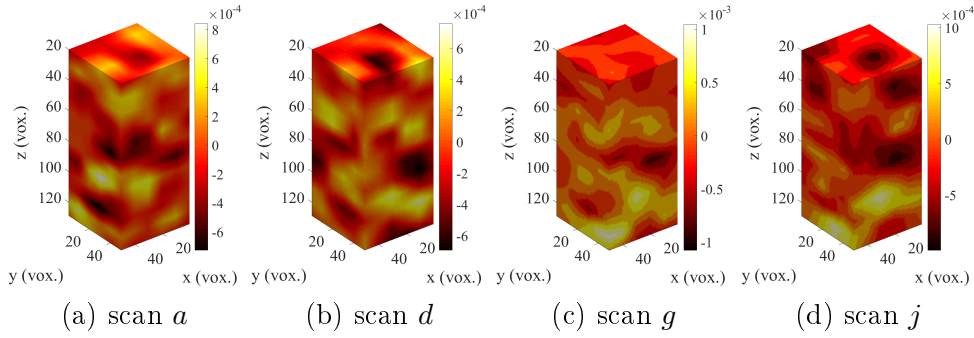
262 To evaluate the measurement resolution, instead of acquiring only one scan
263 in the reference configuration, two scans are acquired without any sample
264 displacement [38]. The DVC code is run on these two scans and any devia-
265 tion from zero is interpreted as representative of the measurement uncertainty
266 associated with the present setup, data acquisition and processing. The stan-
267 dard displacement resolution is of the order of 0.01 voxel for C8 elements of
268 size equal to 10 voxel and a regularization length of 30 voxels. Correspond-
269 ingly, the strain measurement uncertainty, as illustrated in Figure 8(a) for
270 the reference volume, is computed to be of order 10^{-3} . Because of the fact
271 that plaster is brittle, and breaks down for low strains, the elastic deforma-
272 tion will not be resolved in the following. Figure 8(b-d) shows that the strain
273 field outside of the compacted zone cannot be measured as being significantly

274 different from 0. Nevertheless, DVC is useful to show, for instance, that cracks
275 with small opening displacement, which would not be visible directly on the
276 tomographic reconstruction, are not present. This uncertainty level is typical
277 of displacement resolutions associated with reconstructed volumes from com-
278 puted tomography [38]. The root mean square level of the correlation residuals
279 is equal to 9.6 gray levels or 3 % of the overall gray level range.

Fig. 8. (a) 3D renderings of the ϵ_{zz} strain component in the reference configuration measured by RC8-DVC, in order to assess the strain measurement uncertainty. For comparison, a similar plot for the same analyzed ROI located outside of the compacted zone is shown for different stages of loading ((b)-(d)) showing that the strain variation cannot be distinguished from noise. The subvolume analyzed here is located outside the compacted region (in the first quadrant of the global volume)

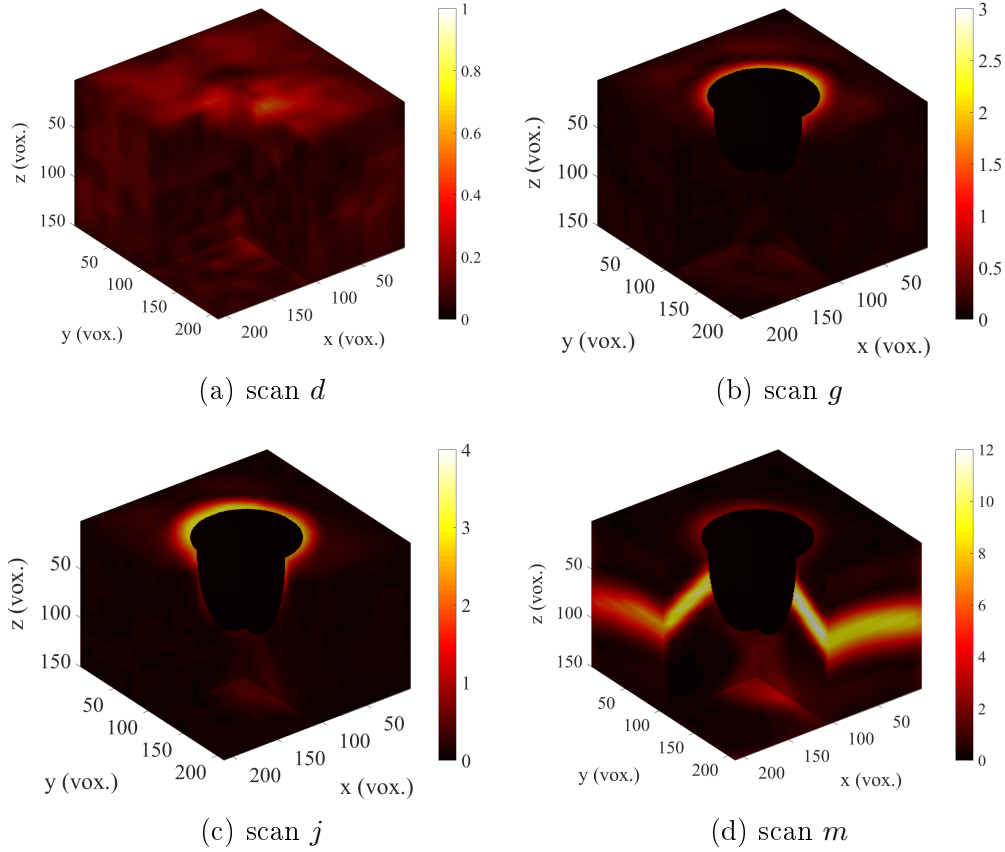
333 Associated with the C8 discretization, the mean Green Lagrange strains are
334 computed over each element [32]. The major positive eigen strain, hereafter
335 termed “equivalent” strain, ϵ_{eq} , is a scalar invariant component that is very

336 suited to reveal crack formation irrespective of their orientation. 3D rendering
 337 of the equivalent strain is shown in Figure 11. As previously discussed, the
 338 crushed region is masked. Outside of it, the amplitude of the equivalent strain
 339 (see Figure 11(a), (b) and (c)) measured by RC8-DVC is very low. Because
 340 it is the largest (positive) eigenstrain, random fluctuations of zero mean will
 341 give rise to a positive mean value for ϵ_{eq} that should not be confused with the
 342 statement that strains (apart from the presence of the final cone crack) are in-
 343 distinguishable from 0. At the last scan, the crack that leads to the breakdown
 344 of the sample can be clearly seen from the apparent strain field (Figure 11(d)).
 345 It is “apparent” because the displacement discontinuity is distributed over the
 346 element size. The crack opening is more easily read from Figure 9(d), although

Fig. 11. 3D renderings of major principal strain ϵ_{eq} in % obtained from DVC results. Because of the value of the correlation residual is high in the compacted area under the head of the nail, this area is hidden in the major principal strain fields
