# Failure Mechanisms of Plasterboard in Nail Pull Test Determined by X-ray Microtomography and Digital Volume Correlation

Amine Bouterf, Jérôme Adrien, Eric Maire, Xavier Brajer, François Hild, Stéphane Roux

Amine Bouterf, Jérôme Adrien, Eric Maire, Xavier Brajer, François Hild, et al.. Failure Mechanisms of Plasterboard in Nail Pull Test Determined by X-ray Microtomography and Digital Volume Correlation. *Experimental Mechanics*, 2016, 56, pp.1427 - 1437. 10.1007/s11340-016-0168-8. hal-01383905

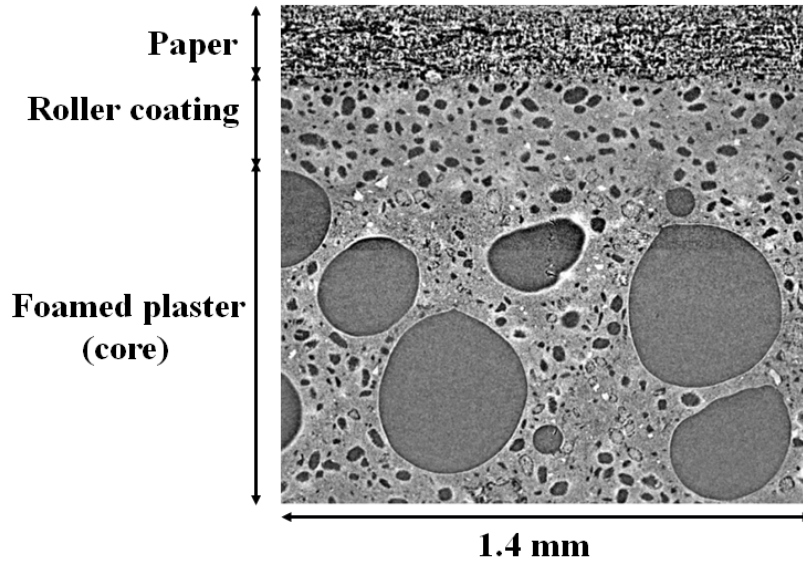
121 Figure 1 shows a slice through a tomographic image volume that reveals the  
122 different components of lightweight plasterboard.

Fig. 1. Main components of lightweight plasterboard revealed thanks to a microtomographic section

123 This scan was acquired at beamline ID19 of the European Synchrotron Radia-  
 124 tion Facility (ESRF, Grenoble, France) at a resolution of 1.4  $\mu\text{m}$ . The studied  
 125 plasterboard has a very high pore volume fraction (about 75%). The higher  
 126 density of the roller coating layer is easily recognized. The microstructure of  
 127 the foam is complex and multi-scale. Well-formed, round pores issued from the  
 128 foam incorporation are observed with diameters ranging from 200 to 500  $\mu\text{m}$ .  
 129 Their surface consists of gypsum micro-crystals lying parallel to the surface.  
 130 The individual gypsum crystals are acicular. Their size is about 0.4  $\mu\text{m}$  in  
 131 width and 5  $\mu\text{m}$  in length. They appear entangled yet they leave a significant  
 132 internal porosity with pore size comparable to that of the micro-crystals.

143 Understanding the failure mechanisms in nail pull tests requires observations  
 144 in the bulk of the material to be performed since no direct information is  
 145 available on the external surfaces of samples. This is possible by resorting to  
 146 X-ray computed tomography [16,17,9]. This technique is particularly appealing  
 147 in the present case since the material is very heterogeneous (Figure 1). Further,  
 148 these analyses can even be more informative when *in-situ* mechanical tests are

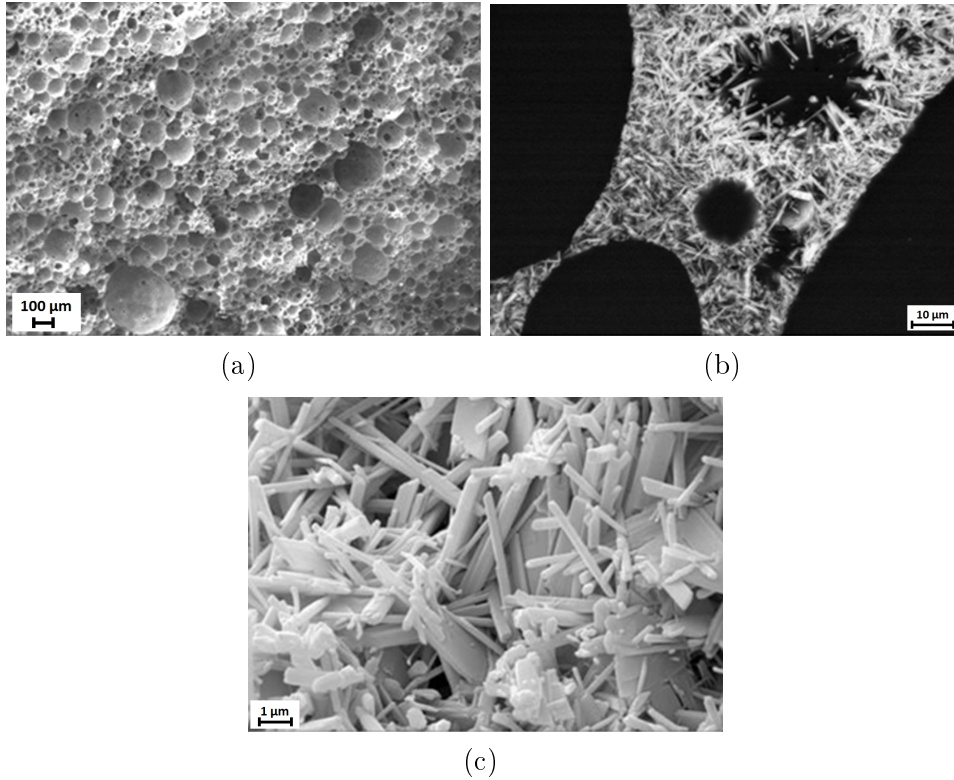
133 Figure 2 shows SEM observations of the studied material. As can be seen in  
 134 Figure 2(a), the material shows a broad range of bubble size, yet most are rel-  
 135 atively large (i.e. few hundredths of micrometers), round shaped, well-spaced  
 136 and rarely interconnected. Figure 2(b) shows that, in addition to the bubbles  
 137 that have smooth boundaries, smaller pores formed during the setting. A late

Fig. 2. SEM pictures of foamed gypsum at different magnifications

138 dissolution and crystallization give rise to a very spiky boundary. At an even  
 139 smaller scale (Figure 2(c)), gypsum crystals are seen to be distributed ho-  
 140 mogeneously, without preferential direction, presenting typical entanglements  
 141 that are known to improve the cohesion and resistance of plaster [14].

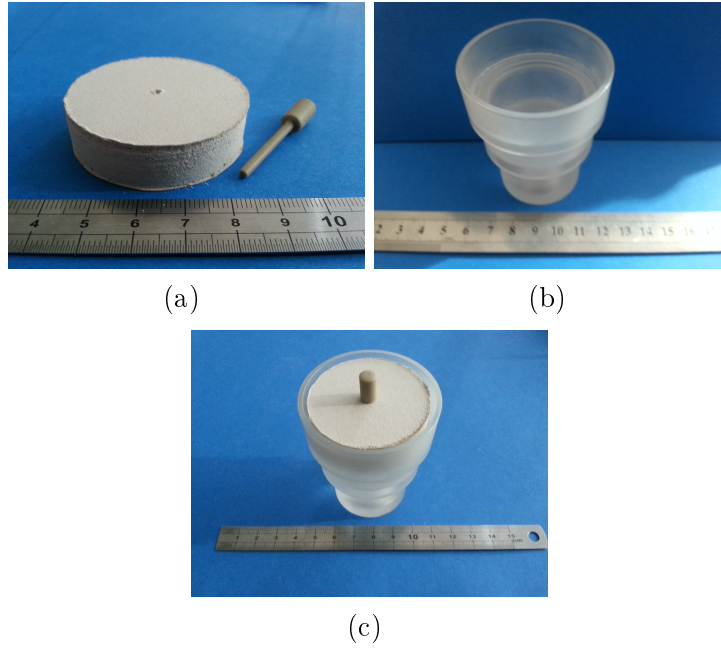
161 The sample used in the reported experiment is prepared from industrial plas-  
162 terboard plates. The specimen is a cylinder 50 mm in diameter and 13 mm  
163 in height. A hole 2.5 mm in diameter is subsequently drilled along its cen-  
164 tral axis (Figure 3(a)). The sample is then put within the nail pull assembly  
165 (Figure 3(b)) made of polymethyl methacrylate (PMMA), which is virtually  
166 transparent to X-rays. The nail is made of polyether ether ketone (PEEK),  
167 which is a semicrystalline thermoplastic with excellent mechanical properties  
168 and has also a low X-ray absorption. The sample is supported over an area of  
169 5 mm around the perimeter of the assembly. Note that the specimen diame-  
170 ter is smaller than specified in the standardized test in order to be properly  
171 imaged in the tomograph.

172 The nail pull assembly (Figure 3 (b)) is positioned in a tension/compression  
173 machine inside the tomograph (Figure 4). The test is performed using the test-  
174 ing device developed at MATEIS laboratory (INSA de Lyon) [23] and designed

Fig. 3. In-situ nail pull setup consisting of a plasterboard circular disk through which a hole has been drilled along the central axis and a PEEK nail (a), a PMMA support (b). Once the disk has been mounted in the PMMA support, the nail head can be pushed through the specimen by an external actuator (c)

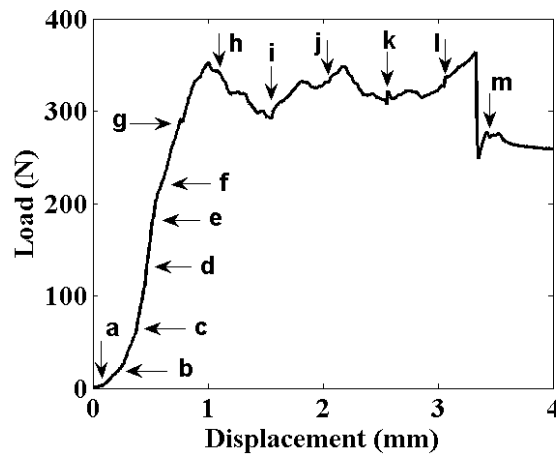
183 The nail pull test consisted of pushing the head of the nail into the sample, un-  
 184 til failure, with a velocity of  $5 \mu\text{m/s}$ . The load-displacement curve was recorded  
 185 during the test (Figure 5). In the first part of the test, the sample was imaged  
 186 at the initial state (i.e. without load) and then at 25 N of loading. Increments  
 187 of approximately 50 N were applied until the load reached the plateau value

Fig. 5. Load-displacement curve of the test with 13 scans

188 ( $\approx 350$  N in the present case, see Figure 5). Then 0.5 mm displacement in-  
 189 crements were applied. After each step, the crosshead was stopped and scans  
 190 were acquired after a dwell time (about 20 minutes) to prevent blur caused by  
 191 the relaxation of the sample and the setup during the scan time. The sample  
 192 was imaged in its initial state (i.e. without load) and at different steps of the  
 193 experiment. In total, thirteen scans were acquired.

289 Figure 9(a), i.e. state *d*, shows the displacement fields measured just before  
 290 the change in slope of the loading curve (Figure 5). The displacement am-  
 291 plitudes are very small (i.e. less than 1 voxel or  $25 \text{ }\mu\text{m}$ ) and are mostly due  
 292 to a rigid rotation of the sample. Most of the displacement fluctuations are  
 293 caused by measurement uncertainties, as will be shown below later. Further,  
 294 the correlation residuals have very small levels (RMS level equal to 9.8 gray  
 295 levels, which is very close to that observed when no motion was applied to  
 296 the sample, namely, 9.6 gray levels). In addition, no cracks are detected. From  
 297 these observations, and those as shown below, it is concluded that up to step  
 298 *d* of the nail pull test, the DVC resolution does not allow the motion of the  
 299 plasterboard core to be distinguished from that of a rigid body.

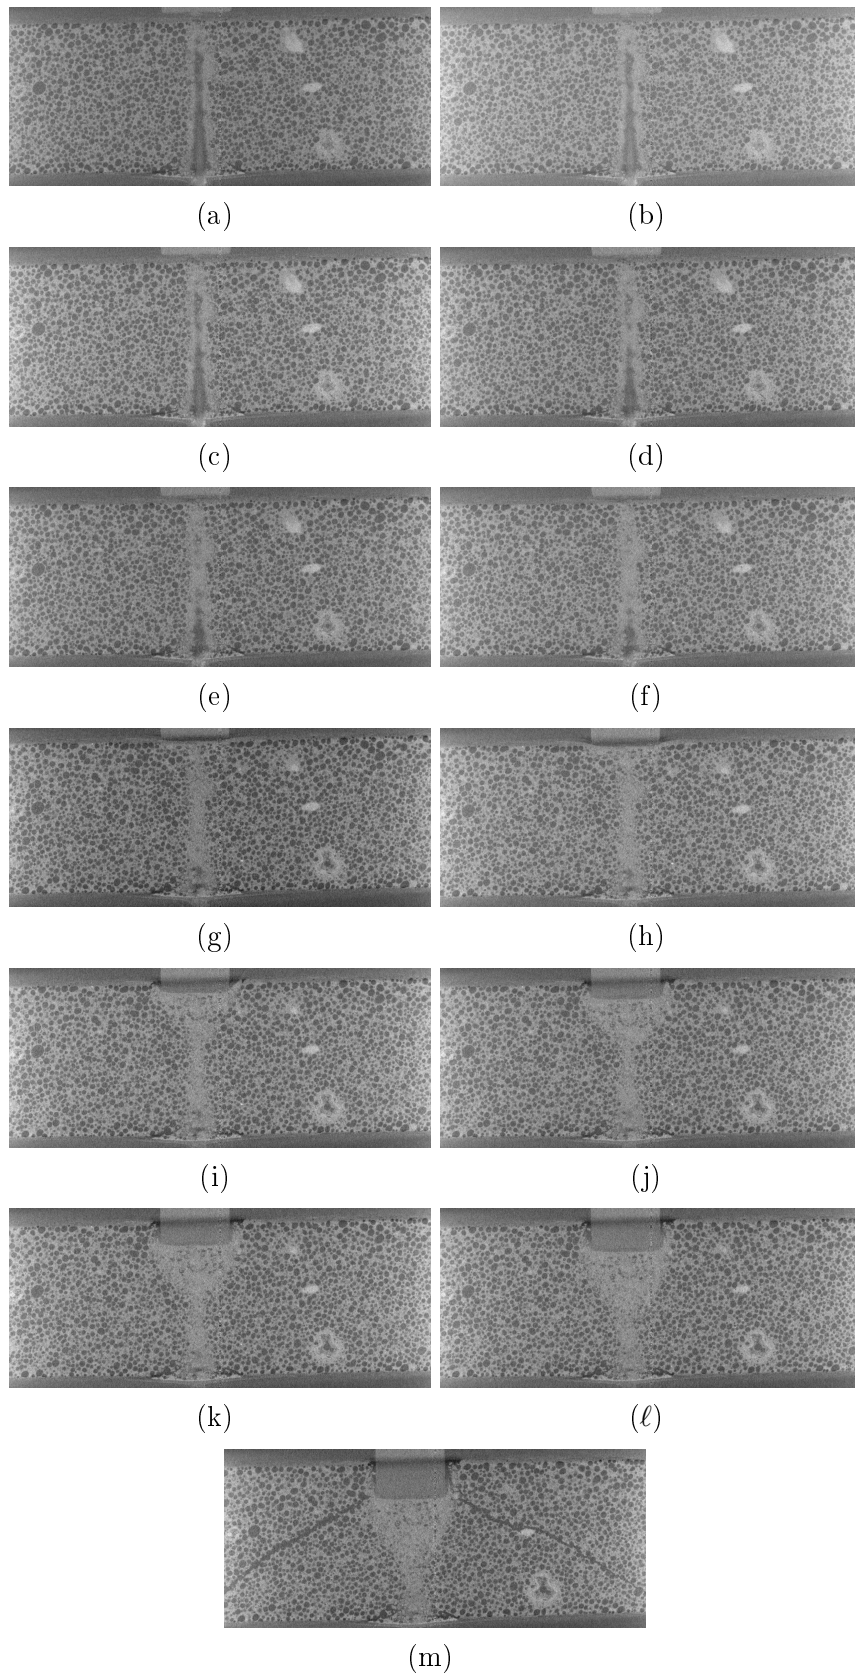
196 Figure 6 shows the microstructural evolution in the same vertical section close  
197 to the middle axis of the reconstructed volumes for the different states (from  
198 *a* to *m*) referenced in Figure 5. The section, which is parallel to the loading  
199 axis, has been selected to be located slightly away from the nail axis. All scans,  
200 including *a*, show a small cone crack close to the rear surface presumably due  
201 to imperfect hole drilling. It will be shown later that this modest imperfection  
202 has no observable influence on the test.

203 The beginning of the loading curve shows a nonlinear increase corresponding to  
204 taking up play between the different moving parts. No microstructural changes  
205 are observed in the corresponding scans (see Figure 6, scans *a*, *b*, *c* and *d*). In  
206 particular, no cracks are visually detected in the tomographic pictures.

207 The second part of the load-displacement curve corresponds to a significant  
208 slope change. By analyzing scans *e*, *f* and *g* (Figure 6), and more importantly,  
209 by zooming around the nail head (Figure 7), plaster compaction is observed  
210 in the upper part of the core. Compaction is caused by pore collapse. Because  
211 plaster is compacted, the paper is loaded in tension and breaks. This phe-  
212 nomenon cannot be observed at the chosen resolution, but is deduced from  
213 the load drop in Figure 5 (between acquisitions *f* and *g*). The roller coating  
214 breaks later on close to the nail edges between steps *h* and *i* (see Figure 6).  
215 The compaction is thus the key point in the failure mechanism of the plate,  
216 because it initiates the tearing of the front face paper lining.

Fig. 6. Sagittal tomographic sections showing the evolution of the microstructure at different loading levels in the nail pull test. Slice (a) shows the initial state (unloaded state)

234  $\approx 8.4$  mm (Figure 6(l)). Since the applied load is equal to 320 N, the crushing  
235 strength is equal to 6.3 MPa. This value is comparable to crushing strength  
236 that was obtained in a spherical indentation test conducted on the same plas-  
237 terboard [13].

238 When the nail head has penetrated about one fourth of the sample thickness  
239 and the collapsed zone has reached about one half of the sample thickness,  
240 the remaining thickness of the plate can no longer withstand the applied load.  
241 The final failure is caused by cone-shaped cracking of the core (i.e. opening  
242 mode) coaxial with the nail axis (Figure 6, scan  $m$ ) giving way to the nail  
243 through the specimen.

300 Figure 9(b) (state  $g$ ) corresponds to the load level just before the tearing of  
 301 the upper paper lining and roller coating (Figure 6 scan  $g$ ). Away from the nail  
 302 head, the measured displacement ranges still have very low levels (i.e. less than  
 303 one voxel or  $25 \mu\text{m}$ ). In the vicinity of the nail head, the correlation residuals  
 304 increase significantly. In the present case, this result indicates a deviation  
 305 from the conservation of gray levels due to pore collapse. In this region the  
 306 initial microstructure is completely lost. Even though a displacement field is  
 307 reported for this region, it is not trustworthy. In fact, this region is masked for  
 308 DVC and a basic interpolation is provided to define the displacement over the  
 309 whole region. This procedure allows for the computation of residuals and thus

313 Figure 9 (c) shows the displacement fields measured in the middle of the com-  
314 paction plateau (Figure 6, scan  $j$ ). The size of compacted region has signifi-  
315 cantly increased (as can be judged from the correlation residuals). Its boundary  
316 was still sharp with respect to the remainder of the sample, which underwent  
317 very small displacement levels. At this late stage of loading, no crack is de-  
318 tected on the correlation residuals (even when this field is carefully inspected  
319 in 3D). It is therefore concluded that, at the resolution of the images, no crack-  
320 ing occurred and that the main degradation mechanism was the compaction  
321 of the plaster core under the nail head.

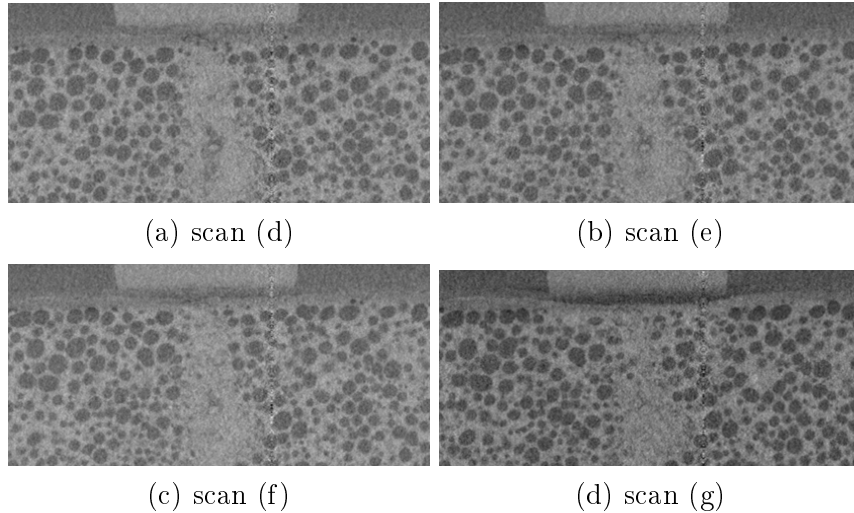
Fig. 7. Sagittal tomographic sections showing the evolution of the microstructure under the nail head for scans  $d$  to  $g$

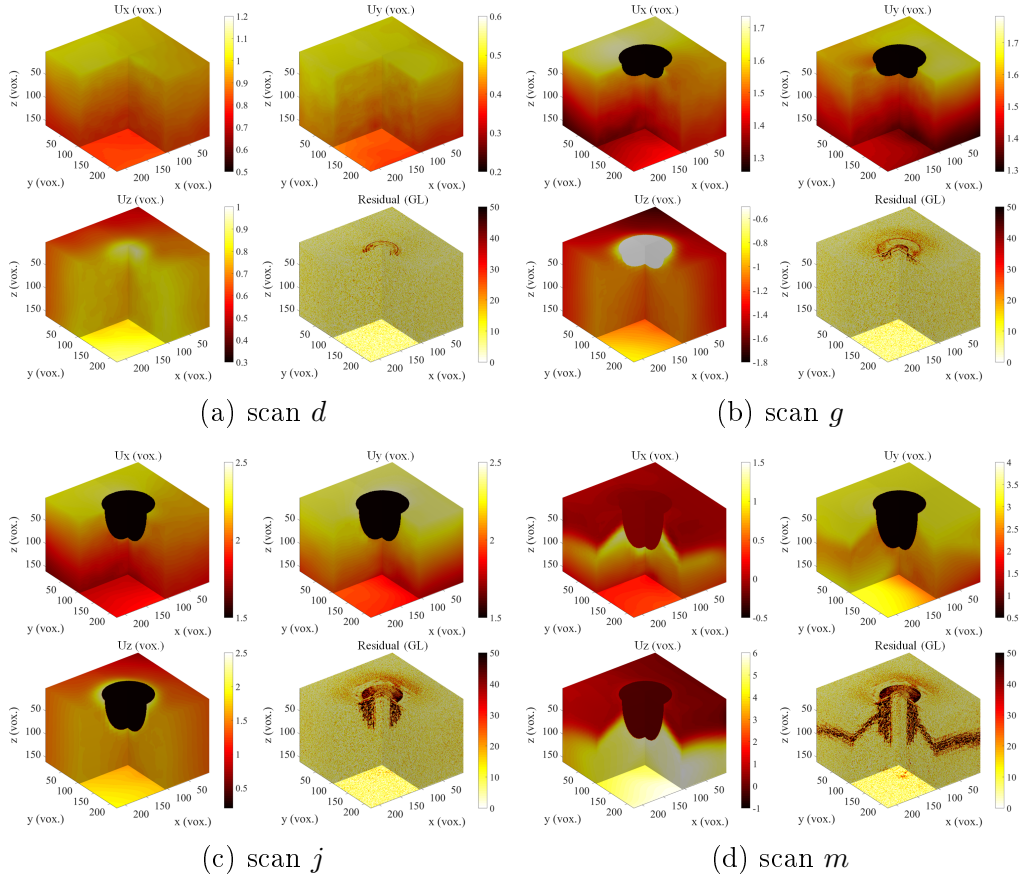
283 field is evaluated has a size of  $220 \times 220 \times 160$  voxels or  $5.5 \times 5.5 \times 4 \text{ mm}^3$ . The  
 284 size of the C8 cube element is equal to 10 voxels (or  $250 \text{ }\mu\text{m}$ ), the regularization  
 285 length is equal to 30 voxels (or  $750 \text{ }\mu\text{m}$ ). This choice leads to a little more than  
 286 23,000 unknown kinematic degrees of freedom to be measured per analyzed  
 287 case. Figure 9 shows a 3D renderings of correlation residuals and displacement  
 288 fields evaluated with RC8-DVC for four steps of the experiment.

Fig. 9. 3D renderings of correlation residuals and displacement fields evaluated with RC8-DVC for four steps of the experiment. The loading direction is  $z$  and the displacements are expressed in voxels ( $1 \text{ voxel} \leftrightarrow 25 \mu\text{m}$ ). The correlation residuals are expressed in gray levels (the dynamic range of the reconstructed volumes is 256 gray levels). The compacted zone is masked in the displacements fields

322 The displacement field measured from the last scan,  $m$ , has a totally different  
323 character as compared to the previous cases (Figure 9(d)). A steep displace-  
324 ment gradient indicative of a discontinuity is clearly observed, which shows the  
325 presence of the cone crack leading to the final failure of the sample. The trace  
326 of the crack is also present in the correlation residuals. In addition, the com-  
327 pacted zone displays only a slight progression when compared to the previous  
328 state  $l$  (not shown here). The occurrence of the cone crack can be connected  
329 to the very abrupt drop in the penetration force applied onto the nail, as the  
330 cone opening gives way to the nail perforation. This observation is consistent  
331 with 3D renderings of the corresponding scan in the reference configuration  
332 (for which no crack is visible) and the deformed configuration (Figure 10)

336 suited to reveal crack formation irrespective of their orientation. 3D rendering  
 337 of the equivalent strain is shown in Figure 11. As previously discussed, the  
 338 crushed region is masked. Outside of it, the amplitude of the equivalent strain  
 339 (see Figure 11(a), (b) and (c)) measured by RC8-DVC is very low. Because  
 340 it is the largest (positive) eigenstrain, random fluctuations of zero mean will  
 341 give rise to a positive mean value for  $\epsilon_{eq}$  that should not be confused with the  
 342 statement that strains (apart from the presence of the final cone crack) are in-  
 343 distinguishable from 0. At the last scan, the crack that leads to the breakdown  
 344 of the sample can be clearly seen from the apparent strain field (Figure 11(d)).  
 345 It is “apparent” because the displacement discontinuity is distributed over the  
 346 element size. The crack opening is more easily read from Figure 9(d), although

347 it is not uniform (ranging from 2 to 4 voxels, or 50 to 200  $\mu\text{m}$ ), because of a  
 348 relative rigid body rotation of the two parts.

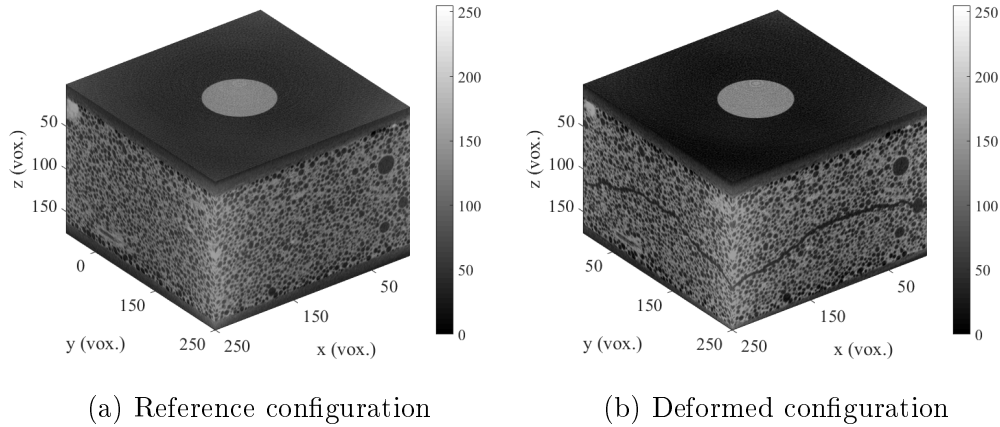
Fig. 10. (a) 3D rendering of the microstructure of foamed gypsum to be subjected to nail pull test. (b) The crack is visible on the lateral faces of the sample (the dynamic range of the reconstructed volumes is 256 gray levels)
