## Non-destructive inspection of initial defects of PA6.6-GF50/aluminum self-piercing riveted joints and damage monitoring under mechanical static loading

Amandine Gay, Jean-Michel Roche, Patrick Lapeyronnie, Frederic Valiorgue,  
Philippe Bertrand

A self-piercing riveting process is used to join a thermoplastic composite sheet of PA6.6-GF50 with an aluminum alloy sheet 5182 O. Two shapes of self-piercing rivet are tested: the countersunk rivet and the button head rivet. Non-destructive inspections by pulse thermography and post-mortem cross-section observations are made to assess the damage that might have occurred during the rivet piercing process. The manufacturing defects are characterized and the possible causes for their emergence are explained. Then, single-lap joint tests were carried out to determine the best joint in terms of its mechanical strength. These tests were also instrumented by various monitoring techniques such as passive thermography, digital image correlation, and acoustic emission to clarify the joint damaging behavior. Non-destructive inspections by pulse thermography are finally correlated with the thermal fields acquired by passive thermography during t

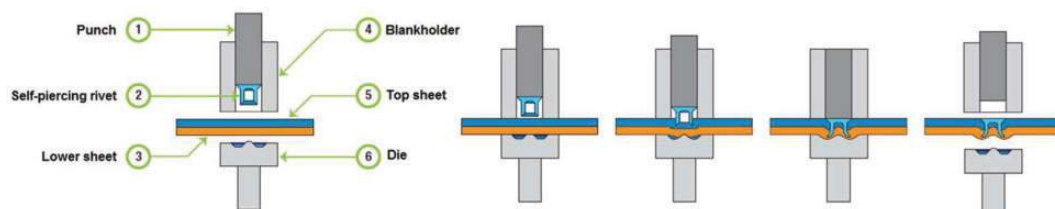
Figure 1. Self-piercing riveting process.

The self-piercing process is shown in Figure 1. For the first step, the top sheet (composite) and the lower sheet (aluminum) are clamped together between the die and the blank holder. This configuration is chosen because the aluminum deformation capacity is higher than the one of the composite. Then, the semi-tubular rivet is pushed by the punch and it pierces the top sheet. The lower sheet begins to be deformed over the die. The self-piercing rivet flares into the lower sheet due to the die shape to form a mechanical interlock. The lower sheet forms a button on the underside. Finally, the punch and the blank holder rise. The joint is then removed.

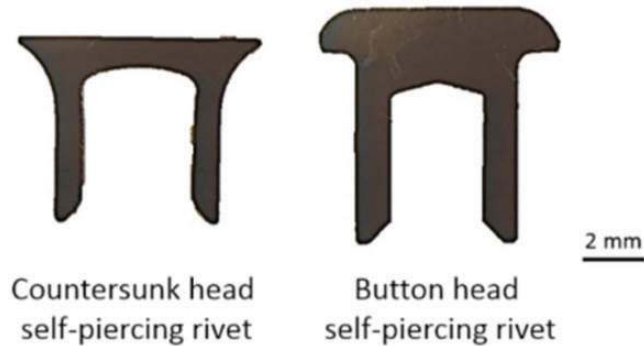
**Figure 2.** Cross-section of self-piercing rivet shapes.

The mechanical connections are made by 5 mm diameter self-piercing rivets (Böllhoff Company). Two rivet shapes are tested: the first one has a button head whereas the second has a countersunk head, as shown in Figure 2.

The countersunk self-piercing rivet is traditionally used in the automotive industry for metallic joints. However, the higher joint strength is expected for the button head rivet because this shape is recommended for thermoplastic materials.

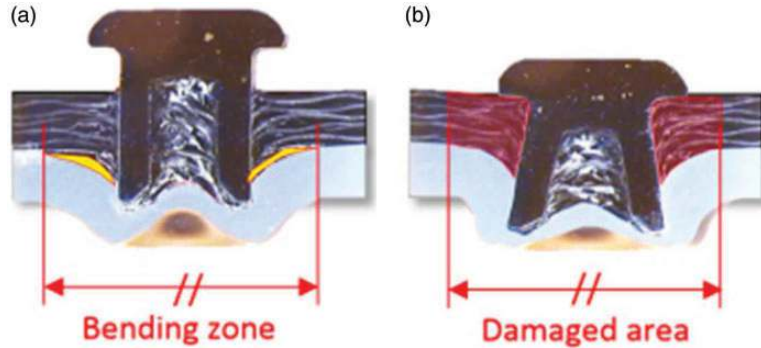
**Figure 4.** Cross-section of the joint (a) during the piercing and (b) at the end of the process.

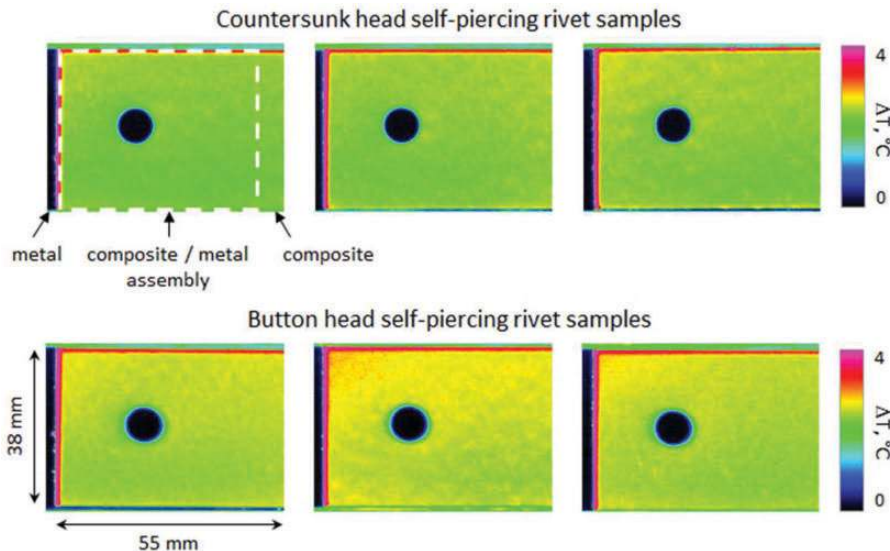
**Figure 5.** Instantaneous temperature fields. Time of observation: 0.5 s after the thermal flash.

*Non-destructive inspection by pulse thermography.* As illustrated in Figure 5, the homogeneity of the thermal maps, from one sample to another, tends to validate the reproducibility of the manufacturing process. No major initial defects are detected on the instantaneous temperature fields: the small-sized delaminations observed on the micrographic cross-sections are not seen, which allows the assumption that they are not critical but which plainly justifies the need for a close monitoring of the damage behavior of the samples under mechanical loading (see “Non-destructive in situ damage monitoring during mechanical testing” section). The region of interest, located around the rivet, is more closely observed with the 18 mm extension optical ring. The TSR second logarithmic derivative images, for which thermal contrasts are optimal, tend to validate the assumed homogeneity.

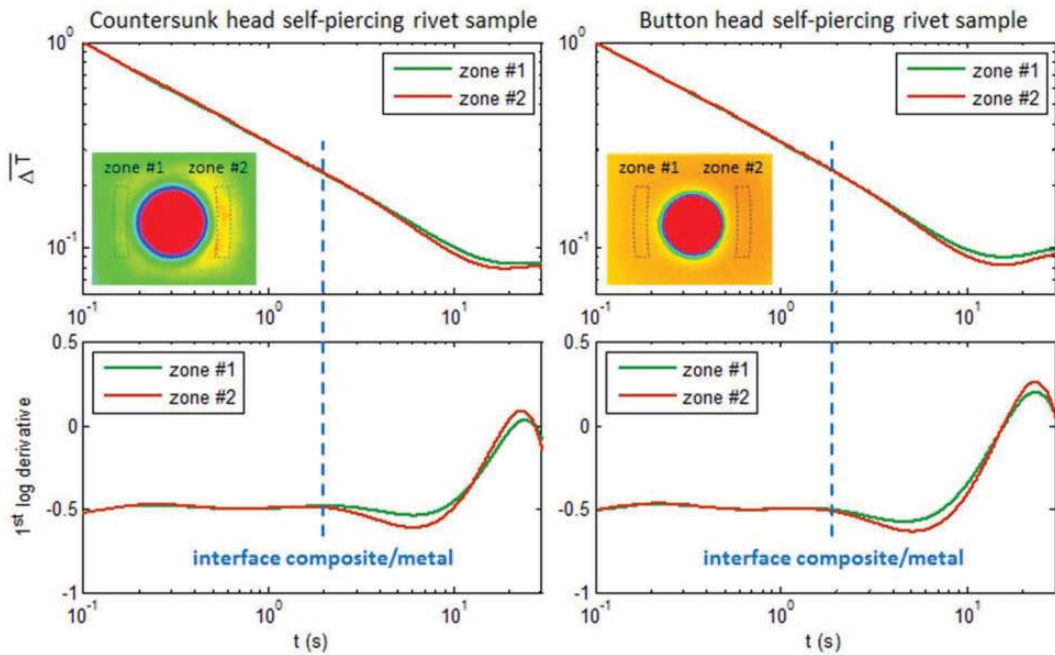
**Figure 7.** Time-evolutions of the TSR-fitted normalized thermograms and of the 1st logarithmic derivatives. Studied zones located on thermal 2nd logarithmic derivative images.

A local analysis of the normalized TSR-fitted thermograms, for each side of the rivet, and of the associated first logarithmic derivatives, shows that the post-flash cooling of the structure is slower on the left of the rivet, that is to say close to the composite edge (Figure 7). The normalized thermogram obtained for the zone located on the left of the rivet, close to the composite edge, is almost similar to the theoretical one of a homogeneous material: linear decrease, with  $a - \frac{1}{2}$  slope in a log/log scale, up to the rear-face. The composite / metal interface, which should be detected by a faster temperature decrease, since the thermal diffusivity of aluminum is much higher than the one of the PA6.6, is hardly seen. On the contrary, the thermograms of the region located on the right of the rivet do meet the expectations: a clear slope rupture is observed when the composite / metal interface is reached. Such variations are even more highlighted by the first logarithmic derivatives. Based on those

observations, it would appear that the composite/aluminum joint is not completely conform on the left side: the surface might be slightly curved, due to the manufacturing process and plastic strain effects. Even though this is definitely not a delamination-like defect, it still might impact the mechanical resistance of the riveted joint, by inducing a premature decohesion of the rivet.

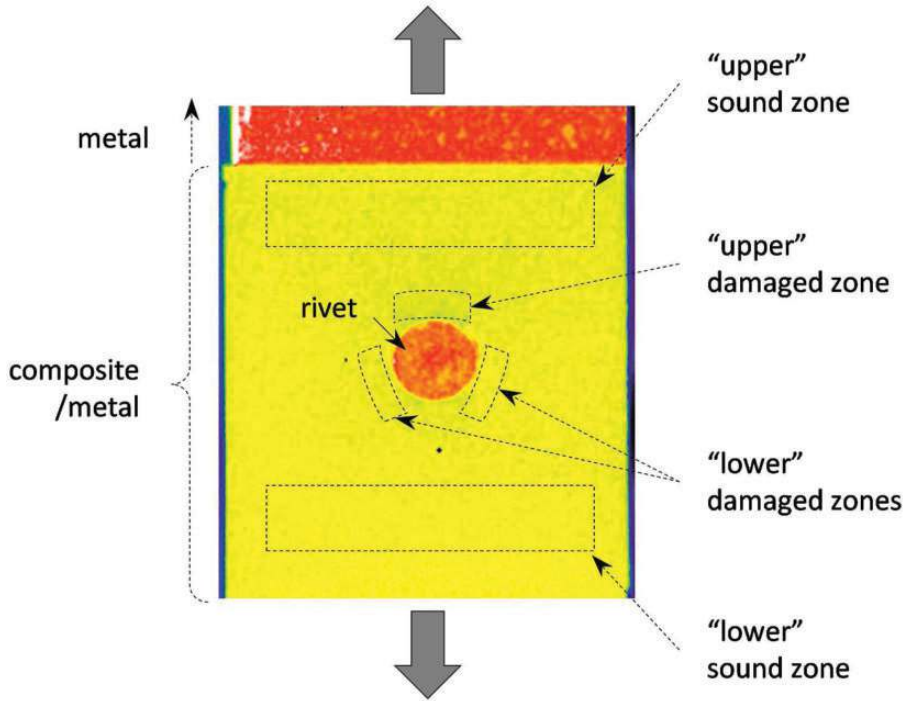
**Figure 9.** Location of the regions of interest thermally monitored during the SLJ test.

*Passive thermal monitoring.* The regions specifically observed by the infrared camera are located in Figure 9: two “sound” zones in which damage is not a priori expected; three “damaged” zones around the rivet. The time-evolutions of the temperature variations  $\Delta T$  (defined as the difference between the instantaneous temperature field and the initial temperature one) are given for these zones in Figure 10.

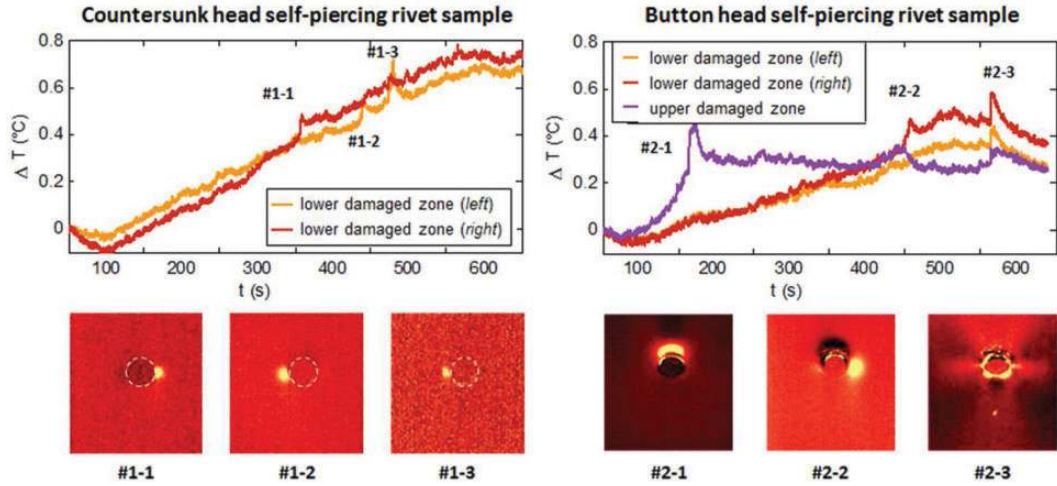
**Figure 11.** Heat signatures of the major damage occurring during the SLJ test.

The loss of linearity, both spotted on the force and temperature time-evolutions (dotted line, Figure 10), corresponds to a damage threshold, which is quite similar from one type of rivet to another, found around  $0.45 \times F_{MAX}$ . The first non-linearities are mainly linked to viscous effects in the composite material and to microscale, diffuse damage. Then, the local temperature rises are associated with intern heat sources that indicate the presence of severe damage, located around the rivet, as illustrated in Figure 11.

Strain fields enable to link the previously detected local temperature rises to actual mechanical effects (Figure 12): the heat source observed right above the button head rivet (damage #2-1 in Figure 11) is due to a local compression; the other heat sources, for both rivets, are located on a horizontal crease of high deformation gradient. More thorough comparisons are made in “Cross-correlation between experimental data” section (Figures 14 and 15).

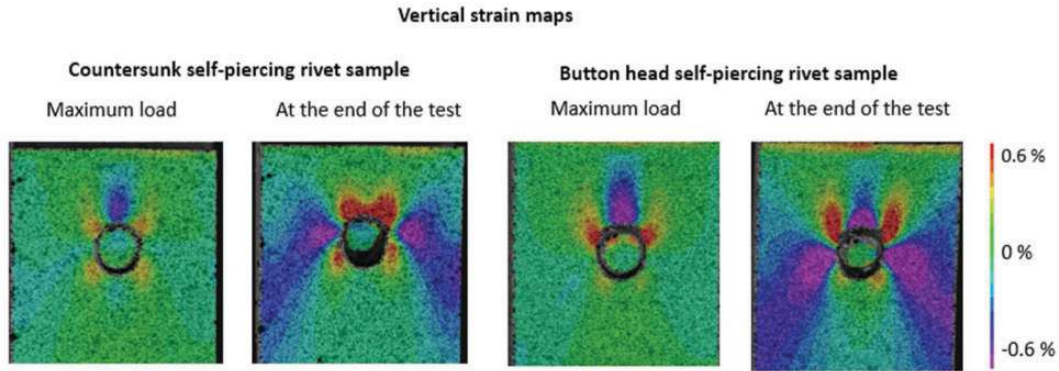
**Figure 12.** Vertical strain maps at the maximum load and at the end of the SLJ test.

*Monitoring by stereo DIC.* Data provided by DIC first show that the self-piercing rivet shape seems to affect the stress distribution around it. For button head riveted joints, the area above the rivet is permanently in vertical compression, which is due to the presence of the rivet head preventing its gradual exit from the composite, unlike what is observed for the countersunk rivet, and consequently allows a better shear strength. In the countersunk case, the progressive exit of the rivet changes the strain field with a vertical tensile area above the rivet, as the matter is free to follow the rotation.

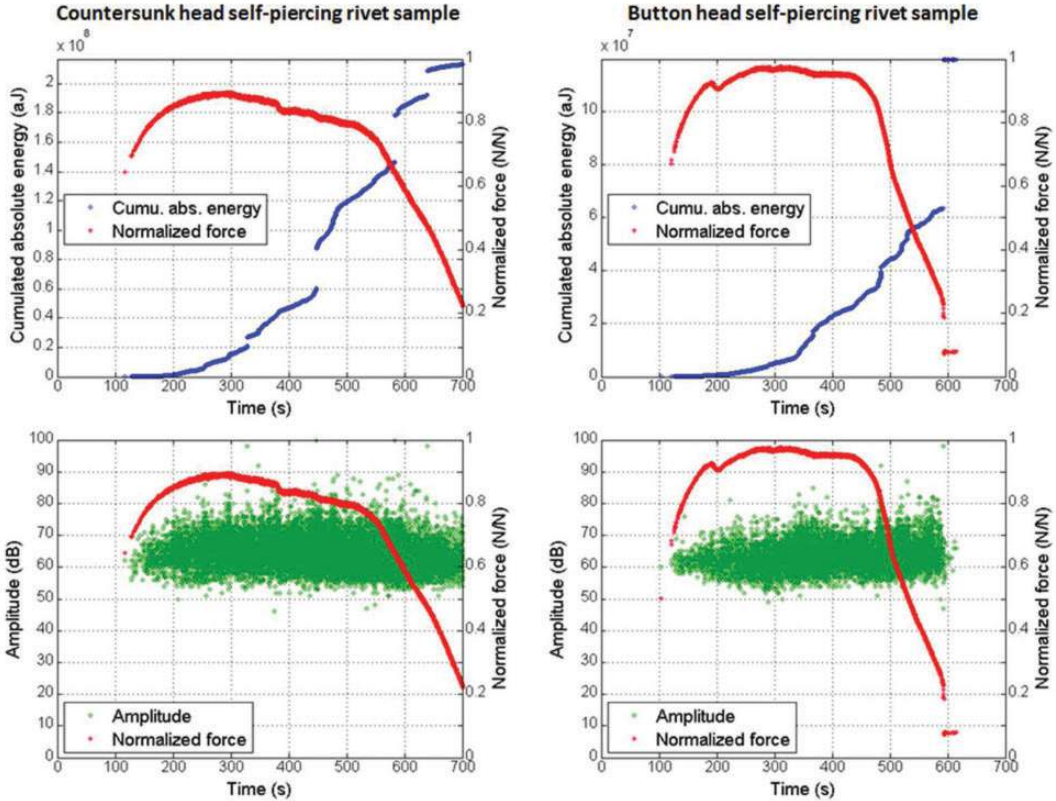
**Figure 13.** Acoustic measurements (amplitude peaks and cumulative energy) during the SLJ tests.

*Monitoring by AE.* As illustrated in Figure. 13, the acoustic activity recorded during the SLJ tests is quite similar from one type of rivet to another. The first acoustic events, mainly isolated, low-amplitude ones, appear for a high fraction of the maximum load  $F_{MAX}$  (around 0.65 for both types of riveted joints). The damage thresholds, associated with the beginning of the growth of the cumulative energy, are really too high, estimated around  $0.70 \times F_{MAX}$ . This value turns out to be significantly higher than what was found by passive thermography, which tends to confirm that the beginning of the heating of the composite is not associated with damage. Overall, it is also observed for both samples that most of the acoustic events are recorded after  $F_{MAX}$  that is to say during the slow decrease of the force and its final quicker drop. Moreover, the average amplitudes of the acoustic peaks are found around 60 dB, which typically corresponds to matrix cracking and delamination (Chen et al., 1992); events of higher energy (from 80 to 100 dB), which should be the signatures of fiber breaking damage, are also detected but in a much lower proportion.

The main difference between both riveted joints remains in the absolute values reached by the cumulative acoustic energy, which are about twice higher for the countersunk head rivet samples, even before  $F_{MAX}$ . This underlines the fact that the SLJ tests generate more damage in the countersunk head self-piercing rivet samples. However, the difference lies in the number of damaging events, not in their amplitude, which is quite consistent with the fact that the ratio between the respective

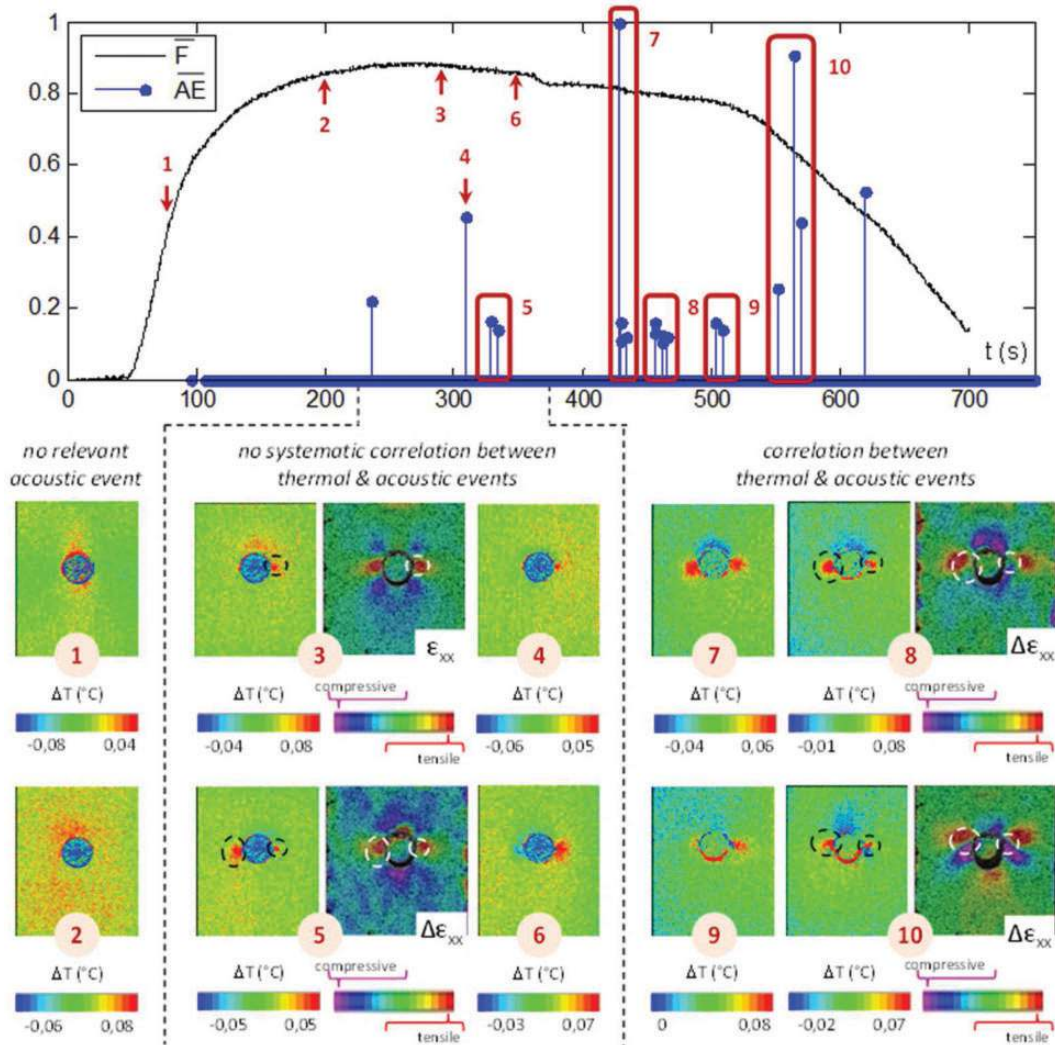
**Figure 14.** Countersunk head rivet in situ damage behavior under SLJ loading: cross-correlation between acoustic data, thermal and strain fields.

The aim of this last subsection is to propose a condensed overview of the damaging behavior of both countersunk head and button head rivet samples, based on the two following representations which illustrate the cross-correlation between all these data (Figures 14 and 15).

The first phase corresponds to the linear elastic regime. A diffuse heating of the composite is observed in the upper part of the rivet, with no creation of damage, at least at a mesoscopic scale, which tends to confirm the assumption of viscous non-damaging effects. It also justifies why the threshold defined from AE data is found at a higher force than the one found with passive thermography.

The third phase, associated with the load decrease due to the progressive decohesion of the rivet from the lower sheet, is quite standard: several isolated damage events are detected by both acoustic energy peaks and local heat sources. It should be noted that depending on the nature and the depth of the damage, the thermal signature obtained on the composite surface may either be instantaneous and punctual, or progressive and diffuse because of lateral diffusion effects (Roche et al., 2015). Some heating zones are thus associated with given isolated acoustic peaks; others are associated with several acoustic peaks occurring at close time intervals. These zones can also be identified on strain fields provided by DIC: the continuing exit of the rivet by rotation keeps the composite under compression on a horizontal crease located halfway up the rivet on its sides. In the end, the damage pattern of both samples differs a bit: the lateral sides of the countersunk rivets are the most damaged; as for the button head ones, the main damage is too lateral but slightly below the rivets. Some remaining acoustic peaks do not have any signature provided by thermography or DIC, which might be due the location of the damage, outside of the observation window accessible to the cameras (in the rivet detachment from the aluminum area, for instance) or too deep inside the composite, and to its limited geometrical extents.

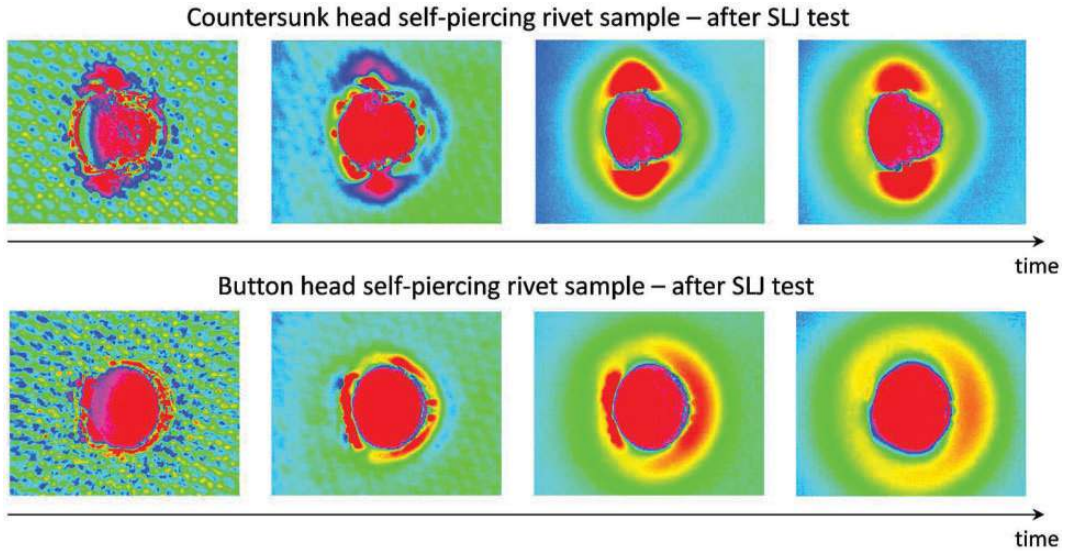
**Figure 16.** Second derivative-TSR maps of the samples after final mechanical failure.

Similarly to what was initially done, the very same pulse thermography inspections are carried out on the damaged composite parts which were dissociated from the metallic parts during the SLJ test.

Severe damage is detected around the rivet, of geometrical extension similar to the rivet diameter. It is visible for early times, which indicates that it is mainly constituted of shallow defects. The countersunk head rivet samples seem to be more damaged on the sides of the rivet than the button head ones (Figure 16), which is in agreement with the previous in situ observations. More globally, the damaged zones detected by post-SLJ test pulse thermography can be linked to the ones detected during the SLJ test (Figure 17).

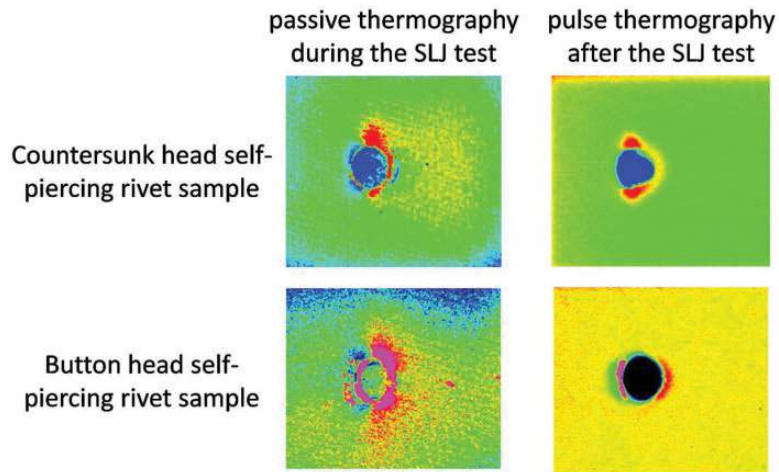
**Figure 17.** Comparisons between thermal maps acquired during the SLJ test by passive thermography and after the SLJ test by pulse thermography.
