## Surface characterization and influence of anodizing process on fatigue life of Al 7050 alloy

Majid Shahzad, Michel Chaussumier, Rémy Chieragatti, Catherine Mabru, Farhad Rezai-Aria

Majid Shahzad, Michel Chaussumier, Rémy Chieragatti, Catherine Mabru, Farhad Rezai-Aria. Surface characterization and influence of anodizing process on fatigue life of Al 7050 alloy. *Materials & Design*, 2011, 32 (6), pp.3328-3335. 10.1016/j.matdes.2011.02.027 . hal-01666700

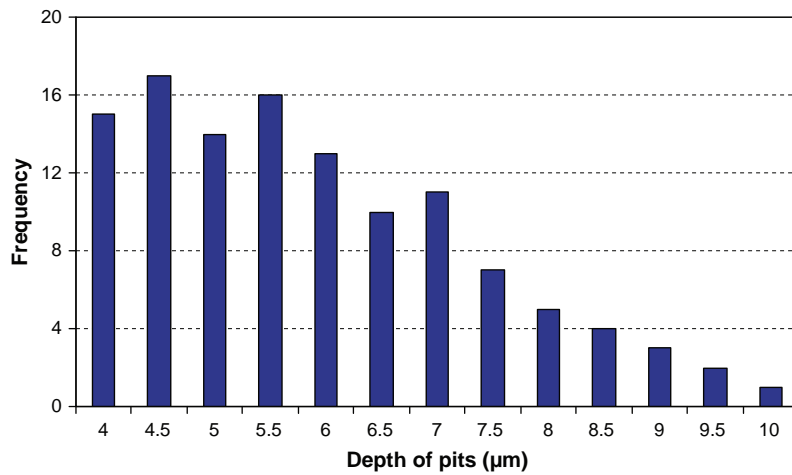
Fig. 4. Distribution of depth of pits formed after pickling solution exposure (topography measurements for a zone of  $4 \times 4 \text{ mm}^2$ ).

Fig. 4 presents the results of topography measurements taken for specimen that has undergone the pickling treatment. Here we can observe that most of the pits have depth below  $8 \mu m$  with very few exceeding this value. The possible reason for this phenomenon, as observed by SEM, that some particles were partially dissolved leaving behind the remnants. In their work for aluminium alloys, Ezuber et al. [17] have shown that pit morphology depends on the type of constituent particles present and their reactivity with the exposed solution.

deep (Fig. 11b). Although there were few pits which were beyond  $8 \mu m$  depth, as determined by topography (Fig. 4) measurements,

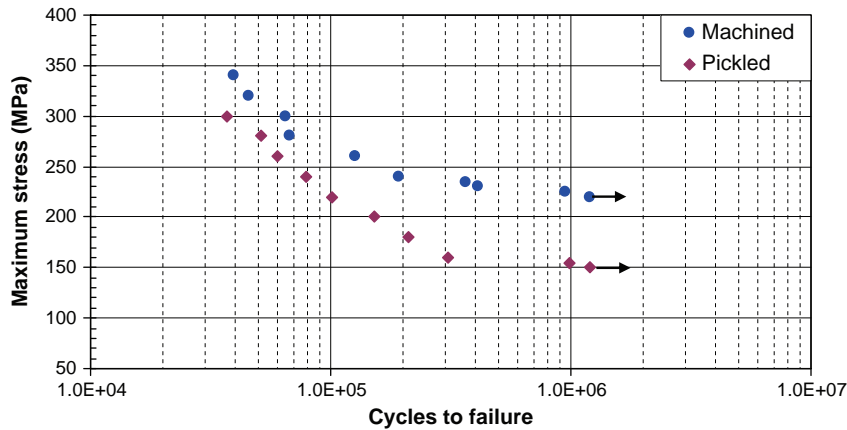
Fig. 7. Fatigue test results for machined and pickled specimens.

degreasing solution exposure and results showed no change in the fatigue life as compared to machined specimens. Fatigue test results for machined and pickled specimens are given in Fig. 7 and from the graph it is possible to evaluate the influence of pickling treatment by taking machined specimens as reference. It can be clearly seen that tendency of pickling process is to degrade the fatigue performance of the given alloy at all stress levels as compare to machined specimens. The presence of pits at the

surface facilitates cracks initiation and as expected, decrease in the fatigue life of pickled specimens increases with the decrease of fatigue stress. The fatigue strength drops from 220 MPa for the machined specimens to 150 MPa for pickled specimens. The surface topography submitted to pickling treatment, shown in Fig. 3 before any fatigue loading, helps in understanding the strong effect of the process on fatigue strength for this alloy. In the Fig. 3, it is possible to observe many pits which resulted as dissolution of  $Al_7Cu_2Fe$  and  $Al_2CuMg$  particles during pickling solution exposure. These pits can act like stress concentration and can accelerate the crack initiation mechanism in the material.
