Surface characterization and influence of anodizing process on fatigue life of Al 7050 alloy

Majid Shahzad, Michel Chaussumier, Rémy Chieragatti, Catherine Mabru,
Farhad Rezai-Aria

Majid Shahzad, Michel Chaussumier, Rémy Chieragatti, Catherine Mabru, Farhad Rezai-Aria. Surface characterization and influence of anodizing process on fatigue life of Al 7050 alloy. *Materials & Design*, 2011, 32 (6), pp.3328-3335. 10.1016/j.matdes.2011.02.027 . hal-01666700

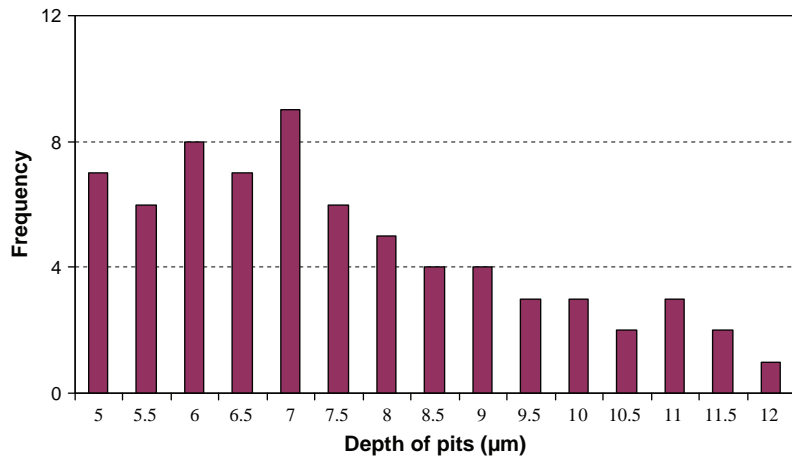
Fig. 6. Distribution of pit depths resulted as complete anodization process (topography measurements for zone of $4 \times 4 \text{ mm}^2$).

In Fig. 6 distribution of depth of pits measured by topography is given for the anodized specimens. Here we can observe that size of the largest pit observed has been increased as compared to the pits observed for pickled specimens which can be explained by the complete dissolution of constituent particles. In a recent investigation for aluminium alloy 7075, Savas and Earthman [18] studied the effects of different anodizing pretreatment solutions on localized corrosion behaviour. They hypothesized that if pits, initiated during pretreatment solution exposure, were beyond a threshold size ($10-20 \mu m$), a higher current density existed at these locations

during anodizing process, thus resulting in deeper pit structure. During this study, the maximum pit depth was determined to be $12 \mu\text{m}$ by topography measurements for anodized specimens.

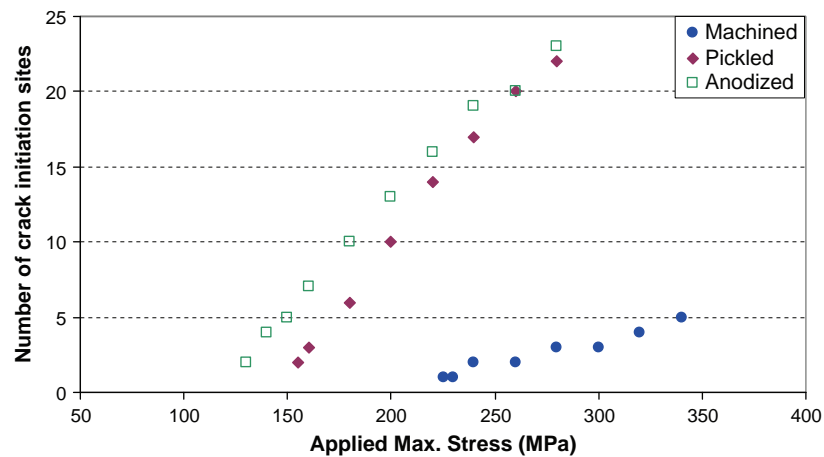
Fig. 13. Number of initiation sites as function of max. stress for three different conditions.

At same stress level, the numbers of cracks formed on fractured surface of the pickled and anodized specimens were larger than that of the machined specimens (Fig. 13). The fracture surface is not flat (Fig. 12a) which also reveals that number of fracture steps exists, indicating that fracture has occurred as a consequence of the propagation of several cracks that initiated from pits. This multi-crack initiation is also responsible for rough fractured surface of the anodized specimen. Shiozawa et al. [20] have also demonstrated this phenomenon that number of crack initiation sites
