## **Relationship between damage and permeability in liner-less composite tanks : experimental study at the lamina level**

# RELATIONSHIP BETWEEN DAMAGE AND PERMEABILITY IN LINER-LESS COMPOSITE TANKS: EXPERIMENTAL STUDY AT THE LAMINA LEVEL

## ABSTRACT

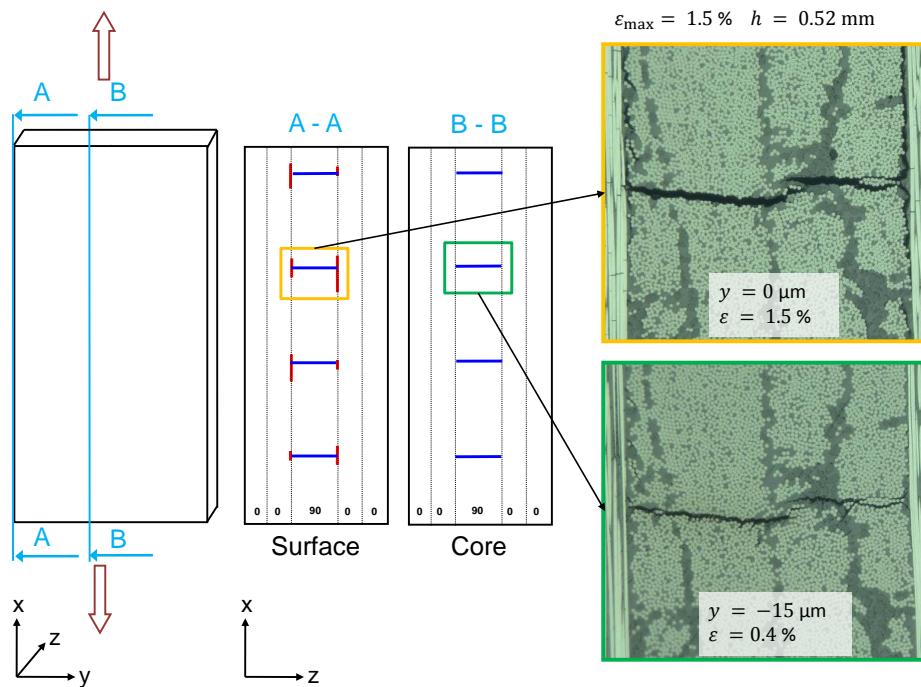
Fig. 4. Cross-section examinations on  $[0_2/90_2/0_2]$ : diagram of the cross-sections and micrographs at the surface ( $y = 0\mu\text{m}$ ) and after removing 15 microns ( $y = 15\mu\text{m}$ ).

Cross section examinations were carried out on damaged tensile test specimens of  $[0_2/90_n/0_2]$  and  $[+45/-45]_{2s}$  layups. Measurements were performed on representative areas of about 50 mm long. Fig. 4 shows a transverse crack and the associated micro-delamination at crack tips on the edge of the sample before and after removing 15 microns by a polishing procedure. 15 microns under the edge surface, no visible delamination remains. Fig. 5(a) presents the evolution of micro-delamination rates before and after polishing for three ply thicknesses. Independently of the ply thickness, the micro-delamination rate tends quickly to zero. Cross section examinations were continued to verify the length of cracks. The crack rate with respect to the polishing depth is reported in Fig. 5(b). Cracks were shown to be continuous for double and triple 90 plies, while a few cracks disappeared in the  $[0_2/90_1/0_2]$  lay-up. This is consistent with edge effects in this layup. This variation of crack rate for the simple ply is about 15% of the crack rate at the surface (see Fig. 6).
