Relationship between damage and permeability in liner-less composite tanks: experimental study at the lamina level

Hortense Laeuffer, Brice Guiot, Jean-Christophe Wahl, Nicolas Perry, Florian Lavelle, Christophe Bois

RELATIONSHIP BETWEEN DAMAGE AND PERMEABILITY IN LINER-LESS COMPOSITE TANKS: EXPERIMENTAL STUDY AT THE LAMINA LEVEL

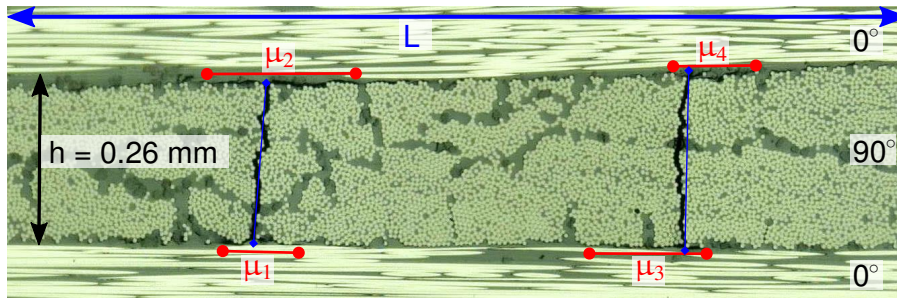
Fig. 2. Measurement of the crack density ρ and average delamination at crack tip μ in a $[0_2/90/0_2]$ lay-up.

The meso-damage state of each ply of a laminate can be described by two damage densities, as illustrated in Fig. 2: the crack density ρ , which is the average number of transverse cracks over the observed length L , and the micro-delamination length μ , which is the average length of micro-delamination at each crack tip. The corresponding dimensionless variables are defined by:

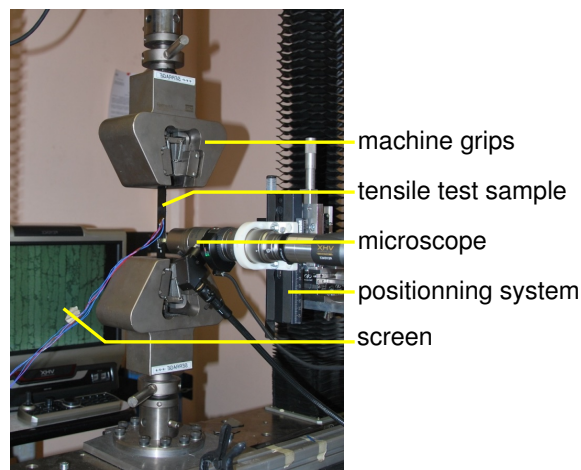
Fig. 3. Damage observation under tensile loading test.

In the present work, the assessment of the damage densities was carried out by optical microscopy for several loading levels. Tensile test were performed on specimens polished on one edge. Transverse crack and delamination at crack tips were identified with a travelling optical microscope (Fig. 3). The observation area was chosen quite large, i.e. about 100 mm, in order to evaluate statistical effects. The material is carbon fibre and thermoset matrix M21 T700. Plate samples were manufactured by Automated Fibre Placement (AFP). The thickness of the elementary layer is 0.26 mm. Several layers of the same orientation can be stacked together in order to obtain a thicker ply, e.g. in a $[0_2/90_3/0_2]$ laminate the thickness of the 90° ply is 0.78 mm.

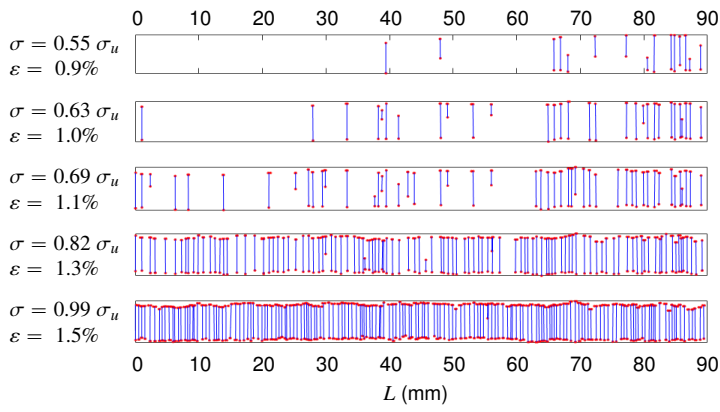
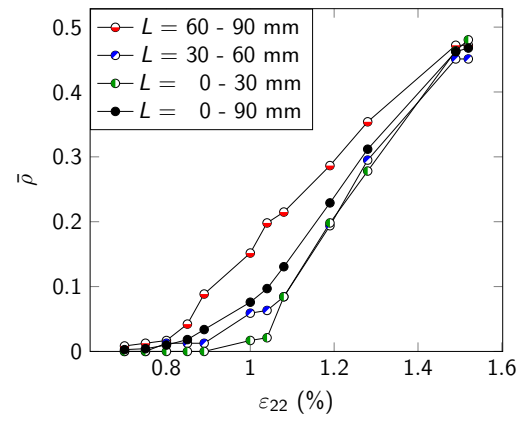
(a) Position of cracks observed on the edge for 5 loading levels.

(b) Crack density $\bar{\rho}$ at the surface.

Fig. 7. Damage measurements on a $[0_2/90_1/0_2]$ specimen, ply thickness $h_{90} = 0.26$ mm.

Evolution of transverse cracking was observed as previously described in Section 2.2 for $[+45/-45]_{2s}$ and $[0_2/90_n/0_2]$ layups with n varying from 1 to 3. As the first one was shown to be not subjected to transverse cracking, this section is devoted to the latter. The position of cracks measured for several loading levels on a $[0_2/90_1/0_2]$ specimen is plotted in Fig. 7(a). The corresponding crack rate has been computed for the whole observed area and also for each separate third of the same area, see Fig. 7(b). The two figures highlight the benefit of observing a large enough and hence representative area. Depending on the piece of sample one chose to focus on, initiation and slope of crack growth may be very different, at least concerning the beginning of crack growth. It is likely due to weak areas (defect locations) that drive the position of the first cracks. The effect of defects on the damage threshold vanishes when damage increases: for higher strains, the distance between consecutive cracks becomes more homogeneous, and no major difference can be observed between the three small areas. The average crack rate computed on the whole length reveals a preliminary step with a progressive beginning of cracking.

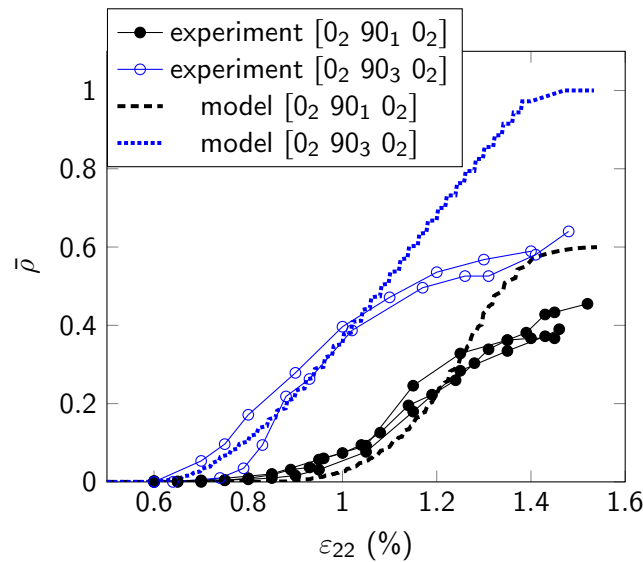
Fig. 8. Measured and predicted crack rates.

The evolution of damage densities according to the applied strain for two ply-thicknesses are presented in Fig. 8. In all cases, the preliminary step in the damage scenario with small cracking rates before a second step where the crack growth speeds up was observed. The curves shows an increase in cracking threshold when the ply thickness decreases. This phenomenon is explained by the energy

The modelling of the preliminary step is fundamental for the prediction of first leak path. This phenomenon due to the variability of the material properties can be introduced in the damage model through a probabilistic approach [8]. Evolution laws for transverse cracks and micro-delamination were built based on Finite Fracture Mechanics and energy release rates [9, 10]. Probability density functions are defined for fracture toughness and strength threshold. A set of simulations are then performed and the average response of the model are computed according to the weight associated to the density functions. Results of the simulation for both ply thicknesses are presented in Fig. 8 by dotted and dashed lines. Preliminary step in the damage scenario is well described even though the densities of probability were not accurately identified yet.

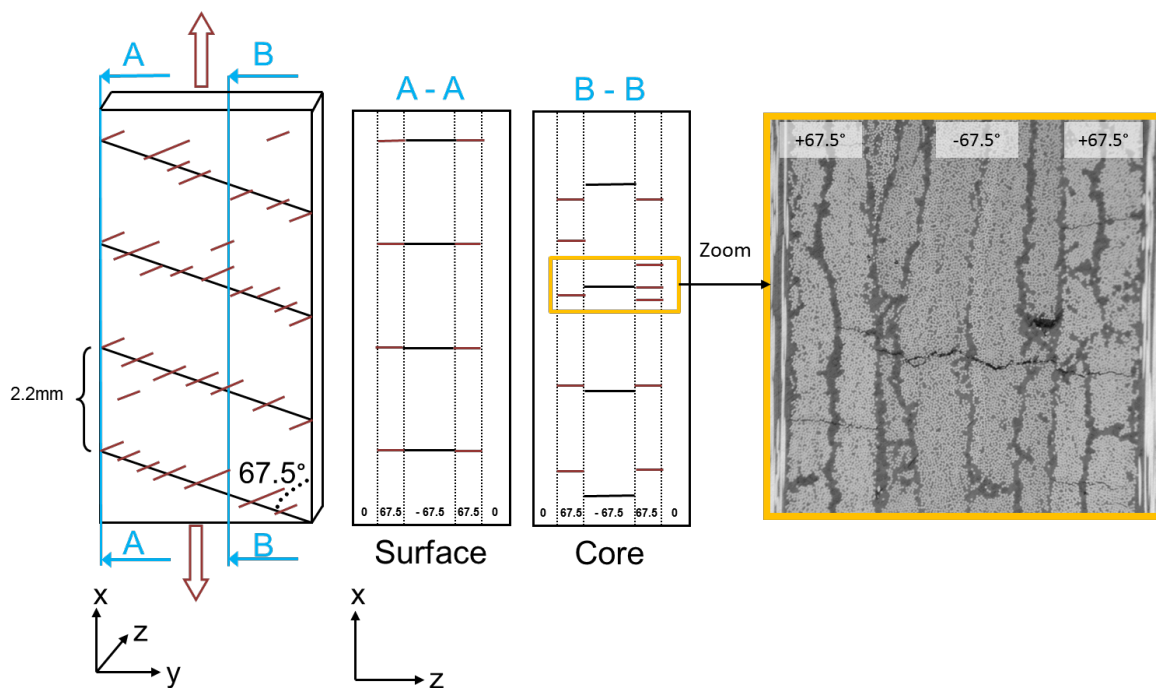
Fig. 9. Crack network in a $[0/+67.5/-67.5]_s$: diagram of the network and micrograph of the three damaged plies.

At the scale of the specimen, the results provide an overview of the network. The position of cracks is schematically drawn in Fig. 9 from the observations. The centre ply, -67.5° , is also a double ply, and thus has a lower cracking threshold. In this ply, cracks occurred first and were continuous through the width. Conversely, cracks in the simple $+67.5^\circ$ plies were short and located around the cracks of the double ply. Hence, existence of cracks in an adjacent ply drives the position and the length of the new cracks. Moreover, the cracking threshold of the simple plies is also modified: cracks occur almost simultaneously in the three plies despite their different thicknesses. Tests on $[0/+67.5/0/67.5]_s$ specimens in which cracked plies are isolated are scheduled. Comparing the results obtained with isolated and not-isolated plies will make it possible to quantify the effect of the interaction between cracks in adjacent plies.

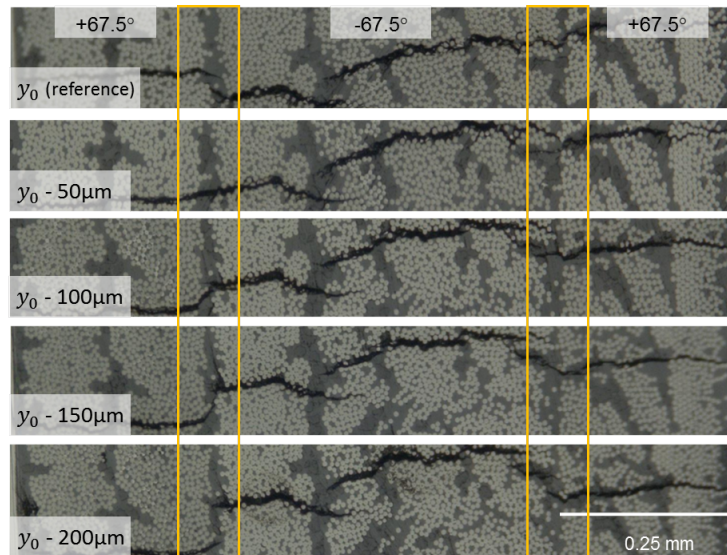
Fig. 10. Intersection between the cracks of three plies in a $[0/+67.5/-67.5]_s$ for several polishing depth.

Fig. 10 focuses on the intersection of three cracks. At the interface between two plies, delamination connects the cracks. This makes the connection area larger than the Crack Opening Displacement (COD) at crack tip and may increase the leakage rate induced by a leak path.
