Study of plant fibre composites with damage induced by laser and mechanical impacts

Pawel H. Malinowski, Luigi Sorrentino, Davi Silva De Vasconcellos, Laurent Berthe, Pedro Pascual Gonzalez, Laurence Chocinski-Arnault, Michel Boustié, Fabienne Touchard, Wieslaw M. Ostachowicz

Green composites
NDT
Laser shocks
Terahertz spectroscopy
Vibrometry
Impact damage

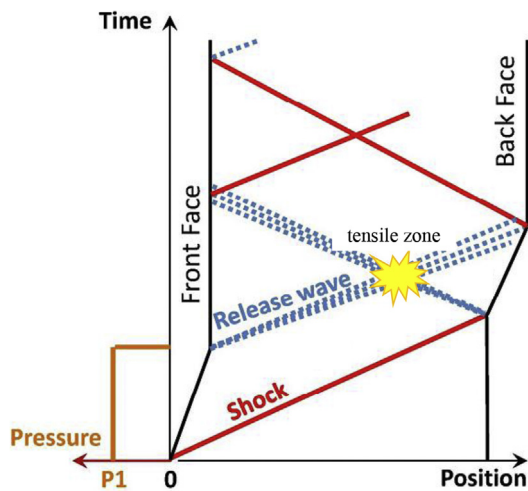
Fig. 8. Laser induced shock wave propagation through a homogeneous material.
