Study of plant fibre composites with damage induced by laser and mechanical impacts

Pawel H. Malinowski, Luigi Sorrentino, Davi Silva De Vasconcellos, Laurent Berthe, Pedro Pascual Gonzalez, Laurence Chocinski-Arnault, Michel Boustié, Fabienne Touchard, Wieslaw M. Ostachowicz

Pawel H. Malinowski, Luigi Sorrentino, Davi Silva De Vasconcellos, Laurent Berthe, Pedro Pascual Gonzalez, et al.. Study of plant fibre composites with damage induced by laser and mechanical impacts. Composites Part B: Engineering, 2018, 152, pp.209-219. 10.1016/j.compositesb.2018.07.004 . hal-01900656

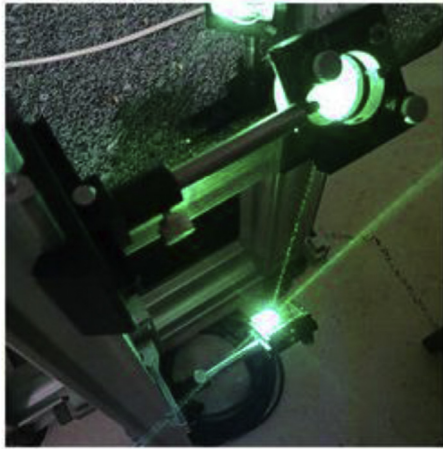
Fig. 7. Laser impact test stand.

The investigated samples were impacted by either a falling dart (Fig. 6) and a laser beam (Fig. 7). The mechanical impacts were performed at a velocity below 2 m/s to simulate the typical impact on

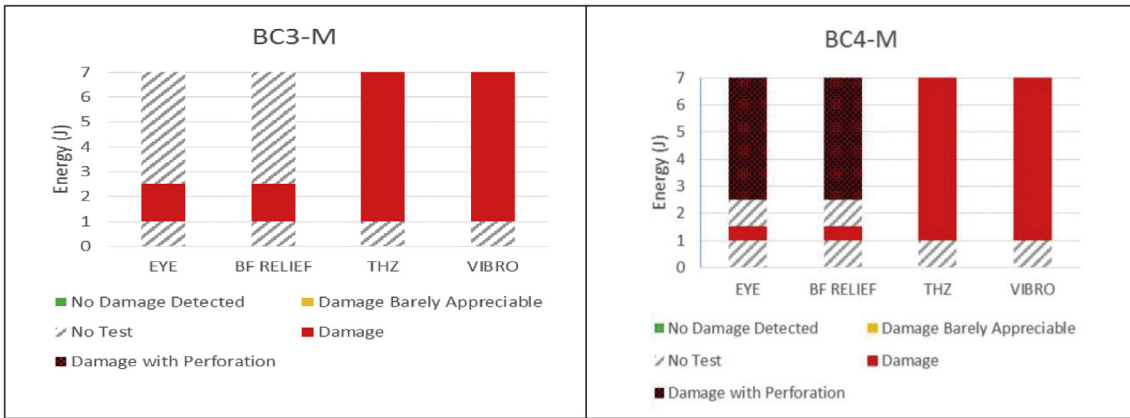
Fig. 16. Damage detection thresholds of BC3-M and BC4-M samples.

The results for samples with medium-length fibres (BC3-M and BC4-M) are depicted in Fig. 16. Damaging was observed already after the impact at 1.0 J and the damage threshold for BC4-M was as for TWA-M sample (Fig. 15), since already after an impact at 2.5 J perforation was detected.
