## On the role of the spherulitic microstructure in fatigue damage of pure polymer and glass-fiber reinforced semi-crystalline polyamide 6.6

# On the role of the spherulitic microstructure in fatigue damage of pure polymer and glass-fiber reinforced semi-crystalline polyamide 6.6

Understanding fatigue damage mechanisms in short fiber reinforced thermoplastics is a key issue in order to optimize material processing and propose physically based multiscale fatigue damage models. The present work aims at further understanding observations of fatigue damage in the polyamide 6.6 matrix with respect to its semi-crystalline structure. In this paper the polymer and associated composite are tested in their ductile regime i.e. above the glass transition temperature. Tomographic and SEM observations are used in order to establish a damage scenario at the spherulitic scale. These observations prove that fatigue damage progresses by intra-spherulitic failure in their equatorial plane. Observations of the spherulite nuclei also evidence the oriented structure of the semi-crystalline polymer induced by the injection-molding manufacturing process.

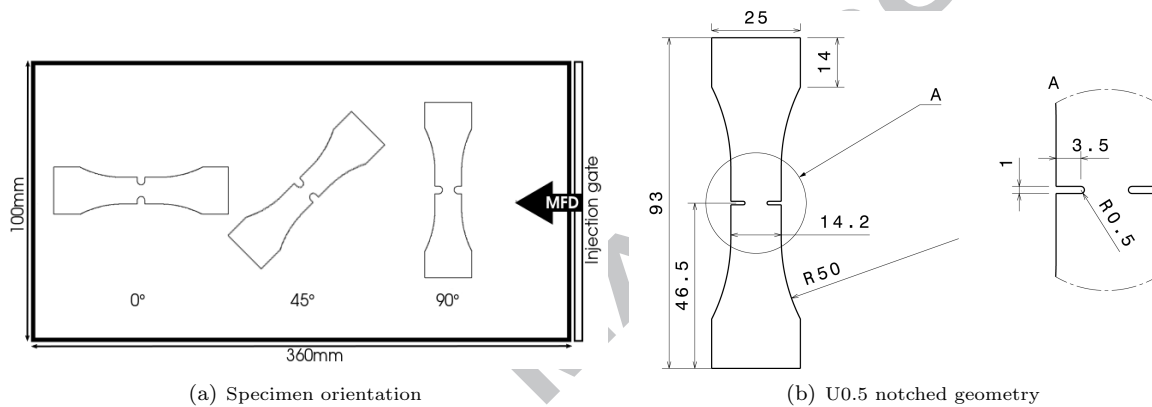
Figure 4: Geometries and S-N curves for the notched specimens.

Fatigue specimens are waterjet-cut from injection-molded rectangular plates  $3.24\text{mm}$  thick. Samples can be cut from plates along three directions with respect to the MFD:  $0^\circ$ ,  $45^\circ$  and  $90^\circ$  (fig. 4(a)) for both pure and reinforced polymer. Specimens are designated by the direction of their main axis with respect to the MFD. The use of notched specimens allows for the localisation of the damage to make the observation of fatigue damage by tomography easier. The notched geometry that was considered here is a symmetric “U” notch of  $0.5\text{mm}$  in radius (fig. 4(b)).

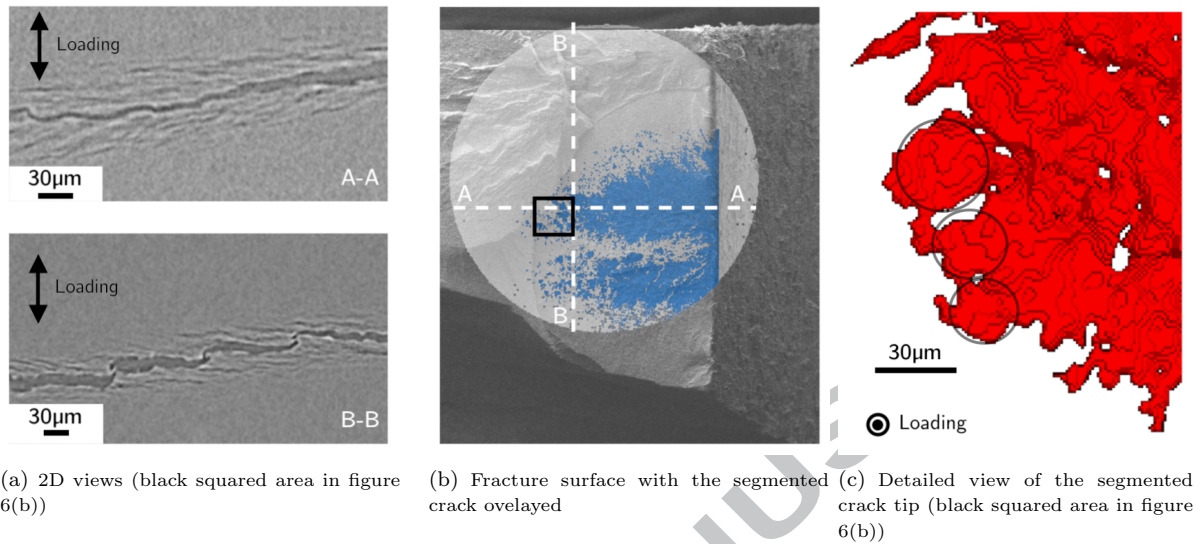
Figure 6: Crack tip in a PA66 notched specimen as observed by microtomography, test interrupted at 2531 cycles and 95% of estimated fatigue life.

Interrupted fatigue specimens were observed using tomography after the initiation of a mesoscopic crack (a few millimeters in size). Typical examples of fatigue cracks as observed on pure PA66 are given on fig. 5 for a several millimeters crack and on fig. 6(b) for what can be considered as a short fatigue crack (few hundred microns in length).

most probably correspond to the cavitation process identified on fig. 5(a). In addition to this cavitation process, some larger damaged area can be clearly identified. Once segmented, they appear as flat, penny shape like volumes about  $20\mu\text{m}$  in diameter (see fig. 6(c)). This size and shape strongly suggest that these penny shaped damage zones correspond to intraspherulitic damage developing ahead the crack tip.

in other regions of the spherulite (see fig. 11(a)) for longer cracks, as suggested by fig. 6(a). However more precise tomographic (nano-tomography) data would be required to fully assess the nature of this secondary damage.

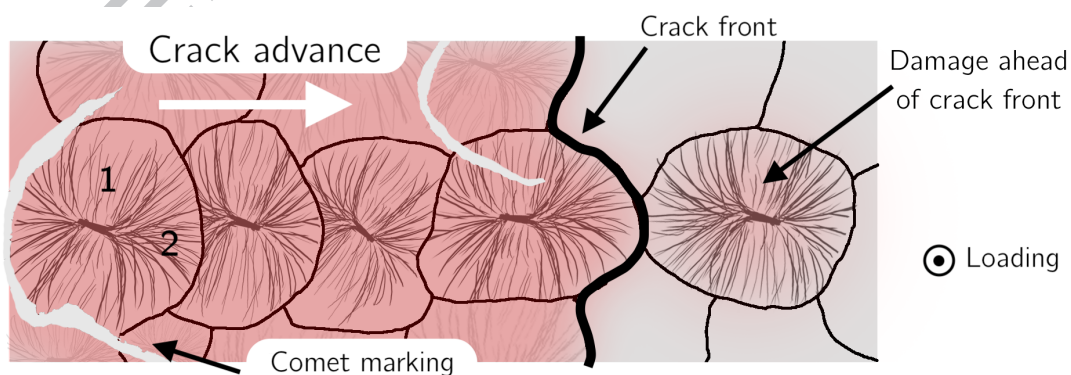
Figure 11: Schematic of the influence of the spherulitic structure of the polymer on fatigue crack advance.

The 2D tomographic observations of a characteristic damage length and the 3D observations of disk-like structures allow to propose a damage propagation scenario as illustrated figure 11. Locally, the crack takes a path that depends on the spatial spherulitic arrangement.

It can be noted that the crack propagates either perpendicularly (region 1 on fig. 11(b)) or parallel (region 2 on fig. 11(b)) to the lamellae in the equatorial plane. More diffuse damage might also develop

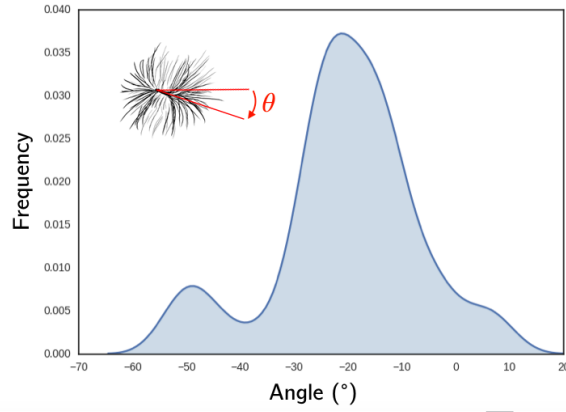
Figure 12: Orientation of the 40 nuclei observed on 3 different PA66 specimens after fatigue testing.

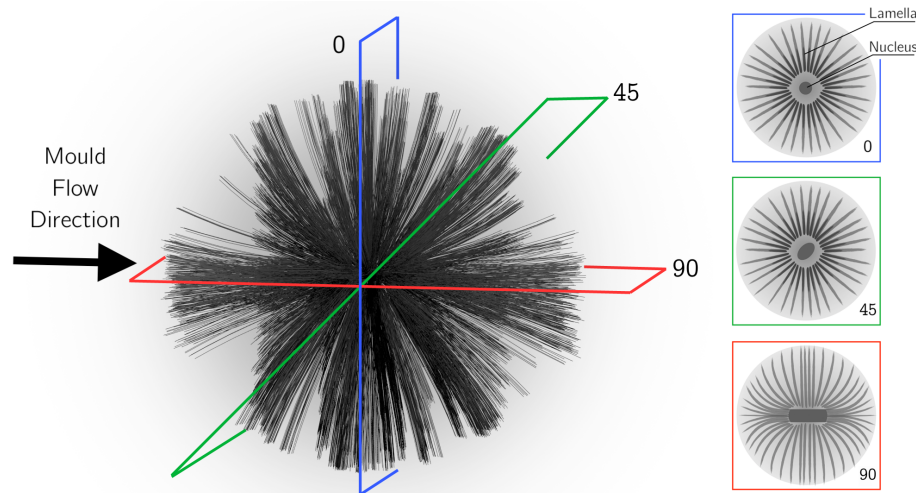
Figure 14: Oriented spherulitic structure induced by the injection molding.

These observations could be explained by a phenomenon of flow-induced crystallization whereby nucleation is in part triggered by the local organisation of the polymer chains induced by the flow. Although the strain in the flow is not important enough to obtain crystallization as a shish-kebab structure [32], it might be sufficient to induce a preferential direction at the onset of crystallization. Some polymer chains extend in the molten polymer and organize themselves resulting in a crystalline structure, oriented in the flow direction, that will form the future nucleus. Subsequent crystalline lamellae growth continues radially from this structure during cooling, thus forming an overall *spherical* arrangement around the oriented nucleus. The semi-crystalline organisation in our injection-molded thermoplastic is therefore an intermediate between purely radial spherulites and strongly oriented shish-kebab structures (fig. 14).
