Crack arrest capabilities of AA2024 and AA7175 aluminum alloys under impact loading

Gunasilan Manar, Patrice Longère

Gunasilan Manar, Patrice Longère. Crack arrest capabilities of AA2024 and AA7175 aluminum alloys under impact loading. *Engineering Failure Analysis*, 2019, 10.1016/j.engfailanal.2019.06.075 . hal-02164321

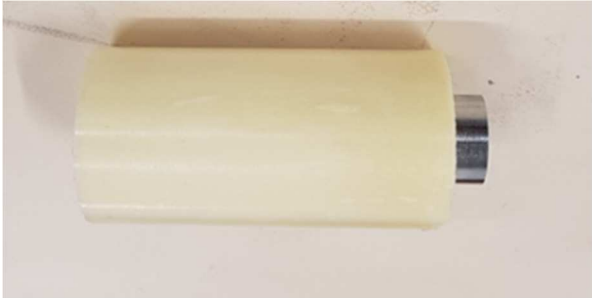
Fig.6 : Steel projectile inside foam housing

Kalthoff and Winkler (KW) type impact tests, see Kalthoff and Winkler [1], were carried out by using 6 m-length and 40 mm-inner diameter gas launcher tube using STIMPACT impact facility – the facility consists of 3 gas launchers with complementary performances with inner diameter of 40, 60 and 120 mm, respectively, see Figs.3-5 for the experimental set-up. The 20 mm-diameter projectile made of hard steel is placed inside a 40 mm-outer diameter cylinder made of foam, see Fig.6, whose function is to reduce the friction inside the gas launcher tube.

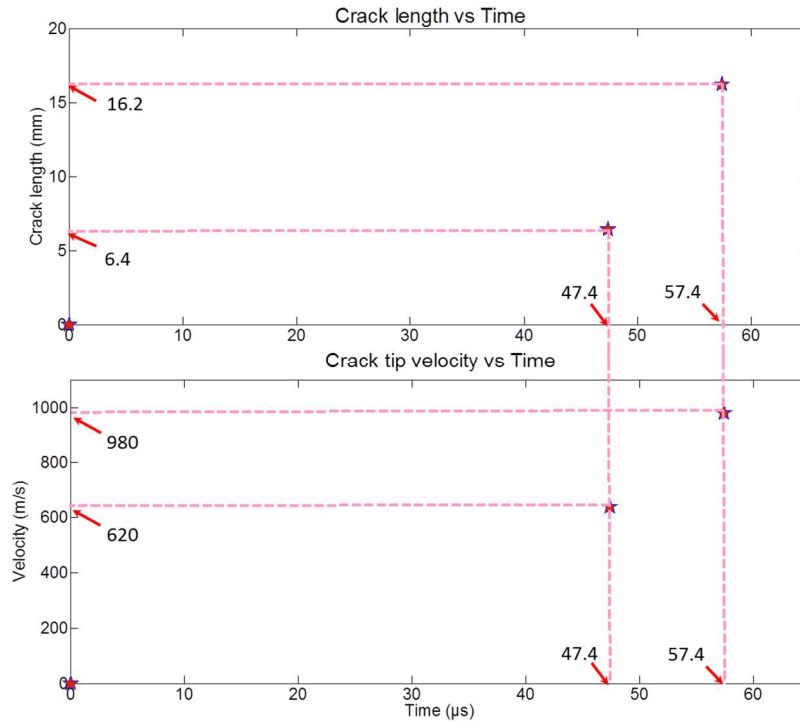
Fig.16 : Crack length and crack tip speed for AA 2024

Fig.16 shows the evolution of crack length and crack tip speed for AA 2024.

- At $t=47.4\mu\text{s}$ crack length is 6.4 mm and at $t=57.4\mu\text{s}$ crack length is 16.2 mm.
- At $t=47.4\mu\text{s}$ crack tip speed is 640 m.s^{-1} and at $t=57.4\mu\text{s}$ crack speed is 980 m.s^{-1} .

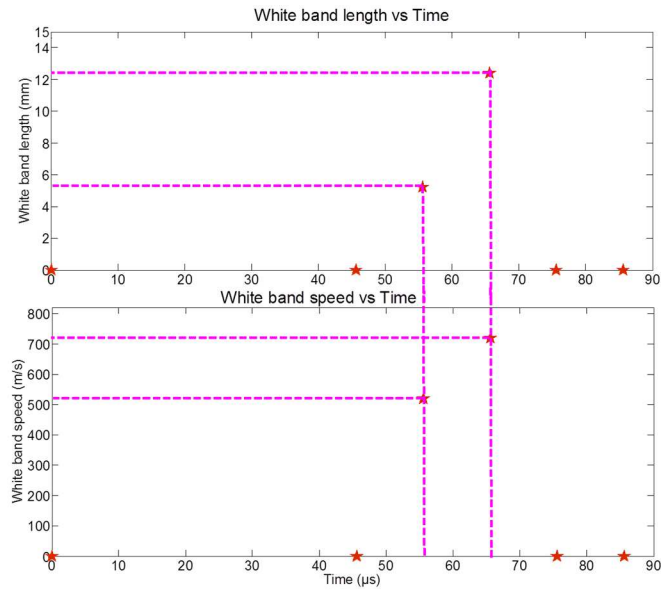
Fig.18 : White band length and white band speed for AA 7175

The average speed of the white band propagation in AA 7175 for the duration of $10\mu\text{s}$ can be estimated by applying equation 2. Fig.18 shows the white band length and its speed evolutions.
