# Electrostatic Discharge Tests for JUICE Photovoltaic Assembly

**Abstract**—In the framework of JUICE Photovoltaic Assembly, development and testing activities have been carried out in order to verify the effectiveness of grounding networks solution against ESDs occurrence in charging environment. During prequalification phase, dedicated coupons have been manufactured and submitted to environmental test campaigns, including ESD characterization. As the PVA design has progressed, a new ESD coupon with more representative technologies has been then manufactured and tested for electrons charging, so to compare results and assess new design and materials. This paper firstly describes the coupons manufactured for ESD testing, then an overview on ESD characterizations performed is provided. Lastly, relevant conclusions and comparisons between the results are discussed.

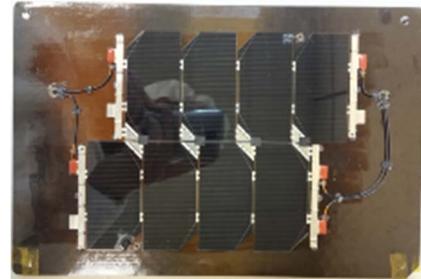
A picture of the coupon A1 is presented in Figure 1: it is remarked that the coupons were manufactured by ensuring an interstring gap of 0.5 mm between the 2 strings, as a worst case for secondary arcing occurrence.

Figure 1 – Pre-qualification coupons layout

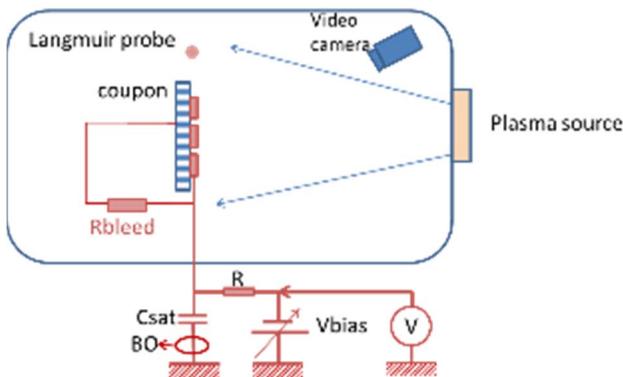
Figure 2 – Set-up in JONAS facility with plasma source

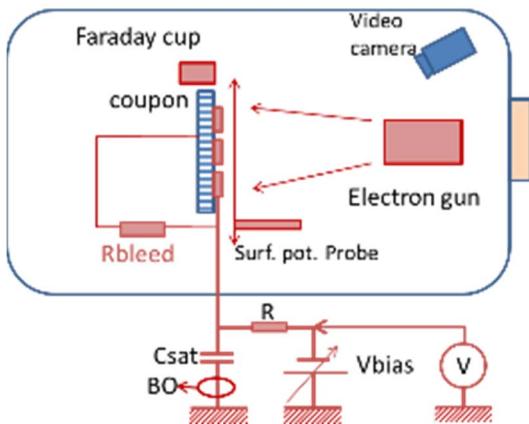
Aim of the primary arcs tests were to highlight which materials of the coupon were more subjected to charging and to identify locations where Inverted Potential Gradient (IPG) was established. In Figure 3, a schematic of the set-up used by ONERA is presented.

Figure 3 Set-up in JONAS facility with electron source

The same set-up presented in Figure 3 has been used by ONERA, biasing the coupon substrate to - 5 kV and irradiating the coupon surface with a 5.5 keV electron beam, with current density of 12 nA/cm<sup>2</sup>. The lateral sides of the coupon have been shielded with Al foil in order to prevent ESDs to occur only on honeycomb's edges.

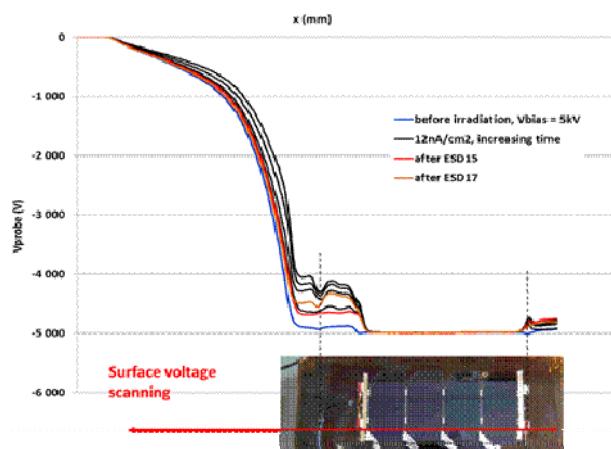
As additional important output of this workpackage, a voltage probe was scanned close to the surface of the coupon's PVA after irradiation's runs, in order to verify the grounding network's effectiveness in keeping the coverglasses potential equal to the one of the coupon's substrate (-5 kV). The result of such scanning on coupon A1 is presented in Figure 4, where it is possible to appreciate that the potential measured close to the coverglasses was indeed -5 kV, without deviations along the whole length of the strings. Similar plot was obtained for coupon A2. Higher potential was measured out of the strings and in particular on the exposed kapton surface, as expected.

Figure 4 – Voltage probe measurement on pre-qualification coupon

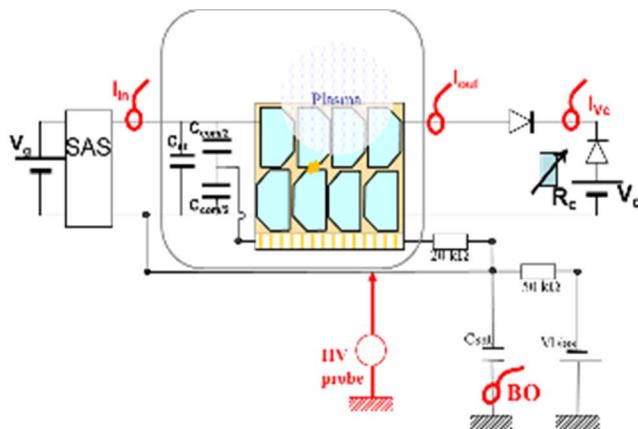
Following step, after primary arcs testing, consisted in biasing the strings in order to check the current-voltage combination needed to trigger secondary arcs on the coupon. The set-up illustrated in Figure 5 was used: by means of a Solar Array Simulator, strings were biased in order to achieve different voltage-current combinations, covering different mission phases of JUICE; current was set to progressively increasing values, starting from very low values (20 mA) up to 0.5 A. Capacitance values were chosen to correctly represent the presence of the remaining strings on the complete solar array. Test was performed in

Figure 5 – Schematics of test set-up for secondary arcs test

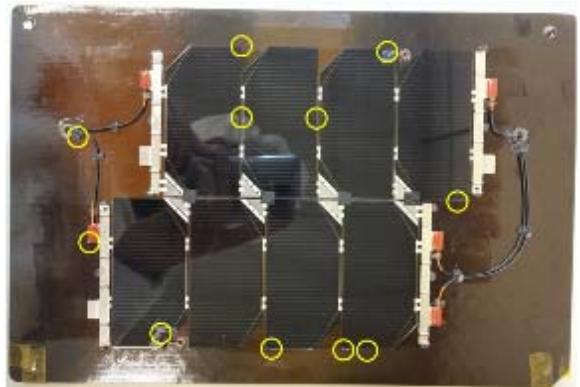
- From ESD test point of view, no difference was observed between coupons that had been submitted or not to TV cryogenic cycling
- No degradation of dark IV curves at string level was observed on both coupons after exposure to plasma source, to electrons beam and after secondary arcs test.
- ESDs have been discovered to occur on several locations of the coupons. Most typical ones, for electrons irradiation, are shown in Figure 6

Figure 6 – ESDs locations on pre-qualification coupons

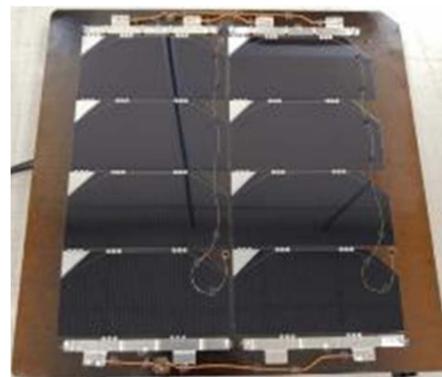
Figure 7 - ESD validation coupon's front side

As the development phase of JUICE PVA progressed, some of the key technologies have been modified or newly designed. On the PVA, the focus of a major improvement has been the grounding network that connects the coverglasses to the rear side: instead of conductive adhesive patches, a metallic wire running on the coverglasses has been preferred [2], so to increase reliability and effectiveness of electrical grounding. Also on the substrate rear side, solar array prime contractor Airbus D&S Netherlands, has chosen a design in which black kapton is applied on the carbon fiber skin [3]. Pictures of the front and rear side of this coupon are presented on Figure 8. Because of these major changes and other minor design modifications, ESD test has been repeated to validate such technologies for electric charging behavior.

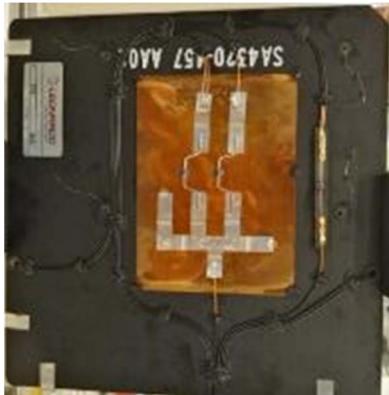
Figure 8 – ESD validation coupon's rear side

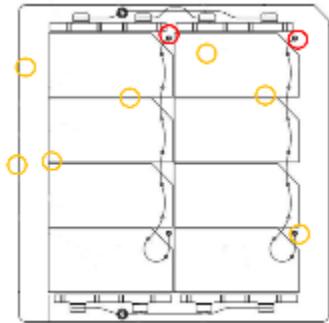
Hereafter focus is put on results regarding irradiation on front side, which is a more critical for the PVA than the rear side. On Figure 10, the positions of ESDs recorded during the 4 hours test are presented: in red circles ESDs are highlighted in case their number has resulted to be higher than 10, in yellow circles discharges occurring less than 2 times during the irradiation time.

Figure 9 – Schematics of ESDs positions on front side

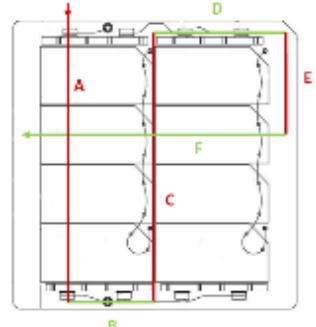
Figure 10 - Schematics of voltage probe scanning path on front side

Voltage probe scanning has been performed following a x-y path indicated in Figure 10 and the associated results in terms of measured voltage are plotted in Figure 11; it can be recognized, on paths A, C and F, that the voltage measured in proximity of the ITO coated coverglasses is in fact equal to -5 kV, demonstrating that no IPG is established on coverglasses or on the grounding network. On path C, small fluctuations that are visible are due to the kapton left exposed on the 3 crop-corners between the two different strings. ESDs are concentrated in correspondence of the two feedthrough holes through which the grounding metallic wire is routed to the rear side: this is explained by the presence of small bushings, that are made of dielectric material, close to the metallic grounding wire. It is worth to mention that, after 4 hours irradiation, ESDs rate decreased by a factor of 5, maintaining a decreasing trend, due to the vaporization of sharp tips that were the location of the cathodic spots.

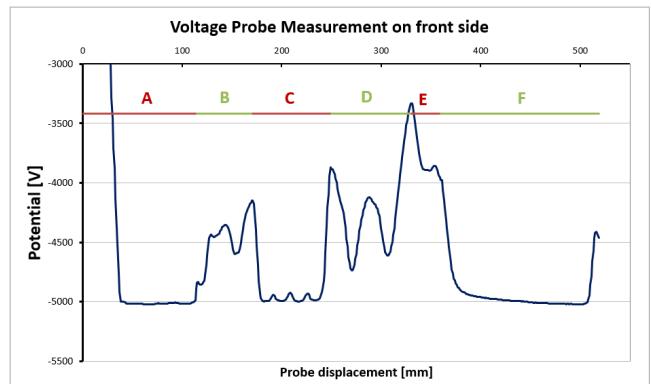
Figure 11 – Voltage probe measurements on front side

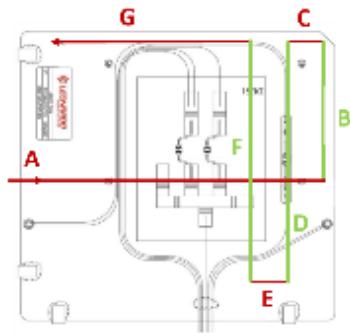
Similar tests have been repeated by irradiating the coupon rear side again with an electron flux equal to  $12 \text{ nA/cm}^2$ . Figure 12 shows the path followed by the voltage probe after irradiation step, while the actual reading is presented in Figure 13. The signal plotted corresponds to the potential bias, where 0 V is the reference ground of the substrate's core. It can be observed that potential is varying significantly: in correspondence of conductive surfaces it is uniform and close to ground, as expected, while IPG occurs in presence of the unavoidable dielectric insulators that are needed for the PVA to nominally operate.

Figure 12 – Schematics of voltage probe scanning on rear side

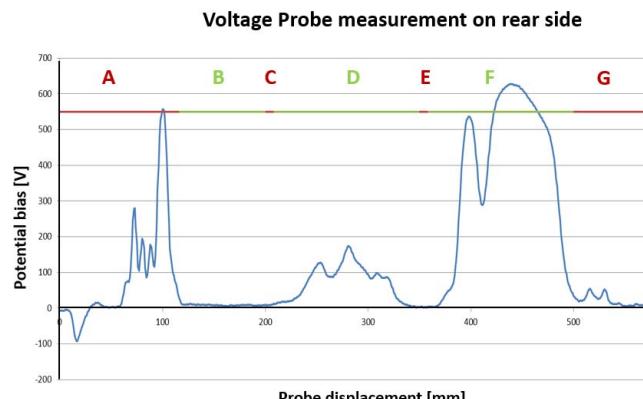
Figure 13 – Voltage probe measurement on rear side
